National Radio Astronomy Observatory
Socorro, New Mexico
VLBA Antenna Memo #69

Fort Davis, Texas VLBA Maintenance Visit May 01-08, 2007.
Team members consisted of Steve Aragon, Eric Carlowe, Ken Lakies,
Ray McFarlin, and Phillip Sanchez. VLBA Site Technicians John Smith
and John Jordon assisted in all areas of antenna maintenance.

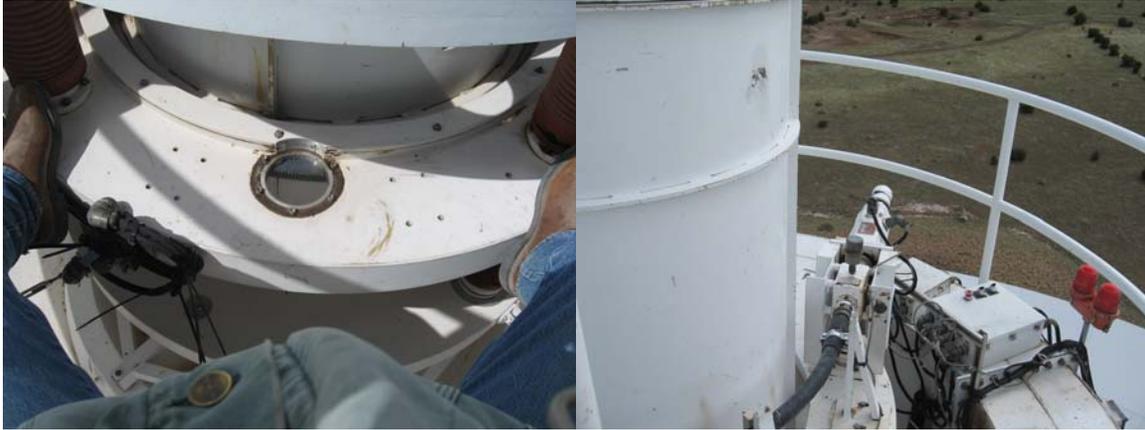
FRM was given a thorough inspection. The flex shaft was replaced 1 year prior to the maintenance visit. Rotation axis had been previously modified to operate on the West position feedback motor only. The sub reflector was previously rebalanced. The snow tarp was removed and three 1 inch drain holes were drilled in the center of the sub reflector for extra drainage.

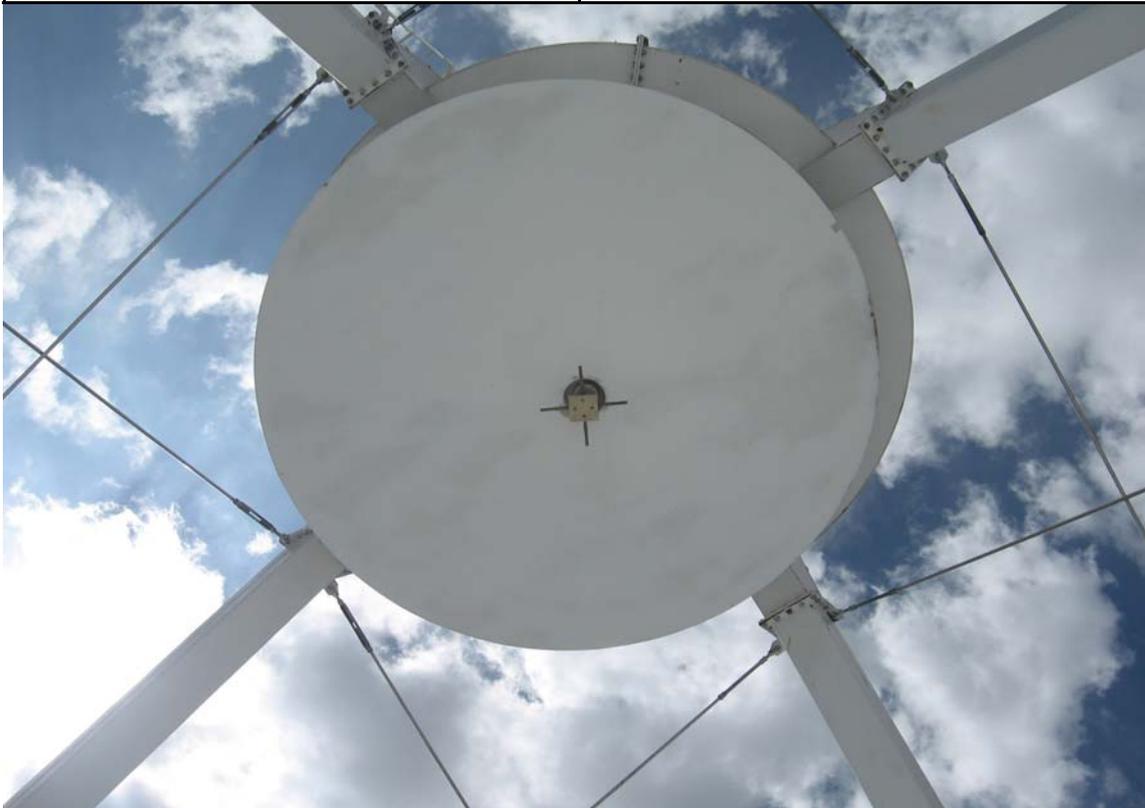
Sub reflector paint is in good condition.

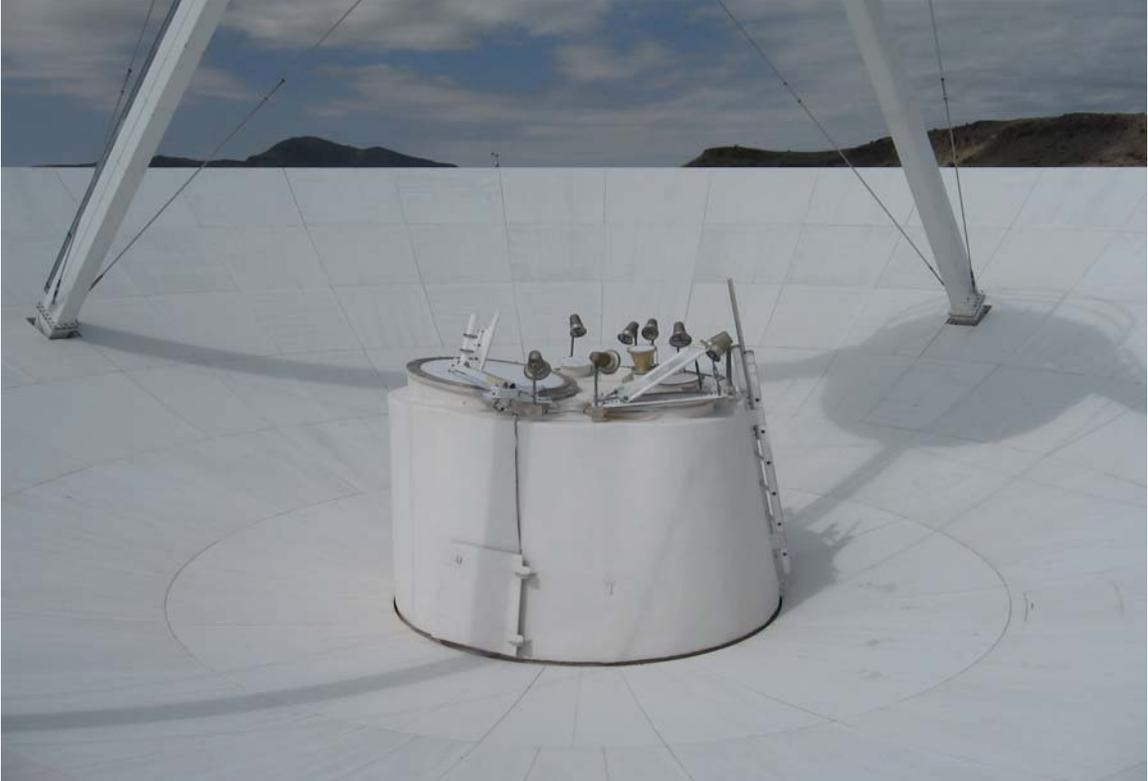
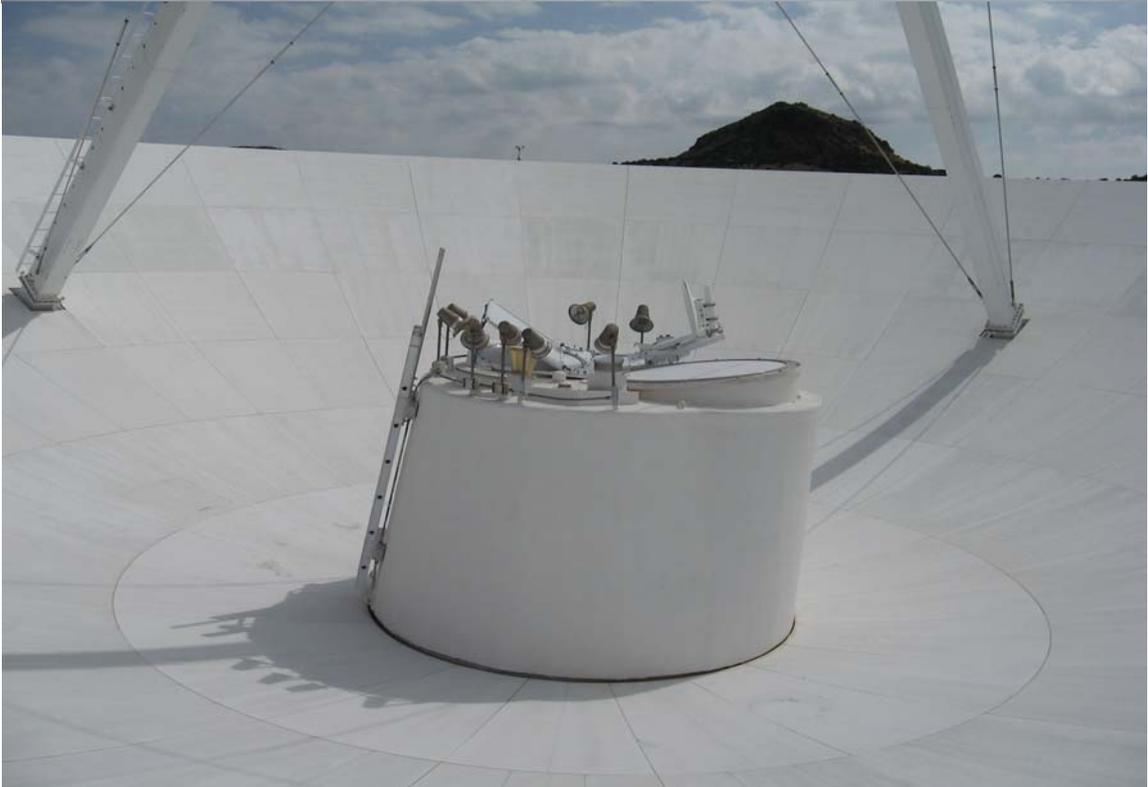
Dish panels are in good condition. The feed cone's elastomeric paint job is holding up well. The feed cone was sealed and painted during the last maintenance trip in 2004.

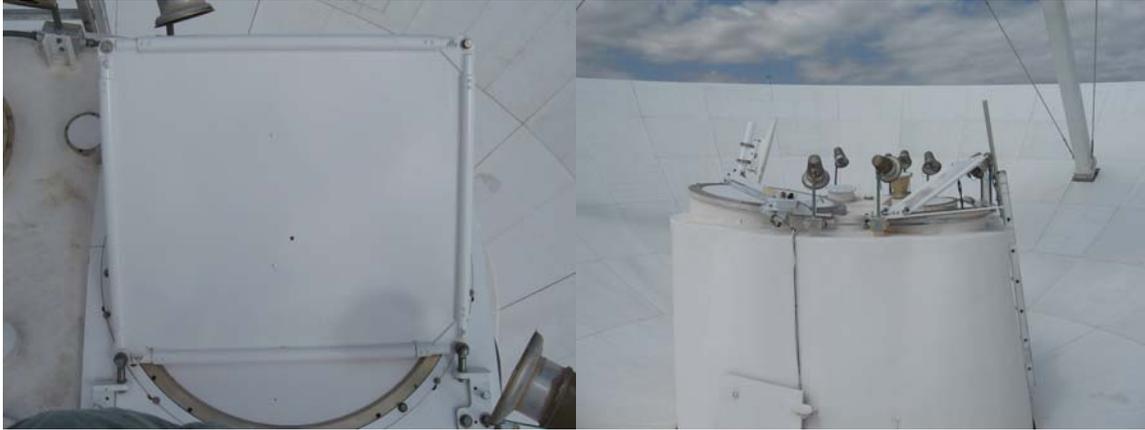
Dichroic reflector is in excellent condition. Ellipsoid reflector is in good condition. Dichroic reflector actuator operates correctly.

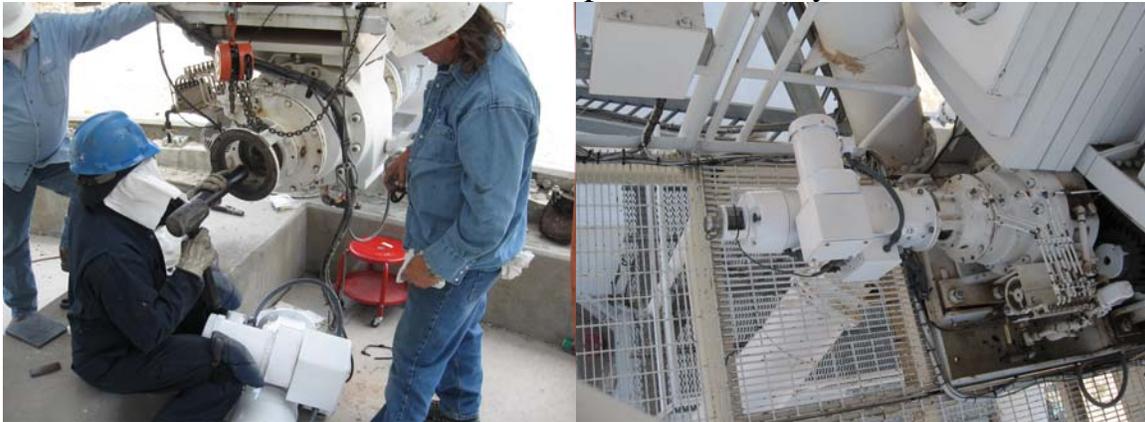
Azimuth #2 Gear Box seal was replaced. Azimuth #2 and Elevation # 1 motors were both replaced. New blower motors and the new design air boxes were installed on Elevation #2 and Azimuth #1 servo motors.

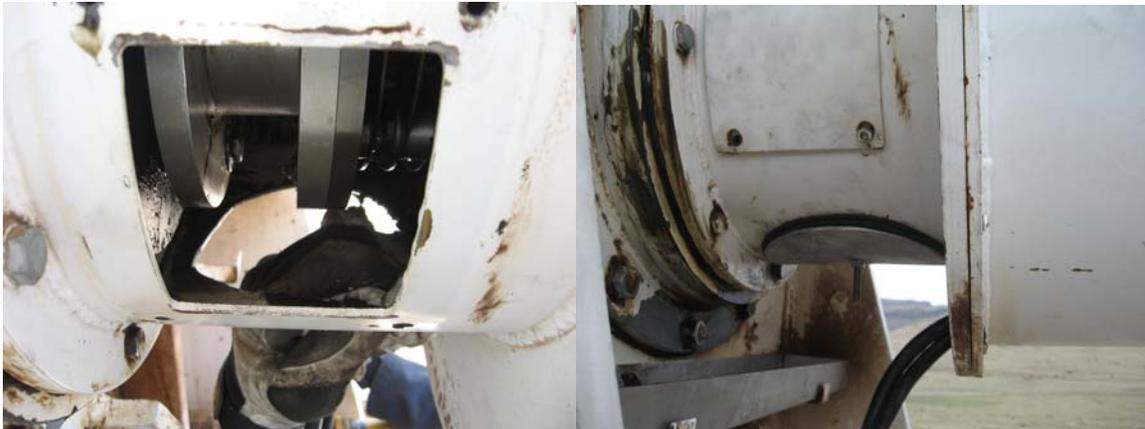
An additional encoder elevation bearing grease clean out was installed. The encoder side elevation bearing **NEEDS** to be replaced ASAP. This bearings grease sample revealed lots of metal and brass particles. Site Techs will take grease samples every 2 weeks to monitor the rate of degradation.

Encoder	Lots of metal-bearing needs replaced.
Synchro	Good grease with no metal flakes.
All bearings are very well lubricated.

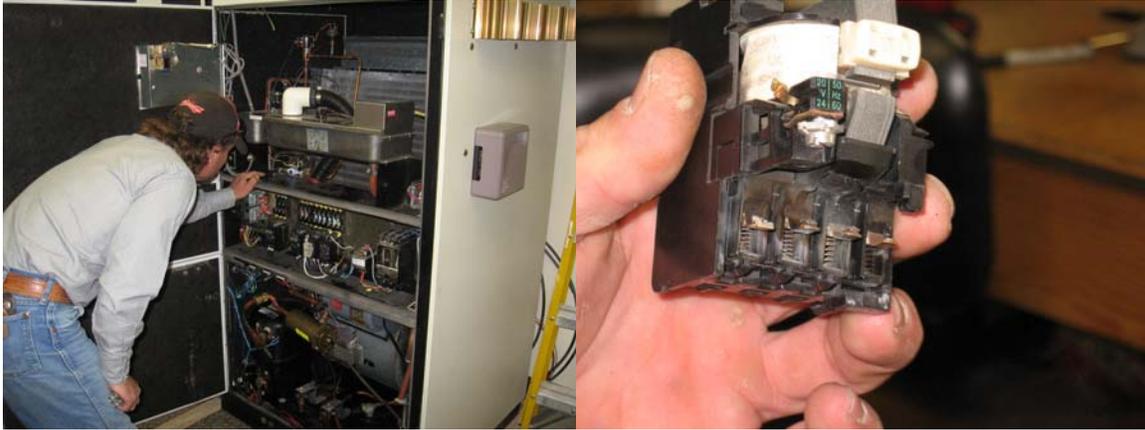
Contempo #2 (Main Unit) compressor was replaced. Several other problems were discovered and repaired on this unit. The vertex room and ped room HVAC systems were both inspected.

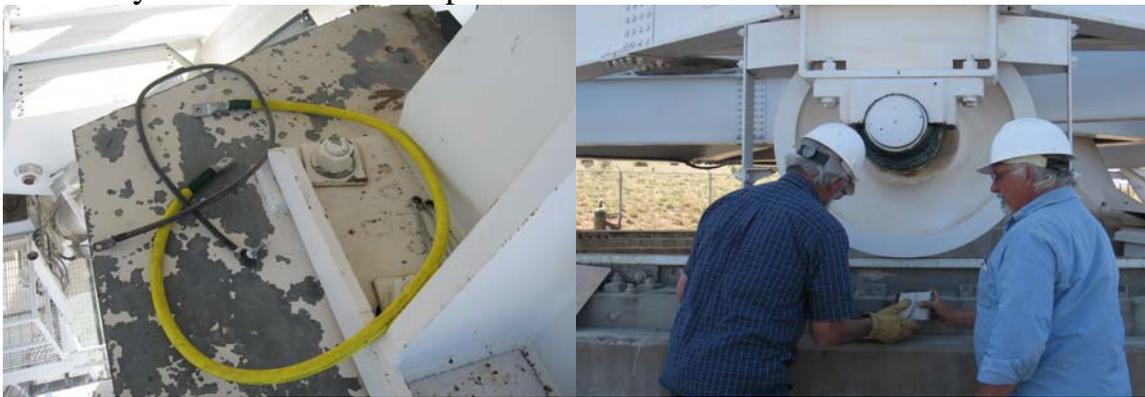
Both elevation axle ground cables were replaced. All azimuth wheel bearings were inspected, none needed replacing.

Pintle bearing is well lubricated with no metal flakes. The new Pintle IF cable wrap upgrade had been previously installed.

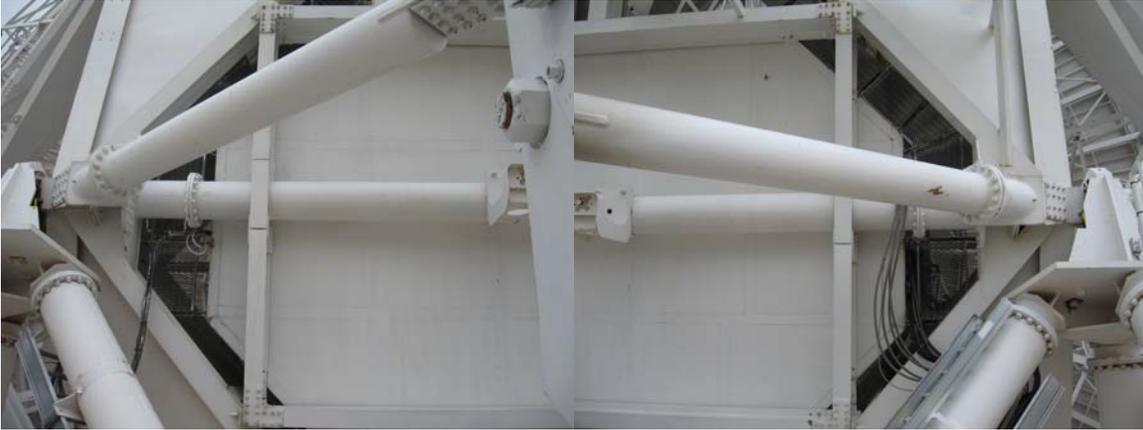
Elevation axle has no visible signs of cracks. Paint is in good condition. The encoder side cable wrap was previously upgraded. No time remained during the maintenance visit to upgrade the synchro side wrap.

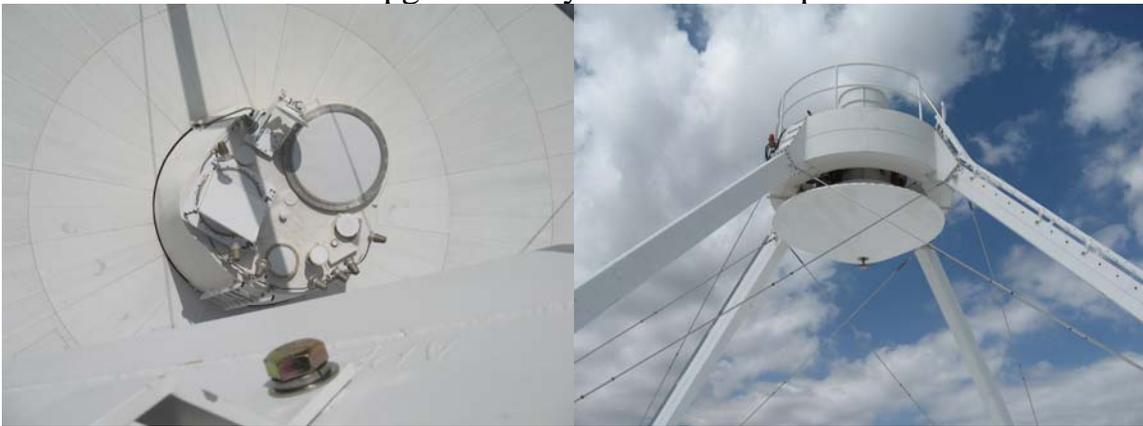
Feed heaters and FE windows are in good condition. Apex paint is in good condition.

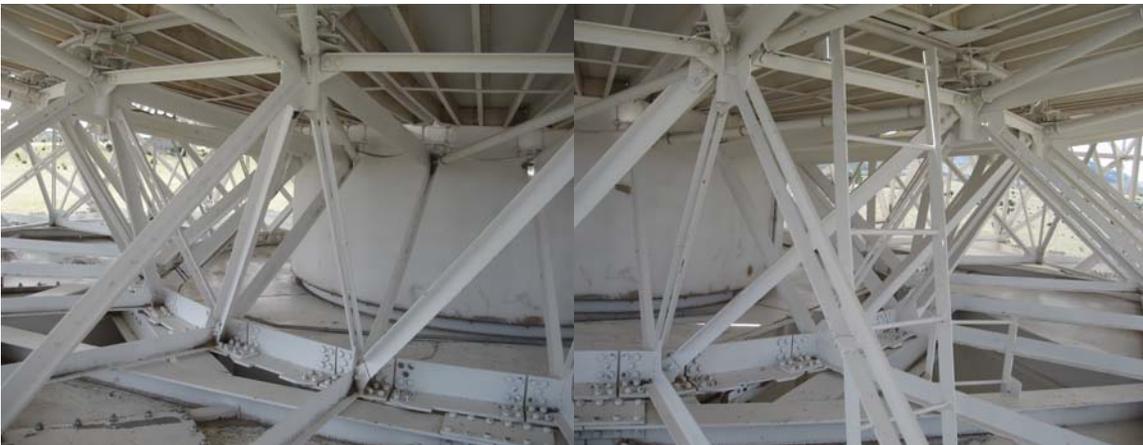
Antenna backup structure is in good condition. Paint is in good condition. No time remained during the maintenance visit to install a new elevation HVAC platform extension.

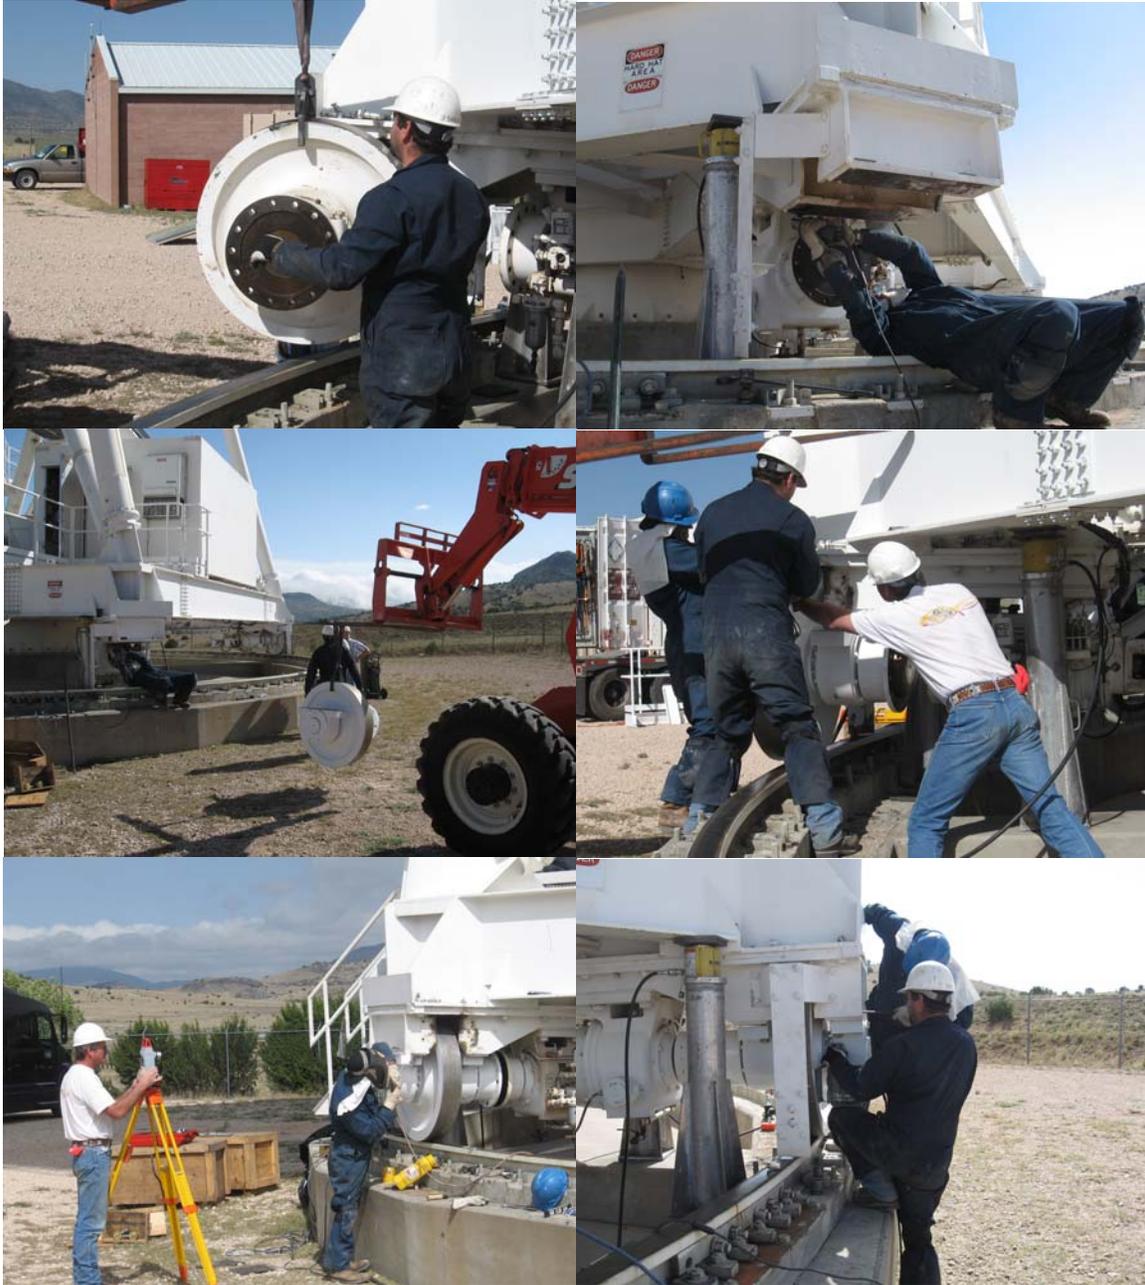
Azimuth #2 Wheel assembly was replaced. The new drive wheel assembly rotated smoothly without any popping or grinding sounds.

MEASURED	SPECIFIED
Conic Radius	300.080	300.00 +/- .25
Coupling Runout	.001	<.005
Vertical	93.462	93.440 +/- .023
Horizontal	.005	<.023

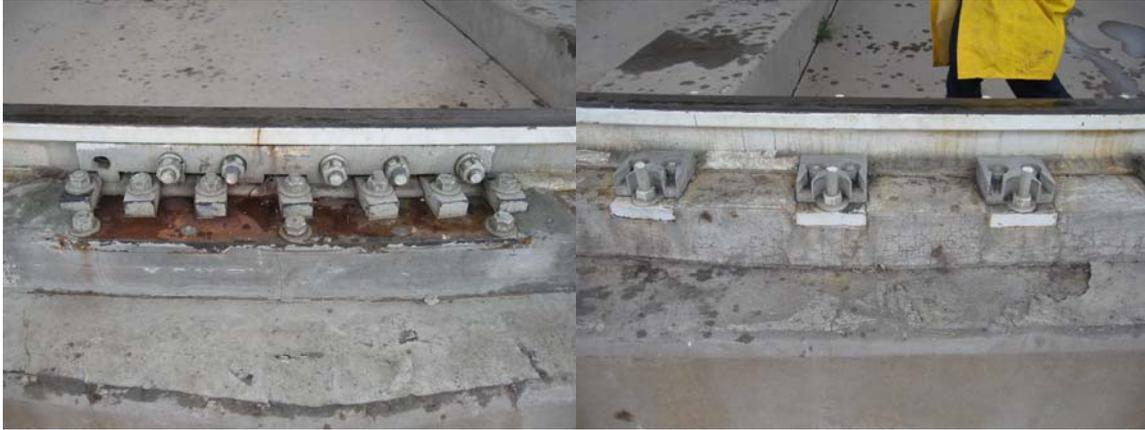
Fort Davis's rail and grout is in good condition. Site Techs should finish removing all remaining Vulchem.
