National Radio Astronomy Observatory
Socorro, New Mexico
VLBA Antenna Memo #71

Brewster, Washington VLBA Maintenance Visit July 24-31, 2007.
Team members consisted of Steve Aragon, Eric Carlowe, Ken Lakies,
Bob McGoldrick, and Phillip Sanchez. VLBA Site Technicians Bob
Sanderson and Mark Hofmann assisted in all areas of antenna maintenance.

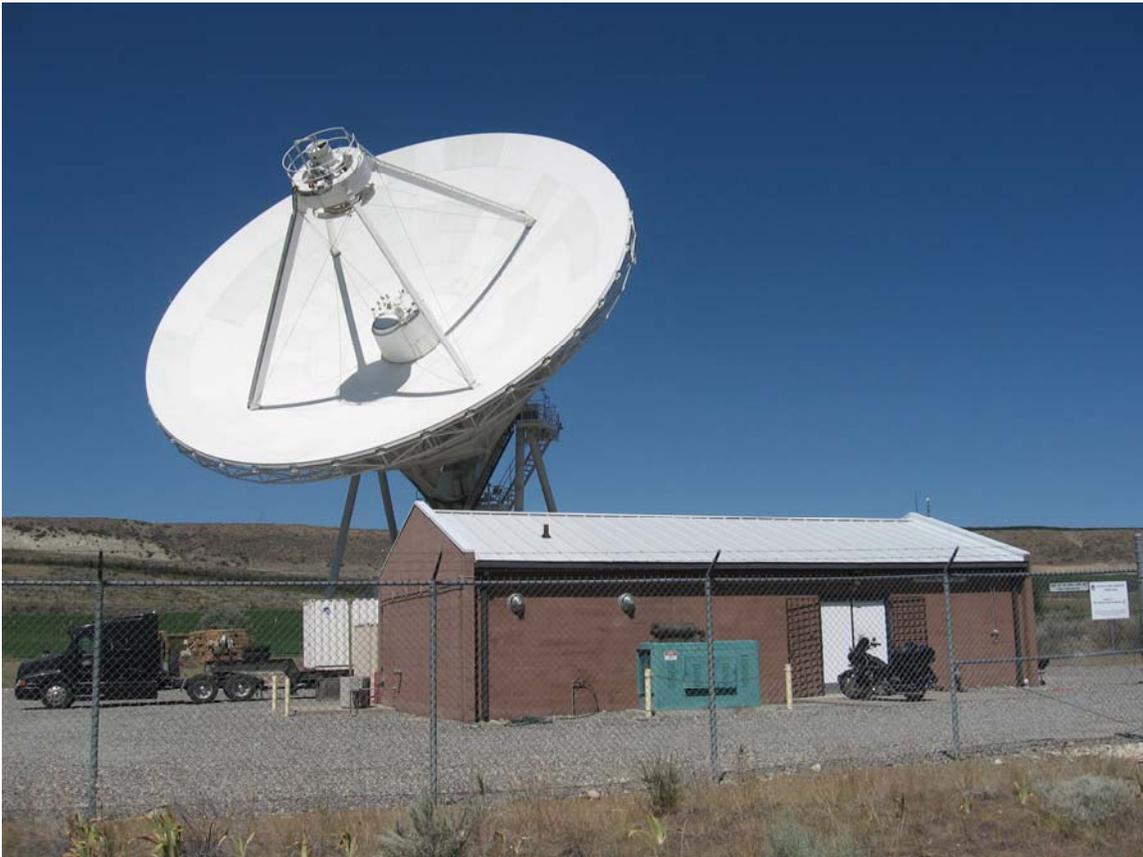
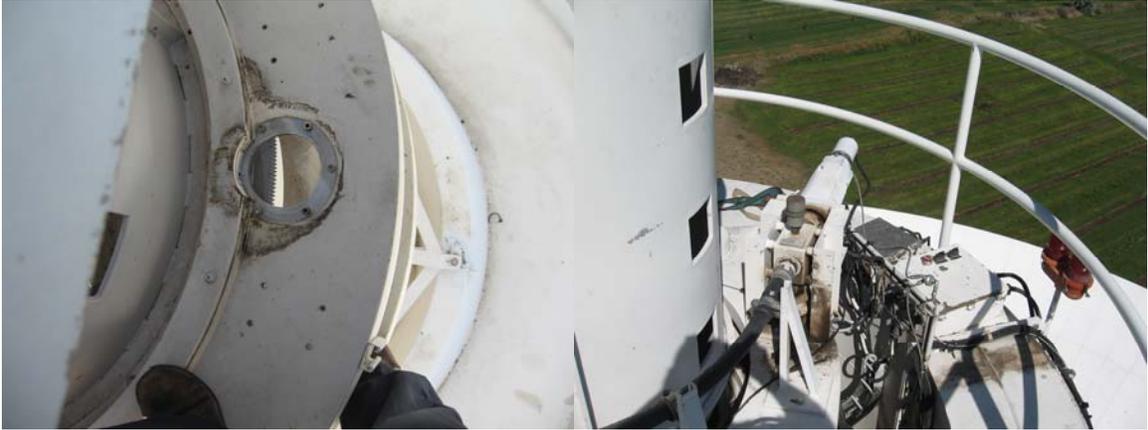
FRM was given a thorough inspection. The focus flex shaft was replaced. The rotation axis was modified to operate on the West position feedback motor only. The sub reflector balance was checked. Three 1 inch drain holes were drilled in the center of the sub reflector for extra drainage.

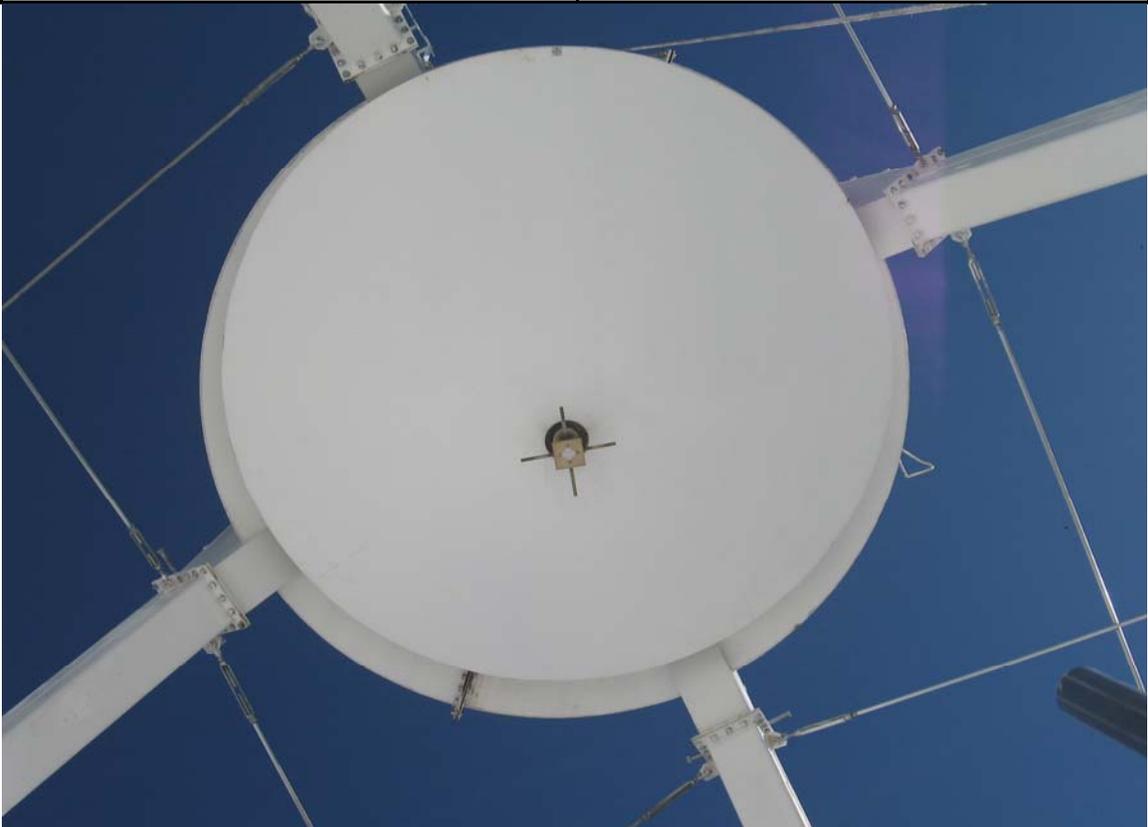
Sub reflector paint is in good condition.

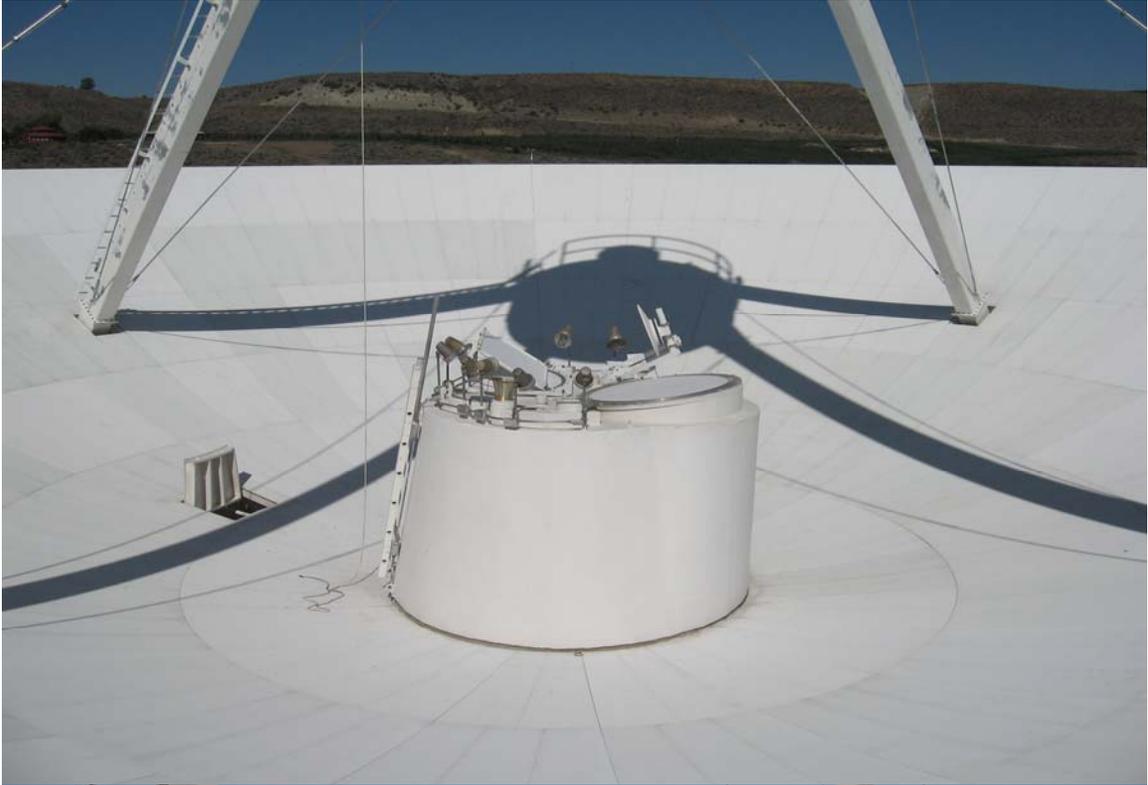
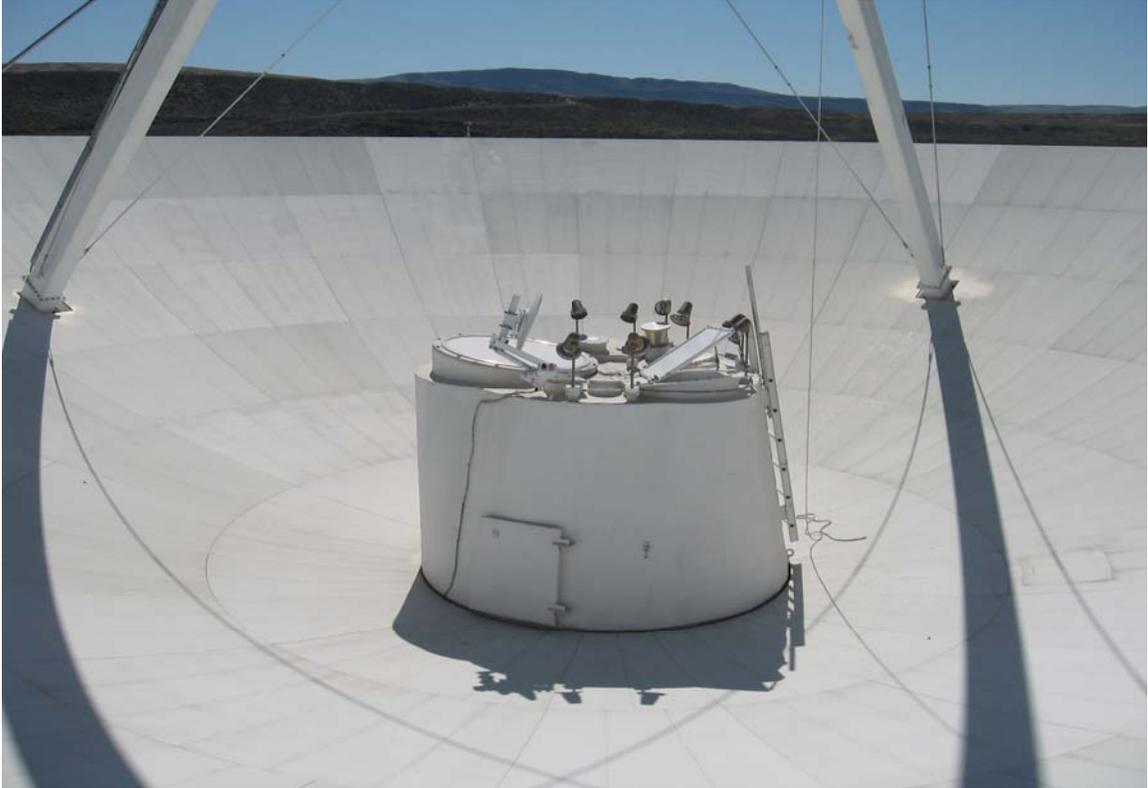
Dish panels are in good condition. The feed cone's elastomeric paint job is holding up well. The feed cone was sealed and painted during the last maintenance trip in 2004.

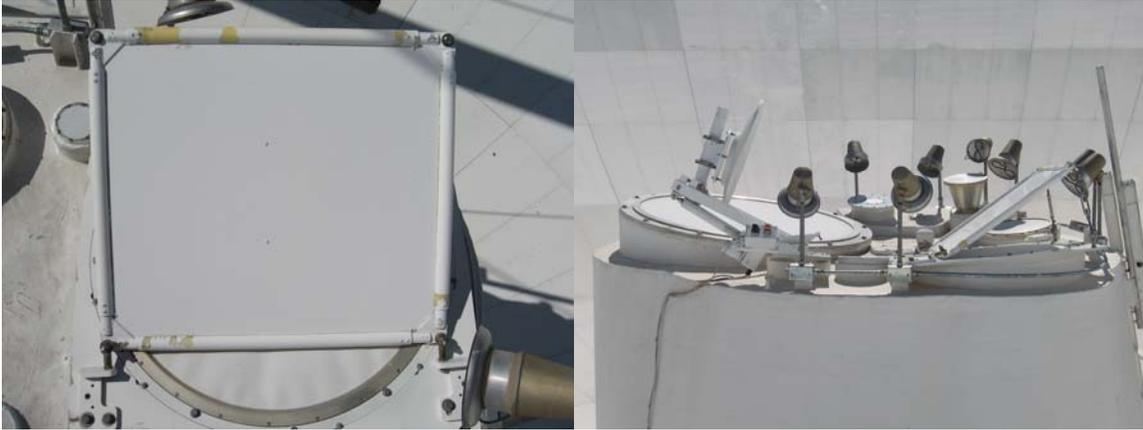
Dichroic reflector is in excellent condition. Ellipsoid reflector is in good condition. Dichroic reflector actuator operates correctly.

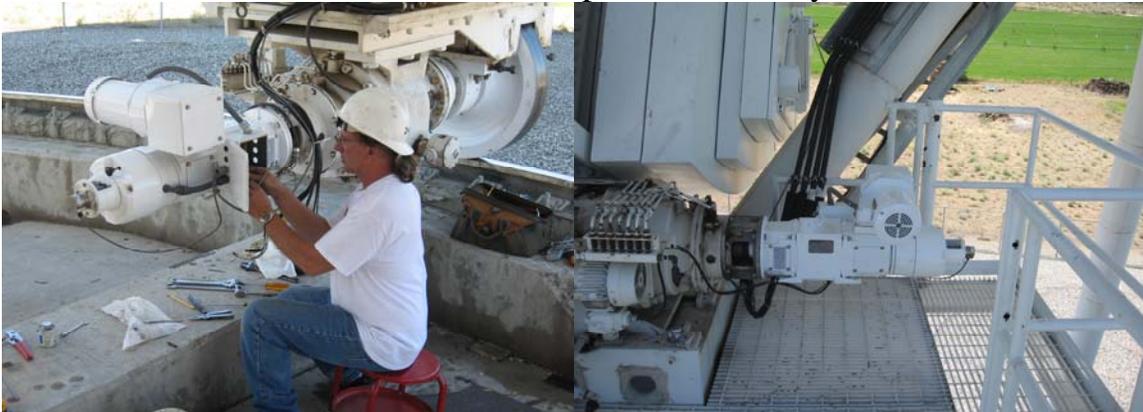
Azimuth #1 and Elevation # 2 motors were both replaced. New blower motors and the new design air boxes were installed on Elevation #1 and Azimuth #2 servo motors.

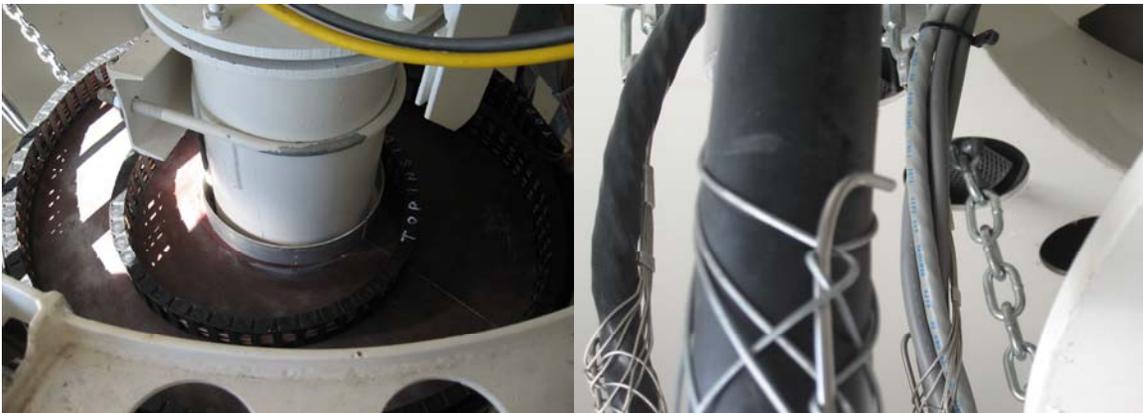
The new IF cable wrap was installed and tested. Two SO power cables strain relief's had to be repositioned to prevent further insulation damage.

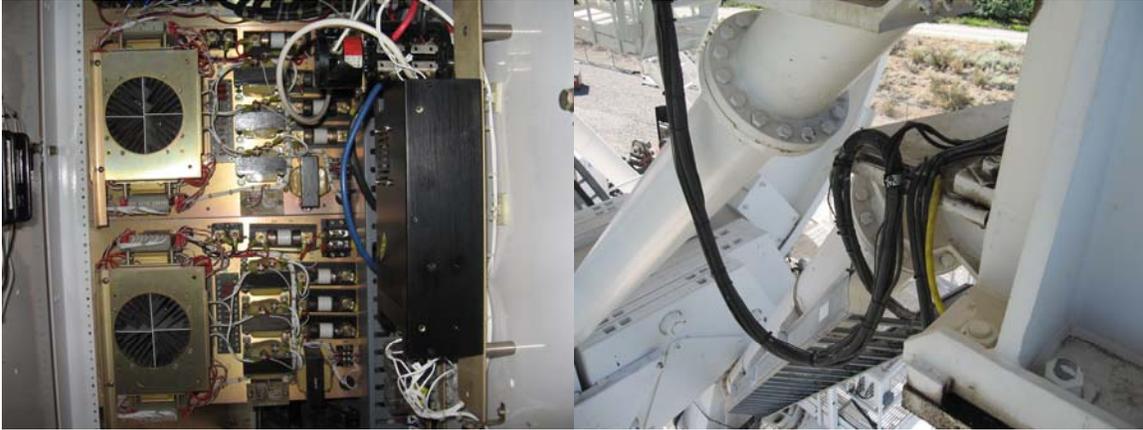
The Servo Drive Cabinet Power Supply upgrade was completed and tested. Both Elevation bearing ground cables were replaced.

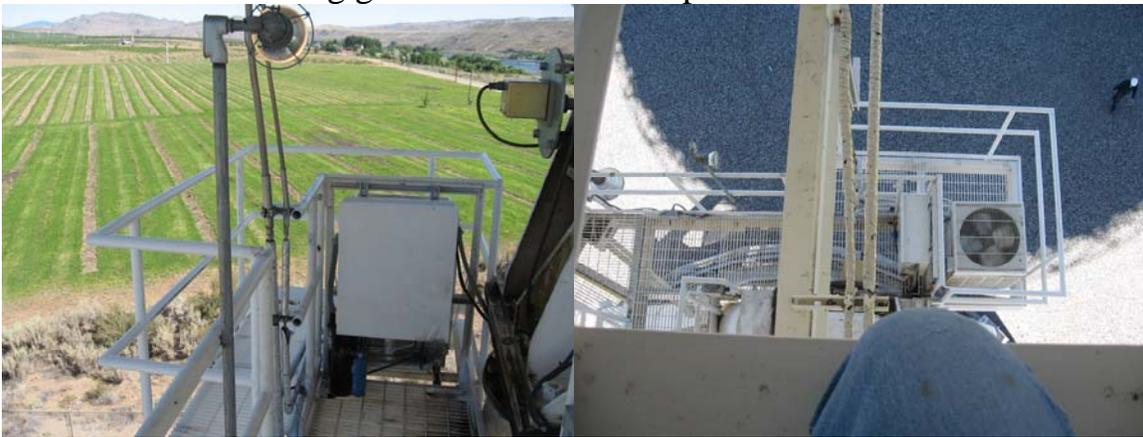
A new Elevation VTX room HVAC extension platform was installed.

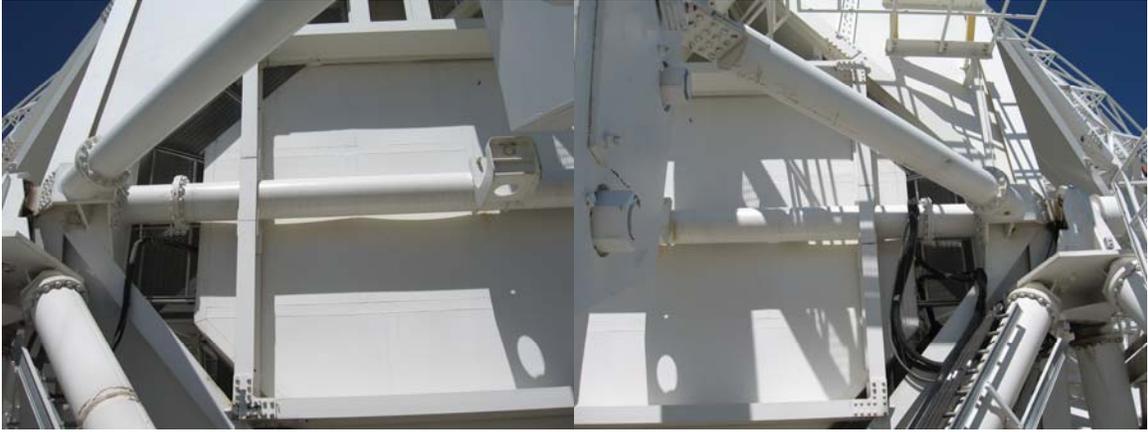
Elevation axle has no visible signs of cracks. Paint is in good condition.

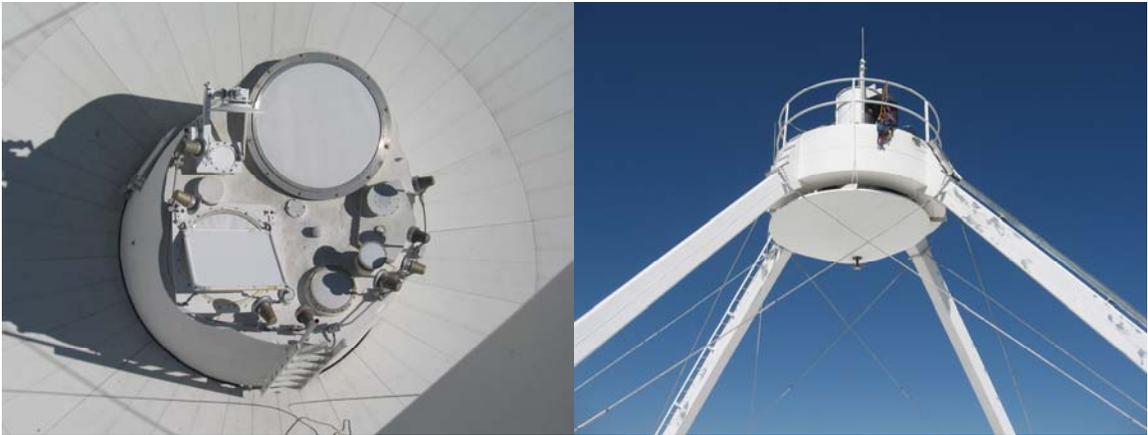
Feed heaters and FE windows are in good condition. Apex paint is in good condition.

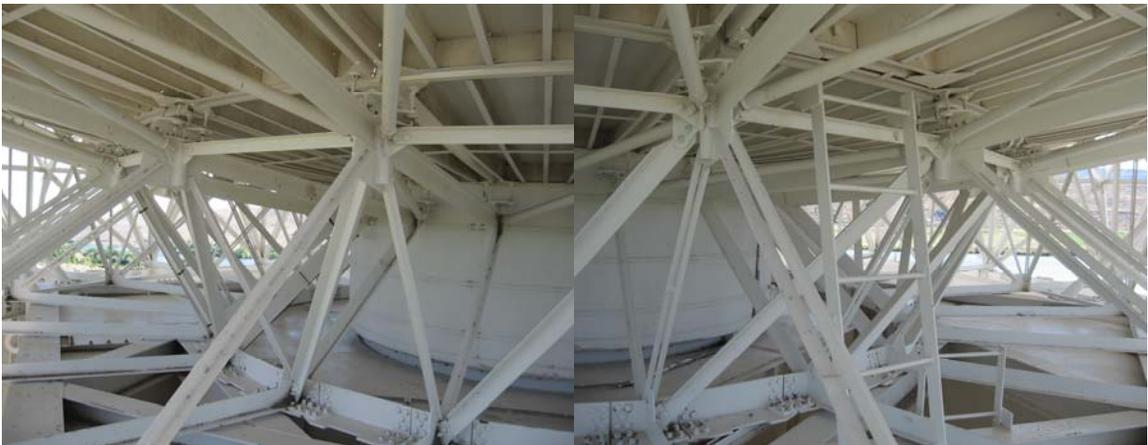
Antenna backup structure is in good condition. Paint is in good condition.

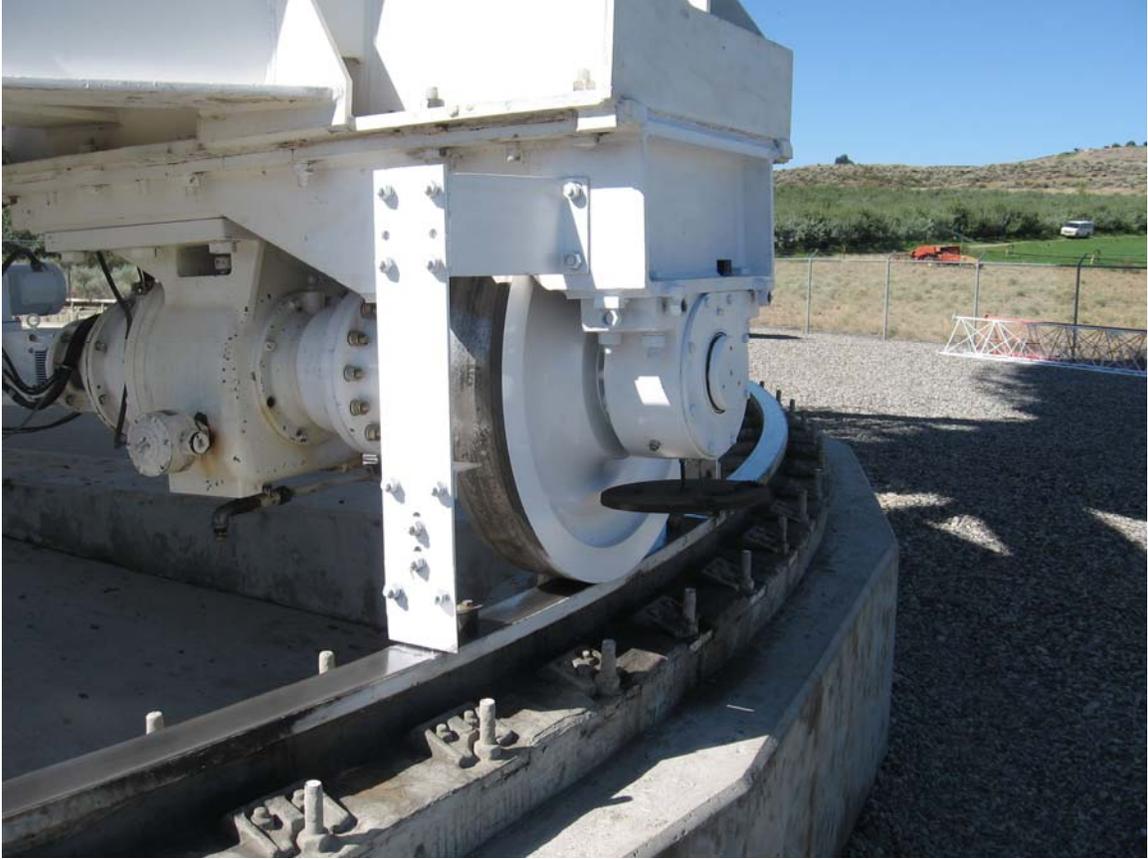
Azimuth #1 Wheel assembly was replaced. The new drive wheel assembly rotated smoothly without any popping or grinding noises.

MEASURED	SPECIFIED
Conic Radius	299.888	300.00 +/- .25
Coupling Runout	.005	<.005
Vertical	93.458	93.440 +/- .023
Horizontal	.021	<.023

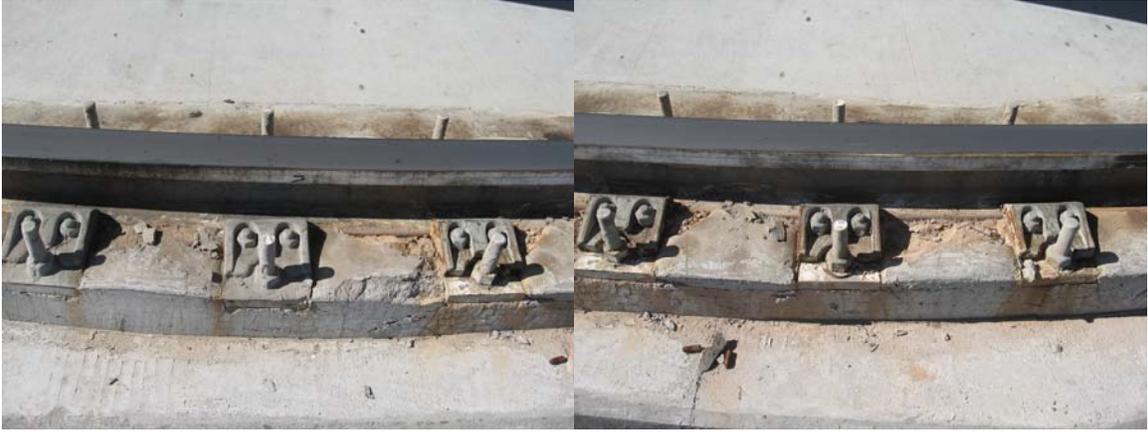
Rail grout is degrading at bolt number 3 and bolt numbers 7, 8 and 9.

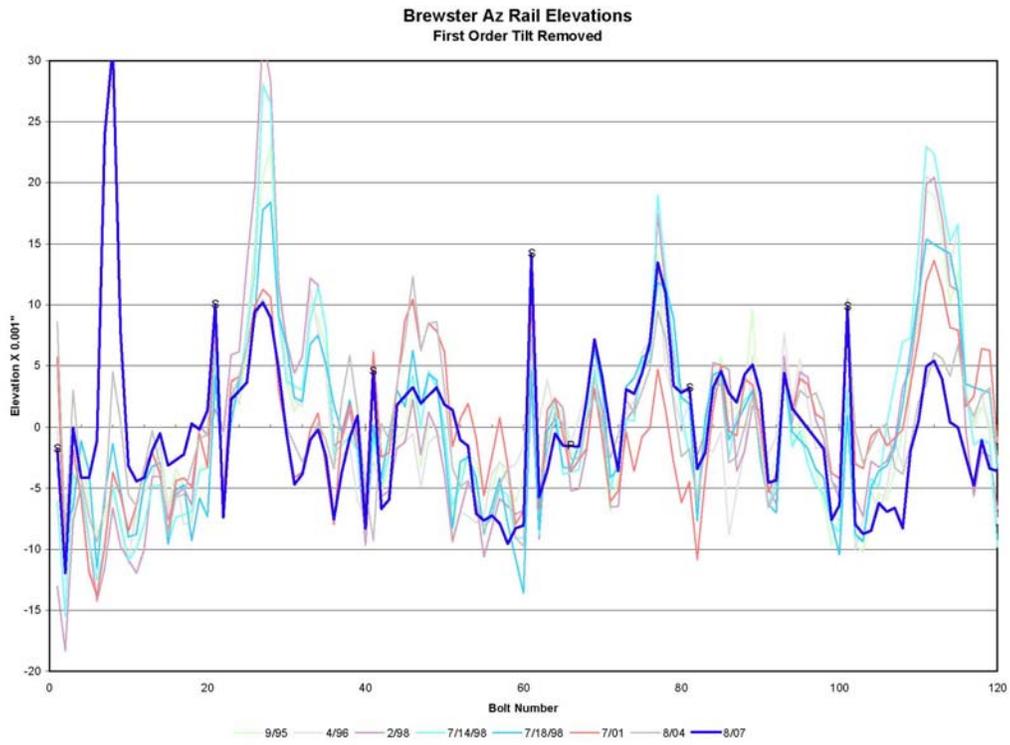
Brewster's Rail Elevations. Bolt numbers 7,8 and 9 are beginning to fail.
