National Radio Astronomy Observatory
Socorro, New Mexico
VLBA Antenna Memo #77

Kitt Peak, Arizona VLBA Maintenance Visit April 27- May 7, 2009.
Team members consisted of Mike Burgert, Eric Carlowe, Ramon Gutierrez,
Ken Lakies and Phillip Sanchez. VLBA Site Technicians Ray McFarlin
and Duane Clark assisted in all areas of antenna maintenance.

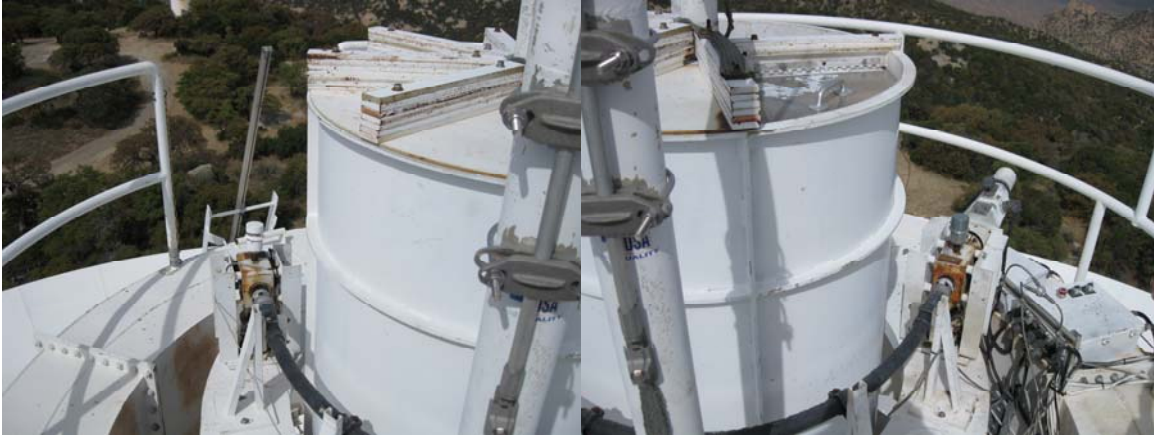
FRM was given a thorough inspection and the focus flex shaft was replaced.

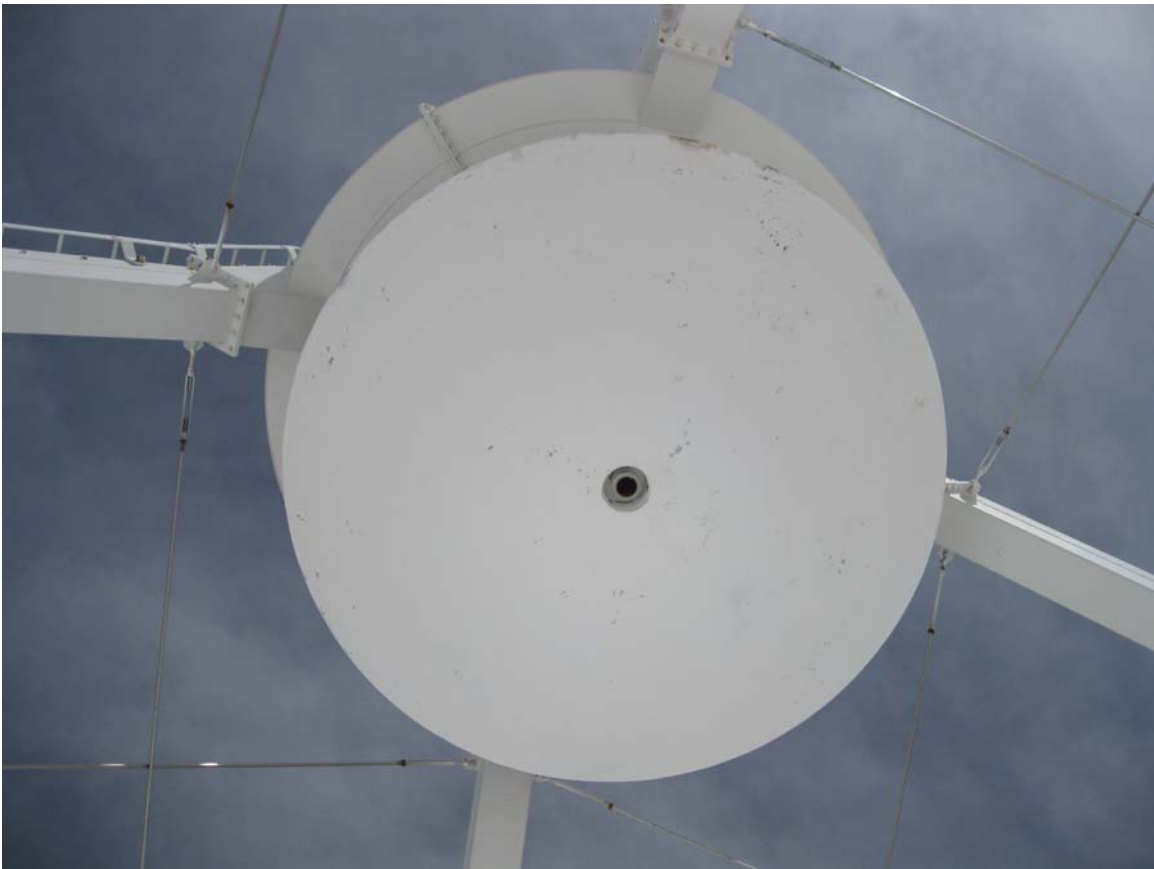
Sub reflector is in good condition. The Di-Pole antenna was removed and sent to Socorro for refurbishing.

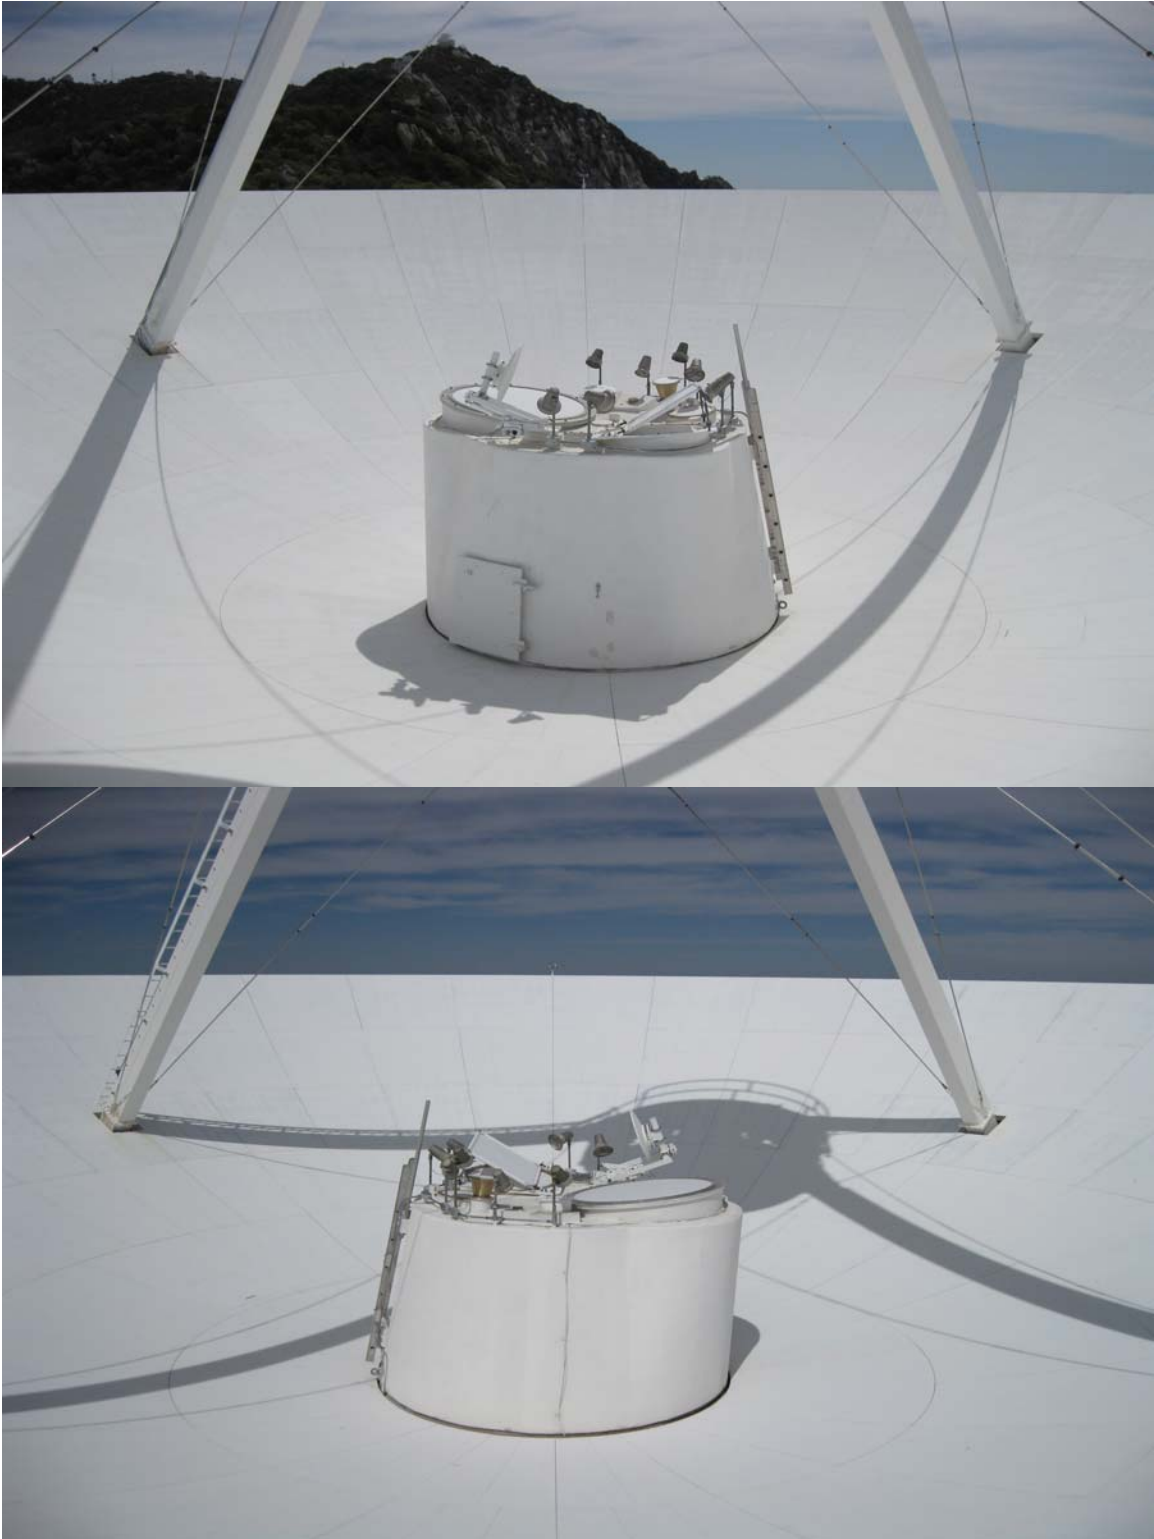
Dish panels are in good condition. The feed cone's elastomeric paint job is holding up well. The feed cone was sealed and painted during the 2003 maintenance trip.

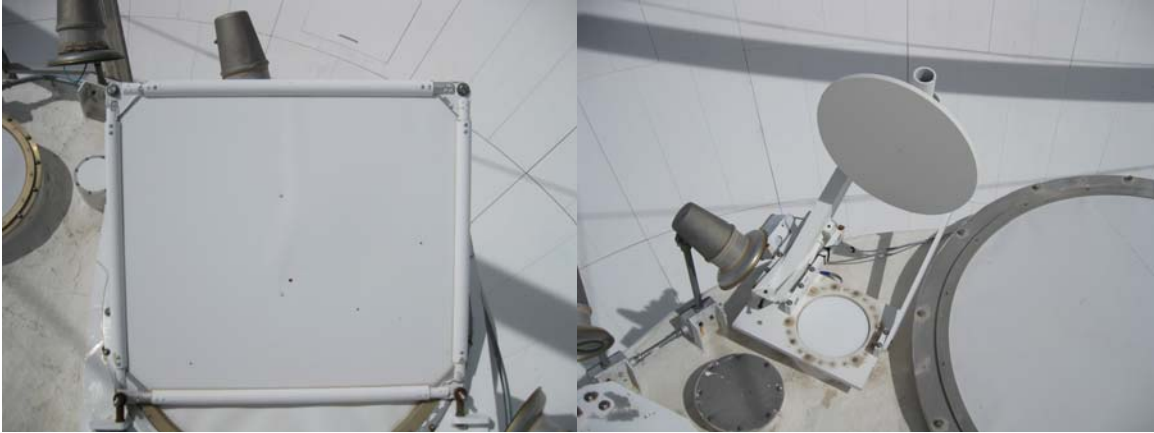
The Dichroic reflector is in good condition. The Ellipsoid reflector is in good condition. Ellipsoid actuator operates correctly.

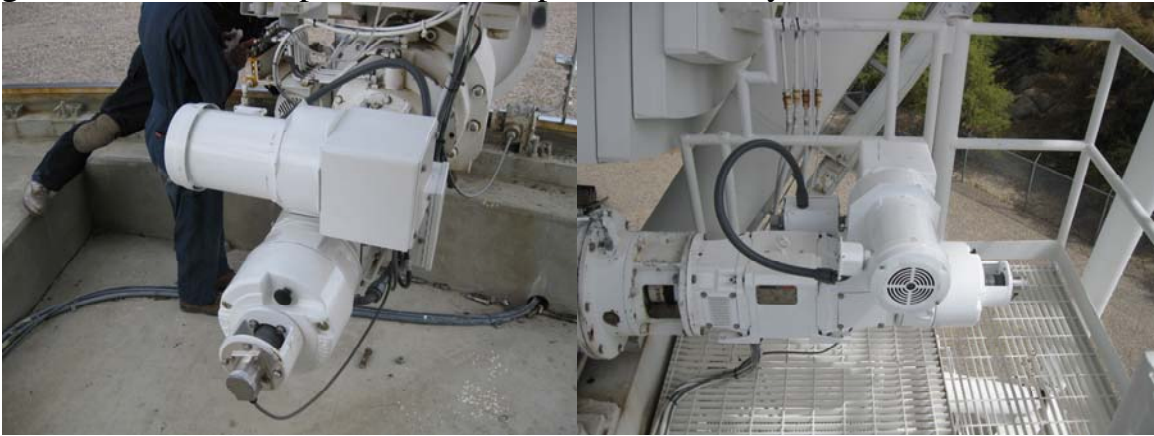
Azimuth #1 blower motor and spider coupling was replaced. Elevation # 2 motor was replaced.

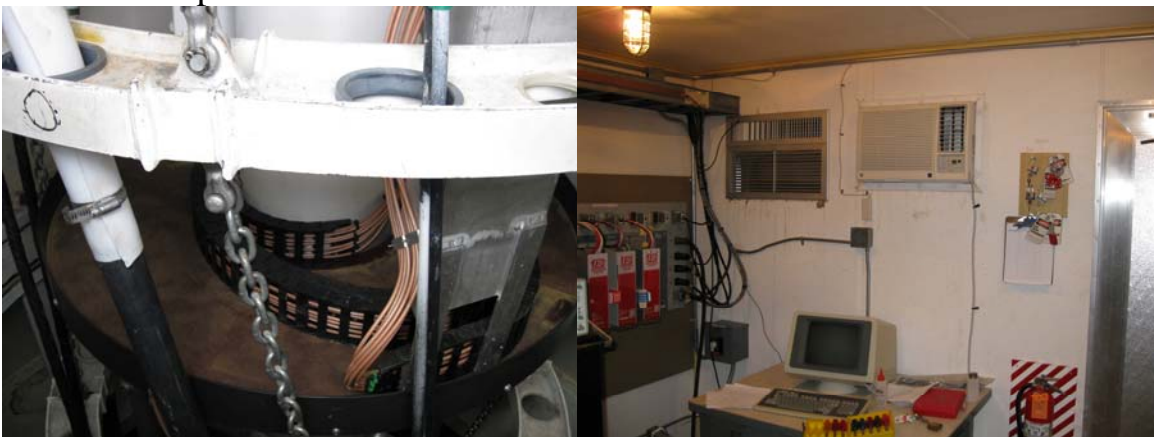
The new IF cable wrap is in good condition. The ped room Marv Air, air condition compressor failed. It was removed and brought back to the VLA for repair.

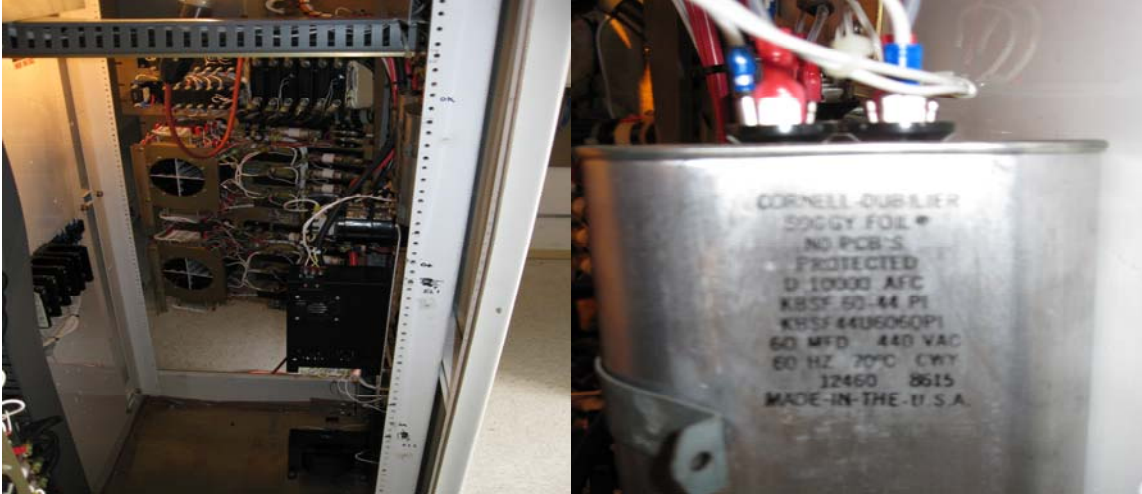
The servo drive cabinet power supply upgrade was completed by the site technicians. A drive cabinet 440v 60uf cap was leaking and was replaced.

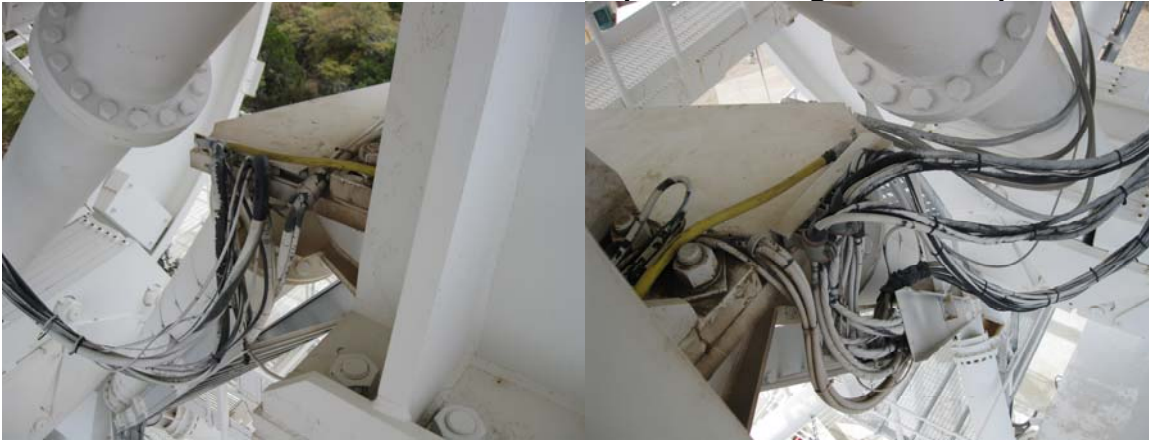
Both Elevation cable wraps are in good condition.

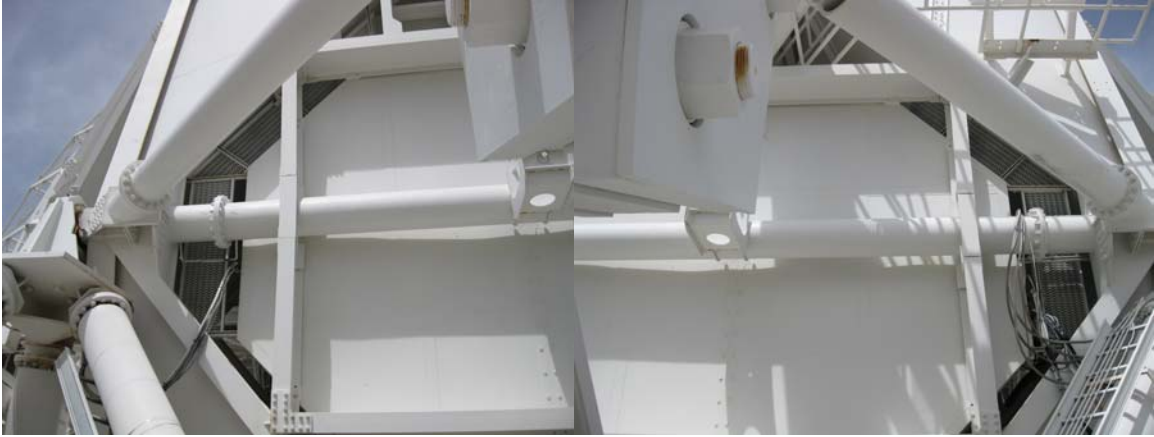
Elevation axle has no visible signs of cracks. Paint is in good condition.

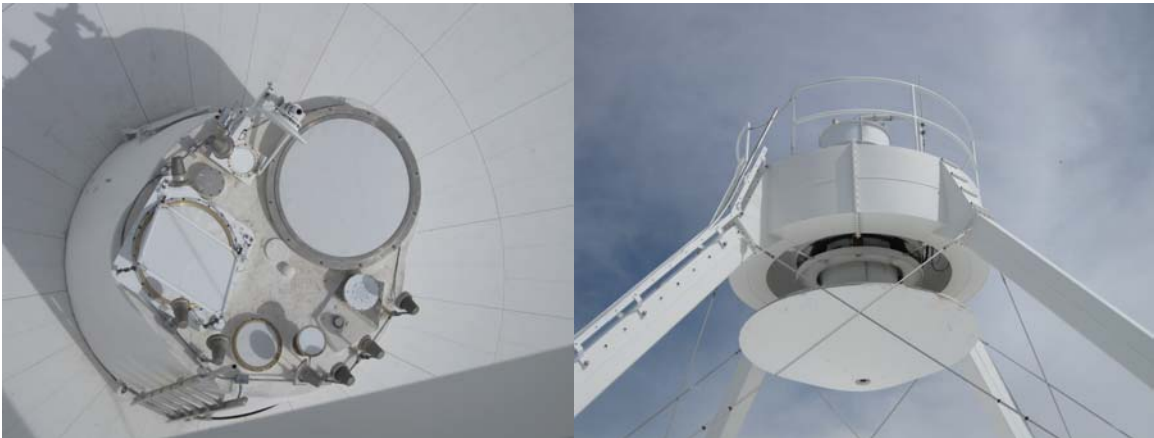
The feed heaters and FE windows are in good condition. Apex paint is in good condition.

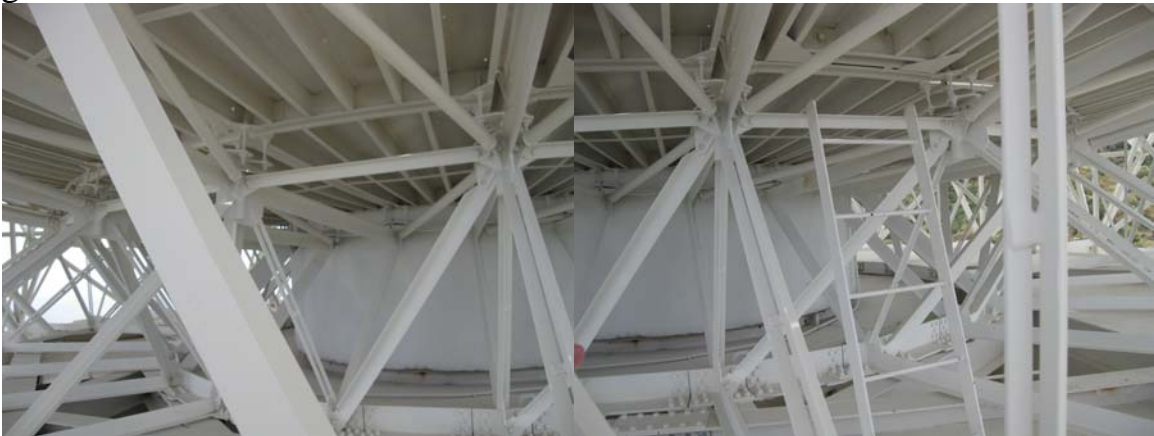
Antenna backup structure is in good condition. Paint is in good condition.

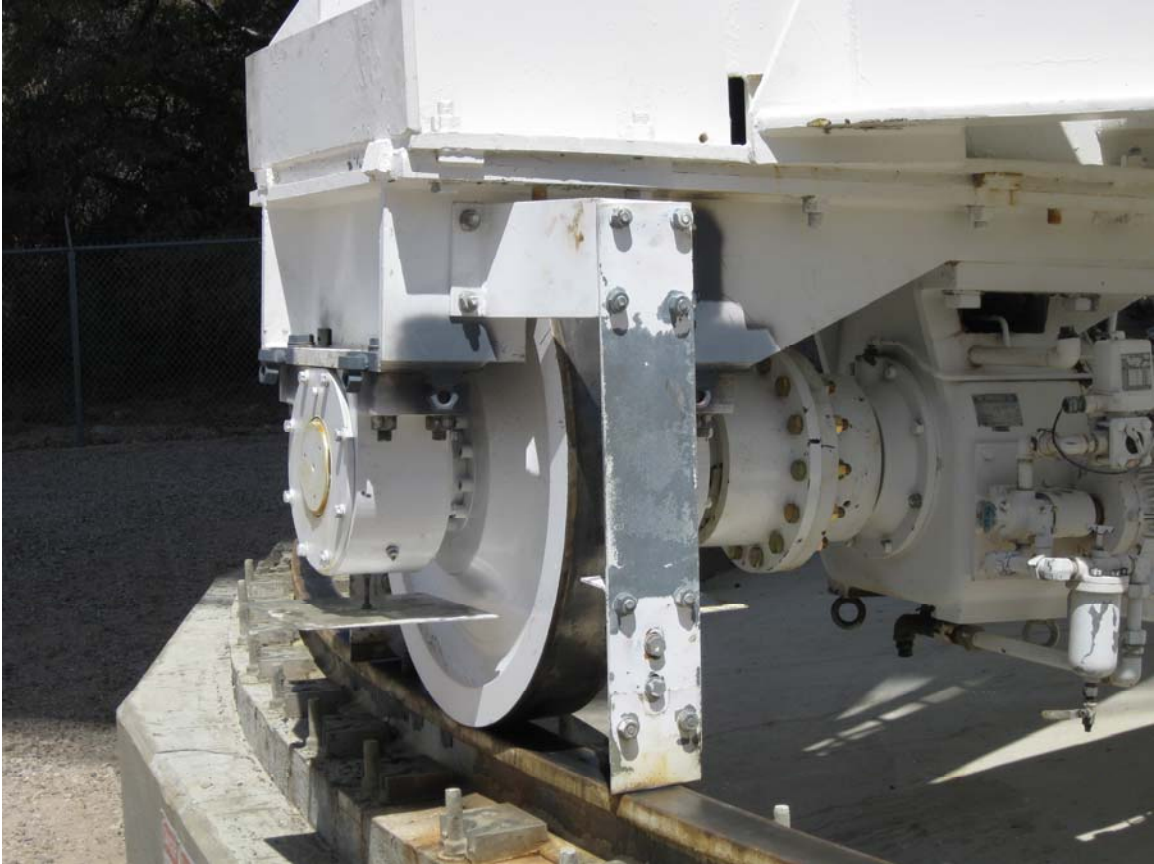
Azimuth #1 Wheel assembly was replaced. The new drive wheel assembly rotated smoothly without any popping or grinding noises.

MEASURED	SPECIFIED
Conic Radius	300.218	300.00 +/- .25
Coupling Runout	.004	<.005
Vertical	93.433	93.440 +/- .023
Horizontal	.003	<.023

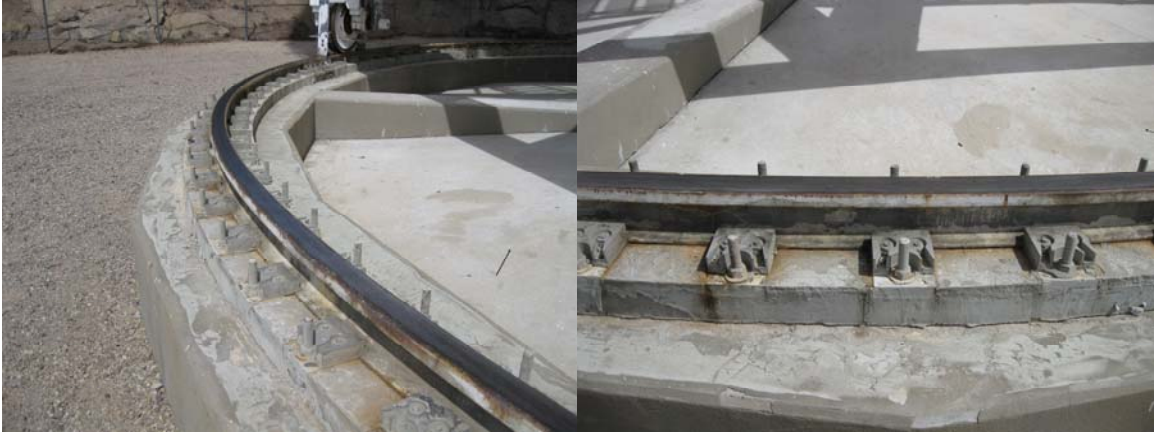
Kitt Peaks rail is in good condition. Sites Techs succeeded in removing all of the vulchem.
