National Radio Astronomy Observatory
Socorro, New Mexico
VLBA Antenna Memo #78

Los Alamos, New Mexico VLBA Maintenance Visit July 14- 16, 2009.
Team members consisted of Eric Carlowe, Ramon Gutierrez, Ken Lakies
and Martin Lopez. VLBA Site Technicians Paul Johnson and Nelson
Atencio assisted in all areas of antenna maintenance.

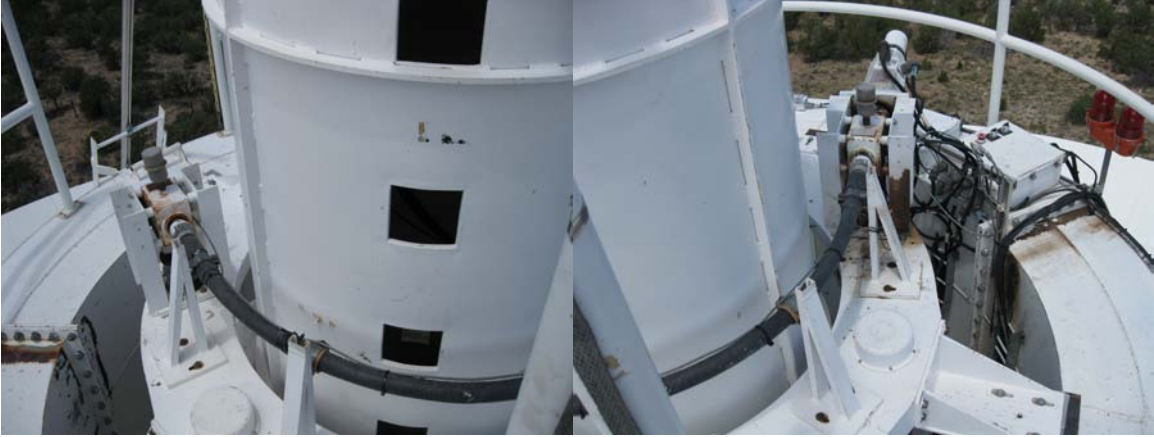
FRM was given a thorough inspection and the focus flex shaft was replaced.

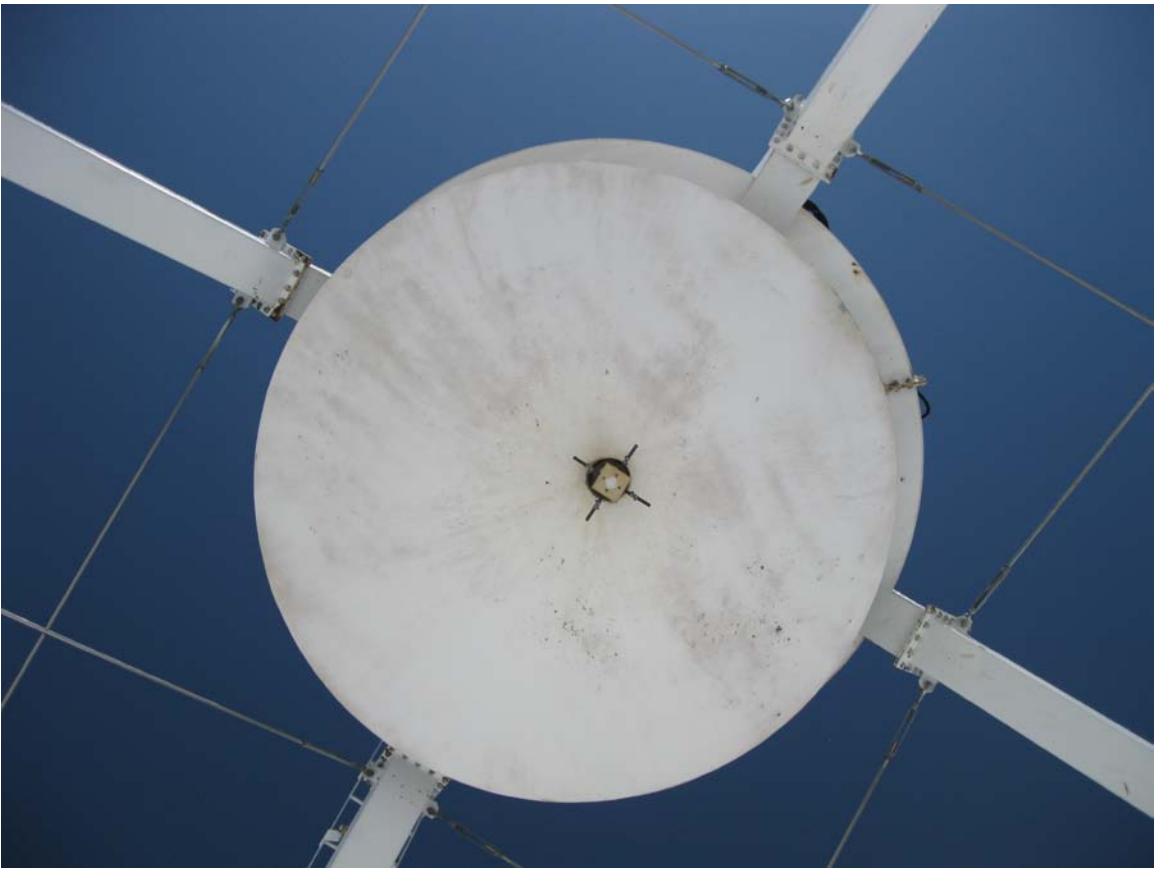
Sub reflector is in good condition.

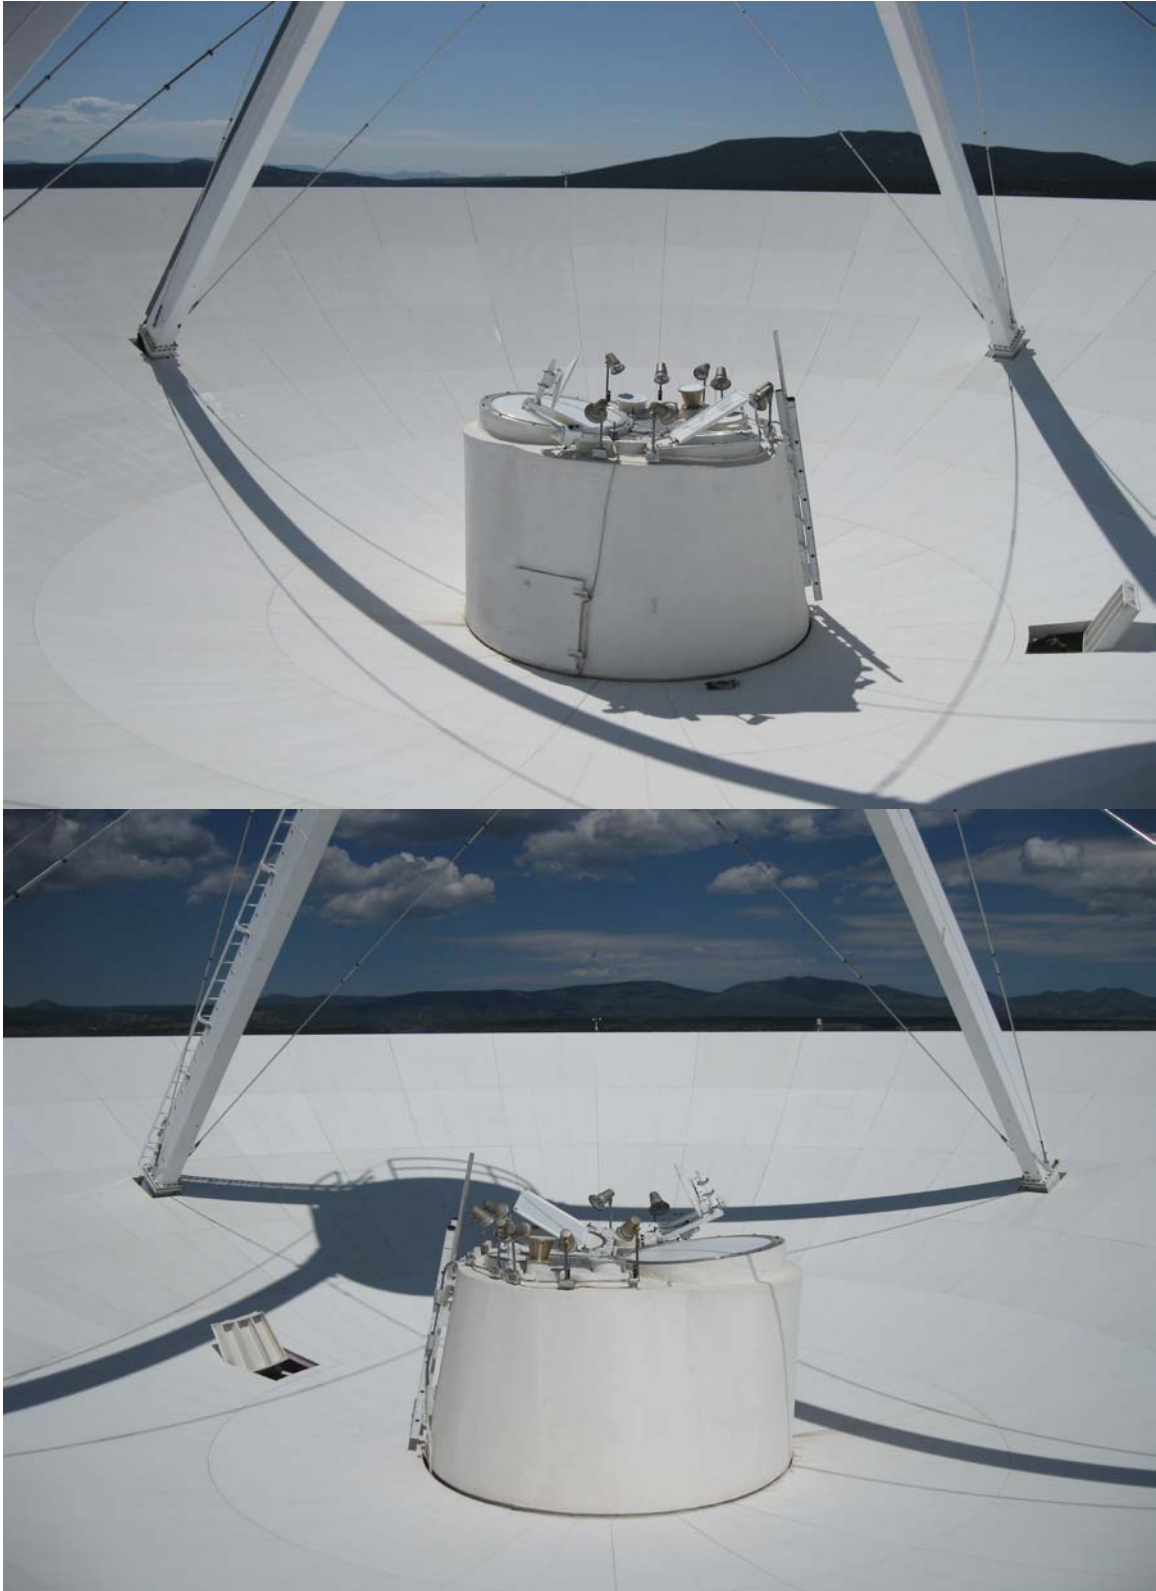
Dish panels are in good condition. The feed cone's elastomeric paint job is holding up well. The feed cone was sealed and painted during the 2005 maintenance trip.

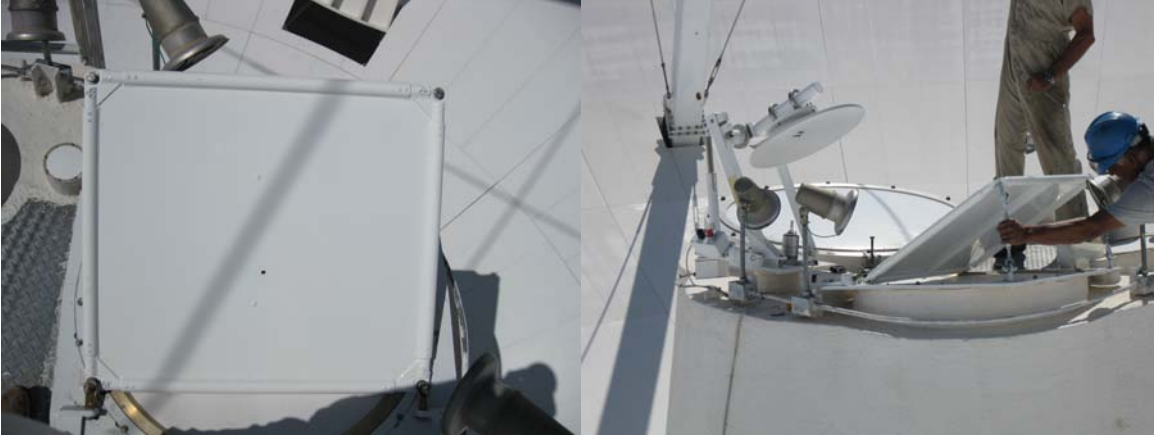
The old Dichroic reflector was delaminating and could not be aligned. The reflector was replaced and the new one aligned.

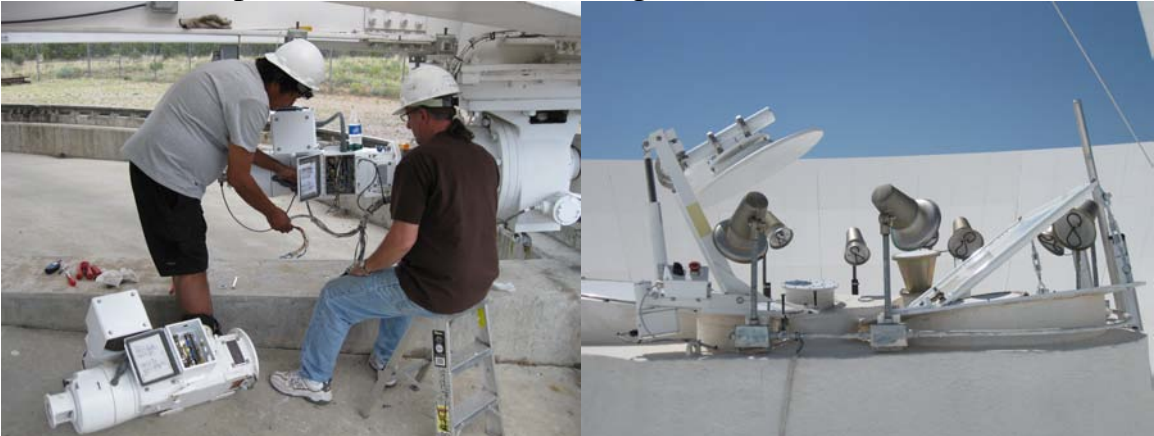
Azimuth #1 motor was replaced. The Ellipsoid reflector is in good condition. The ellipsoid actuator operates correctly.

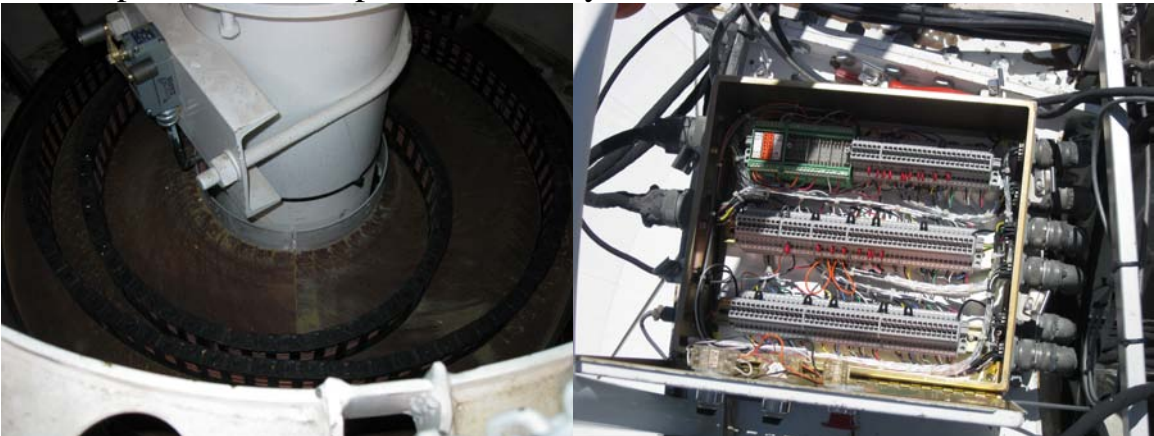
The new IF cable wrap is in good condition. FRM apex signal junction box and cables are in good condition.

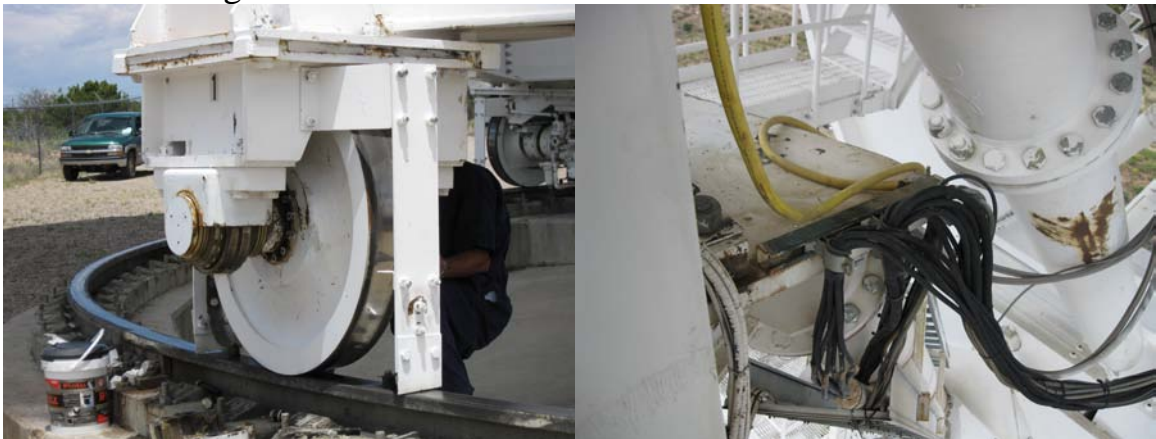
AZ and EL bearings were inspected. Both Elevation cable wraps are in good condition.

INNER BEARING	OUTER BEARING
D1	New Wheel.	New Wheel.
D2	New Wheel.	New Wheel.
I1	Good, no metal.	Good, no metal.
I2	Good, no metal.	Good, few small flakes.
All bearings are very well lubricated.

Encoder	Good grease with no metal flakes.
Synchro	Good grease with no metal flakes.
All bearings are very well lubricated.

Pintle bearing is well lubricated with no metal flakes.

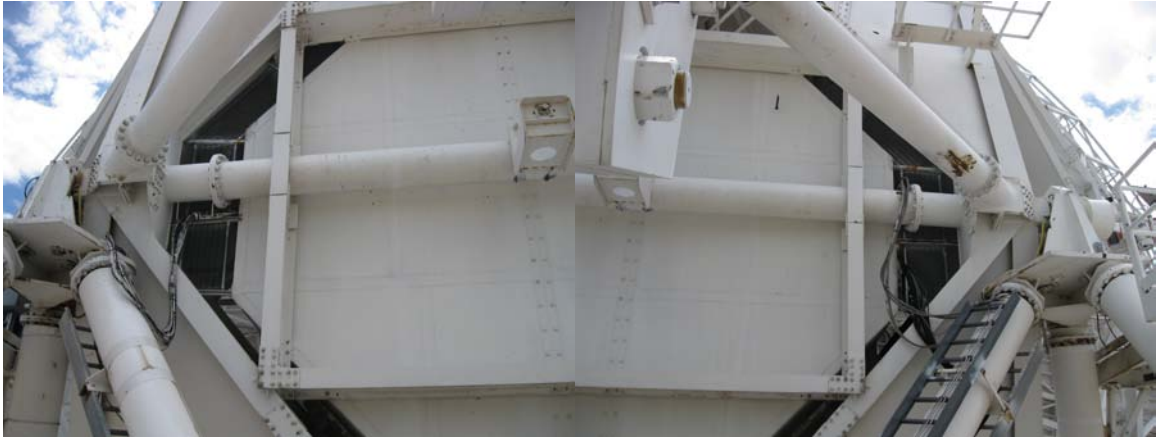
Elevation axle has no visible signs of cracks. Paint is in good condition.

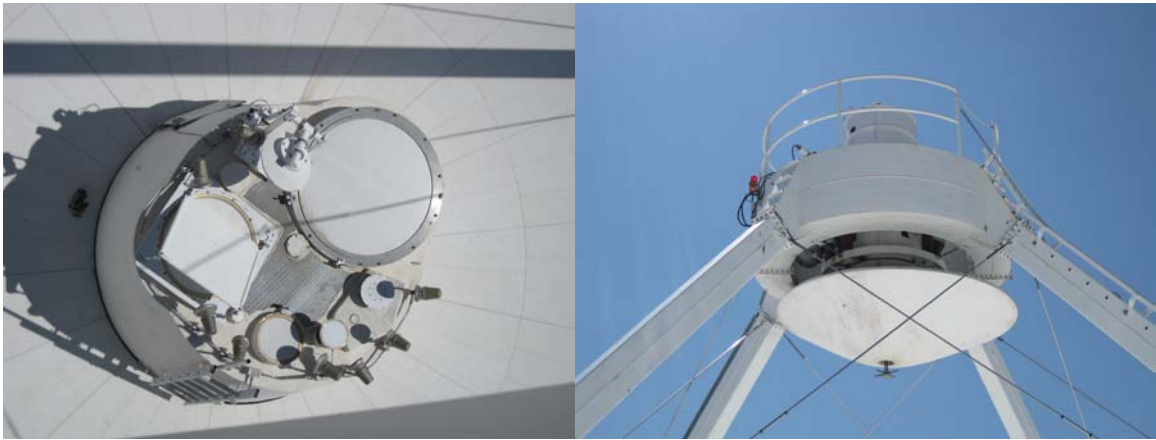
The feed heaters and FE windows are in good condition. Apex paint is in good condition.

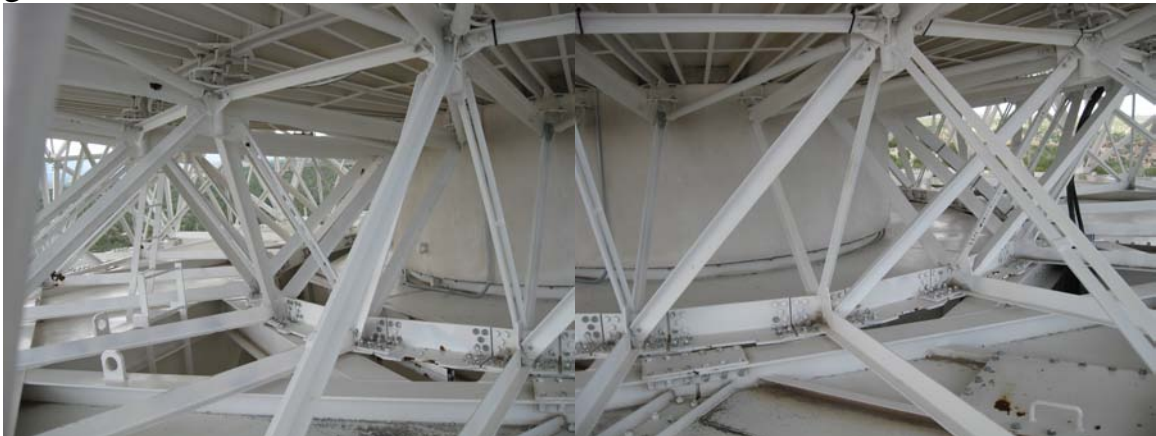
Antenna backup structure is in good condition. Paint is in good condition.

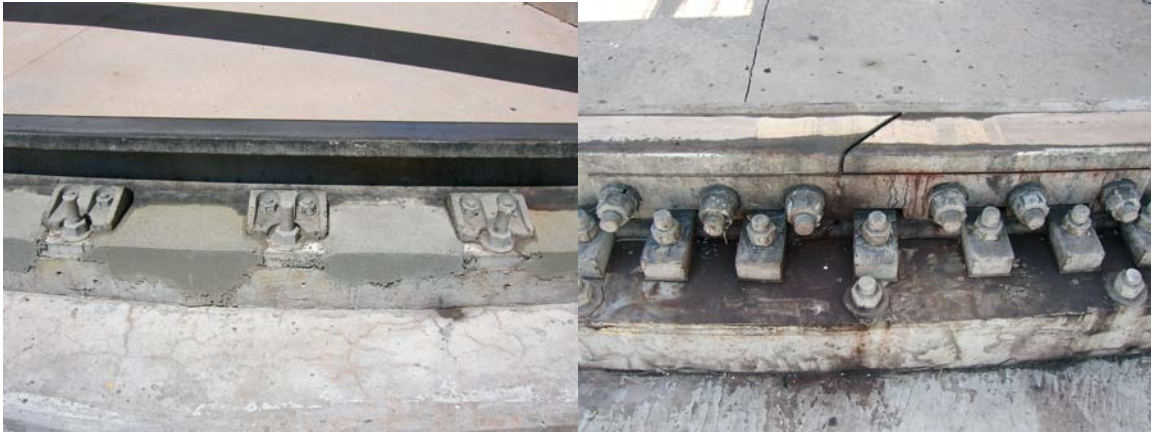
The Los Alamos rail is in good condition.
