VLBA Memo 83: North Liberty Rail Maintenance, July 2010

Bob Broilo

September 2nd, 2010

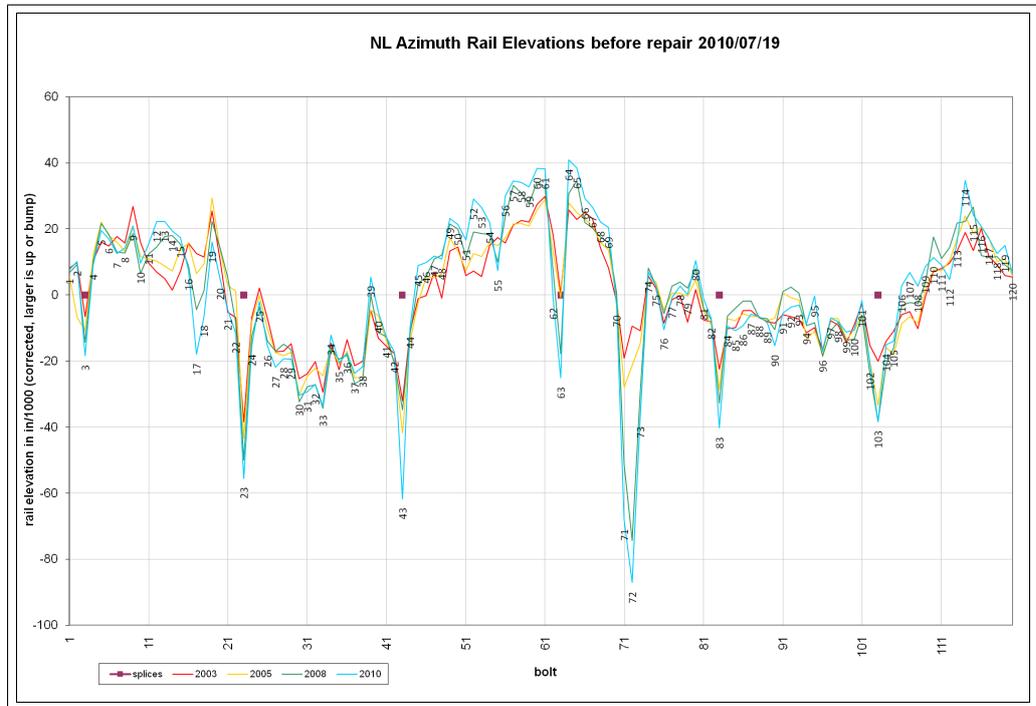
Figure 1: Rail height since last repair

Figure 1 shows rail heights since the last grout repair. Bolts 3, 23, 43, 63, 83, and 103 are splices. The splices already have plates and grout under them. The splices usually start to sag because the shims get pushed out, corrode away, or the rail wears.

Some areas of grout deterioration are clearly seen in the rail height data at bolts 17, 55, 72, and possibly 30-33. Corroborating these with visual inspections we see obvious problems at bolts 17, 55 (figure 2) and 72 (figure 3). Bolts 30-33 look good externally, and bolts 19-20 have visible grout problems that are not yet causing the rail to sag (figure 4).

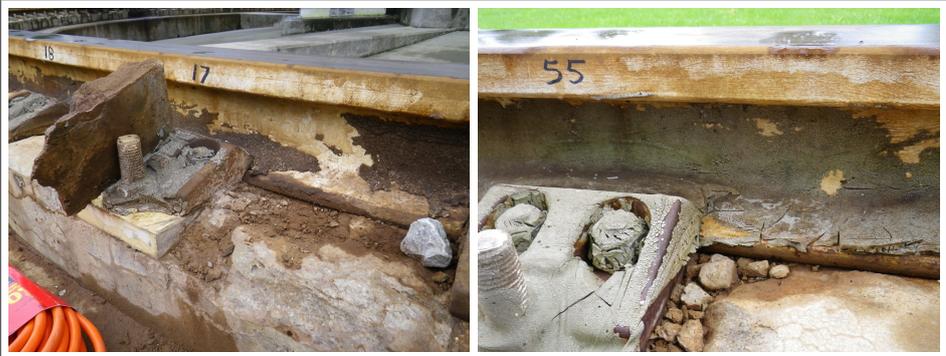
Figure 2: Bolts 17 and 55 before repair

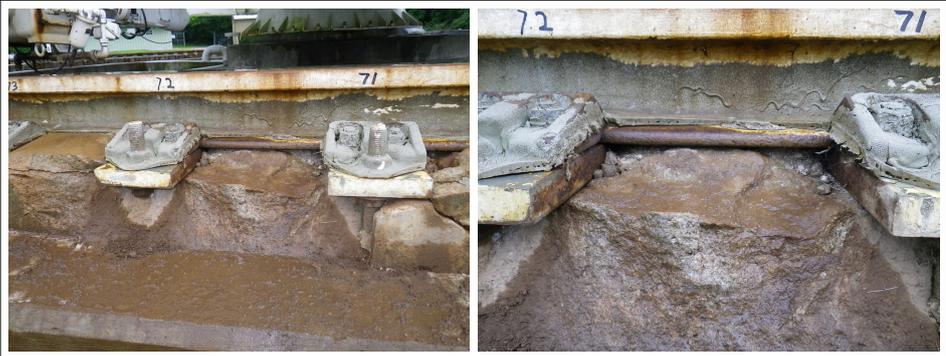
For example, the grout at bolt 72 was in very poor condition. When hit with the tools, it fell out with little effort and in large pieces. A lot of grout is gone by the time the area is clean and solid (Figure 5).

Figure 3: Bolt 72 area before repair

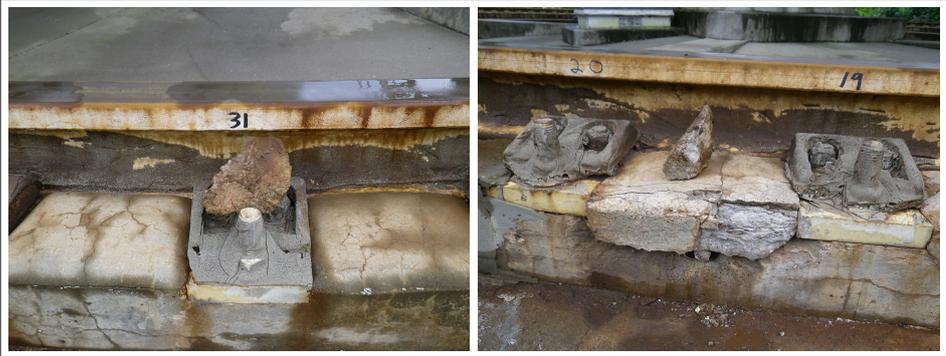
Figure 4: Bolts 31 and 19 before repair

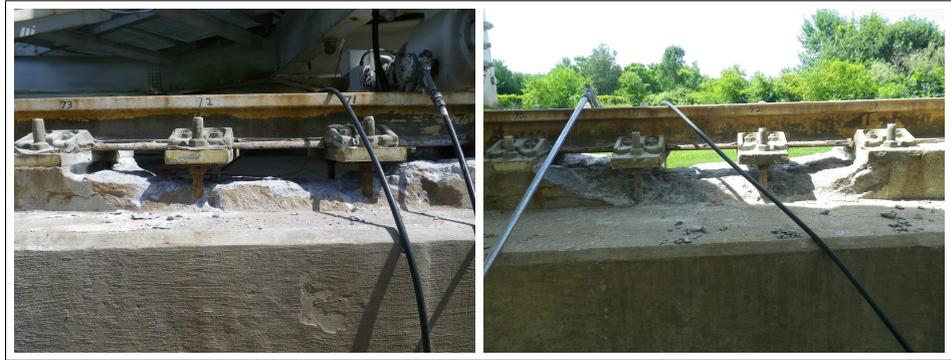
Figure 5: Bolt 72 after grout removal

It is true in this specific example that the area around bolt 72 was clearly worse than bolt 91. These locations were chosen to illustrate the hole size. But more often, an area that looks solid by visual inspection and measurement will fall apart readily. This makes it tricky to try to estimate the exact number of bolts to remove the old grout from.

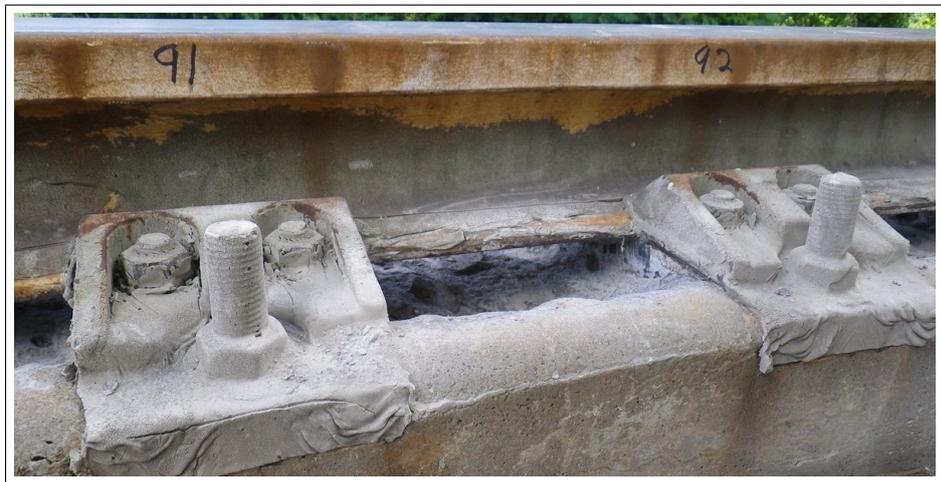
Compare this to an area of more solid grout which can only be chiseled away slowly (figure 6).³ Much more volume of new grout will be needed to fill

Figure 6: Bolt 91 after grout removal

the hole under bolt 72 than bolt 91.

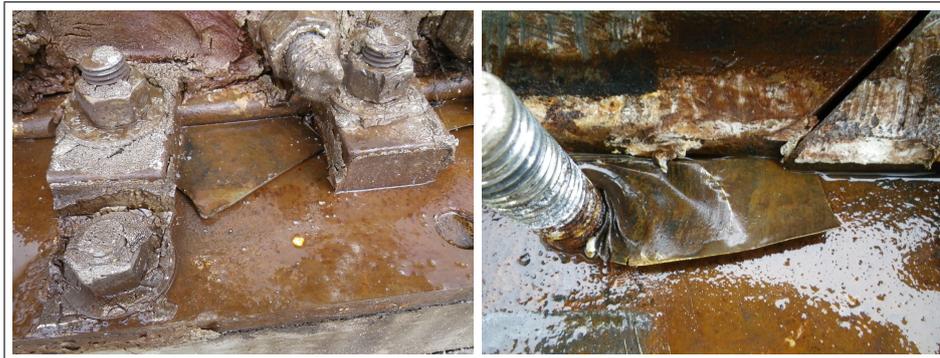
Figure 7: Splice shim migration

The rail splices flex, wear and loosen up as the wheels ride over them. They require regular re-torquing and re-shimming. At North Liberty, the splices had been re-torqued in 2008, yet by the time of our visit many of the bolts had loosened to the point that they could be removed by hand. The rail height data show a steady sinking of the splices since they had been shimmed in 2002. The shims corrode, deform, or migrate out from under the rail. See figure 7 for examples of shim migration.

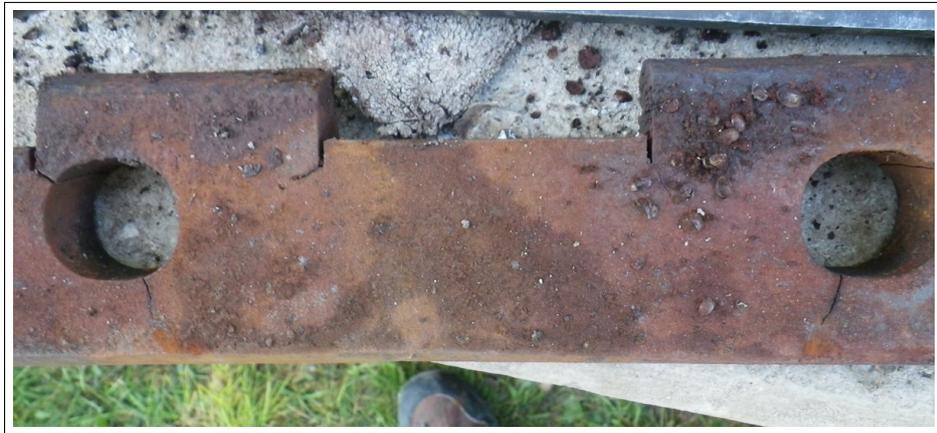
The splice bars were all cracked, and some even completely broken (figures 8 and 9). Some were bent (figures 10 and 11). Some of the cracks appear to be caused by the way the slots for the rail clips were cut. They originate at the corners of the saw lines. But other cracks in bolt holes seem to

Figure 8: Splice bar typical cracks at North Liberty antenna

hint that there may be breakage occurring at other sites where the bars were cut smoothly.

Luckily, the VLA site had a full set (6 pairs) of splice bars. After minor modifications to the slots to fit the Foster rail clips (with smooth rounded cuts to prevent cracking), they were shipped to us at the North Liberty site. The new splice bars improved the rail flatness dramatically as seen in the pre-shimming measurements in figure 12.

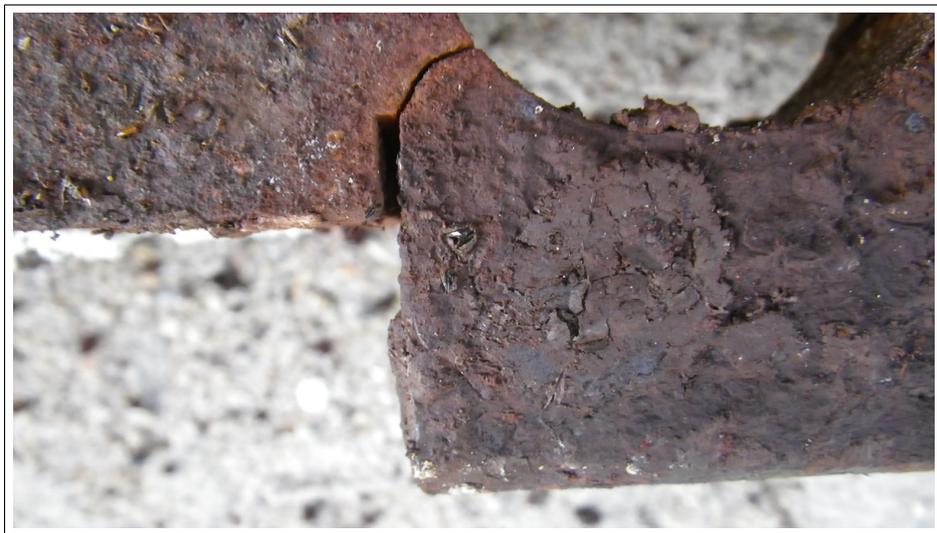
Figure 9: Splice bar typical cracks at North Liberty antenna

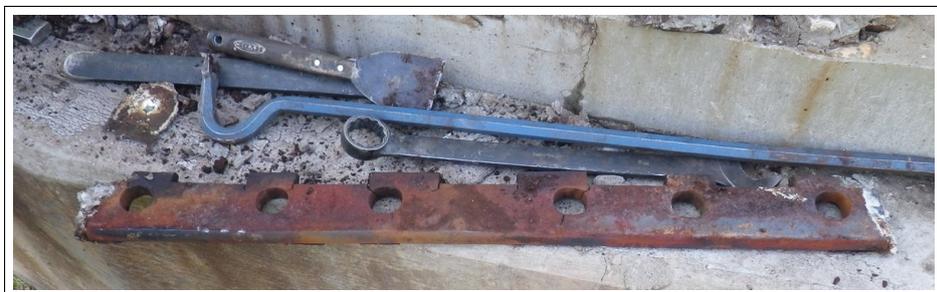
Figure 10: Bent Splice bar from North Liberty antenna

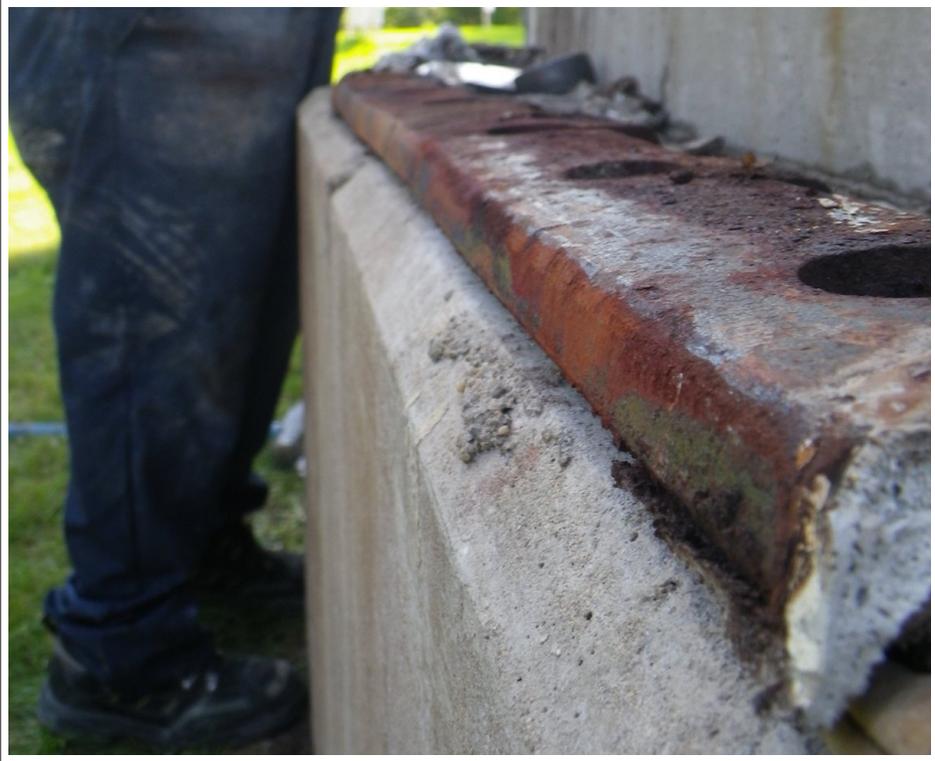
Figure 11: Bent Splice bar from North Liberty antenna

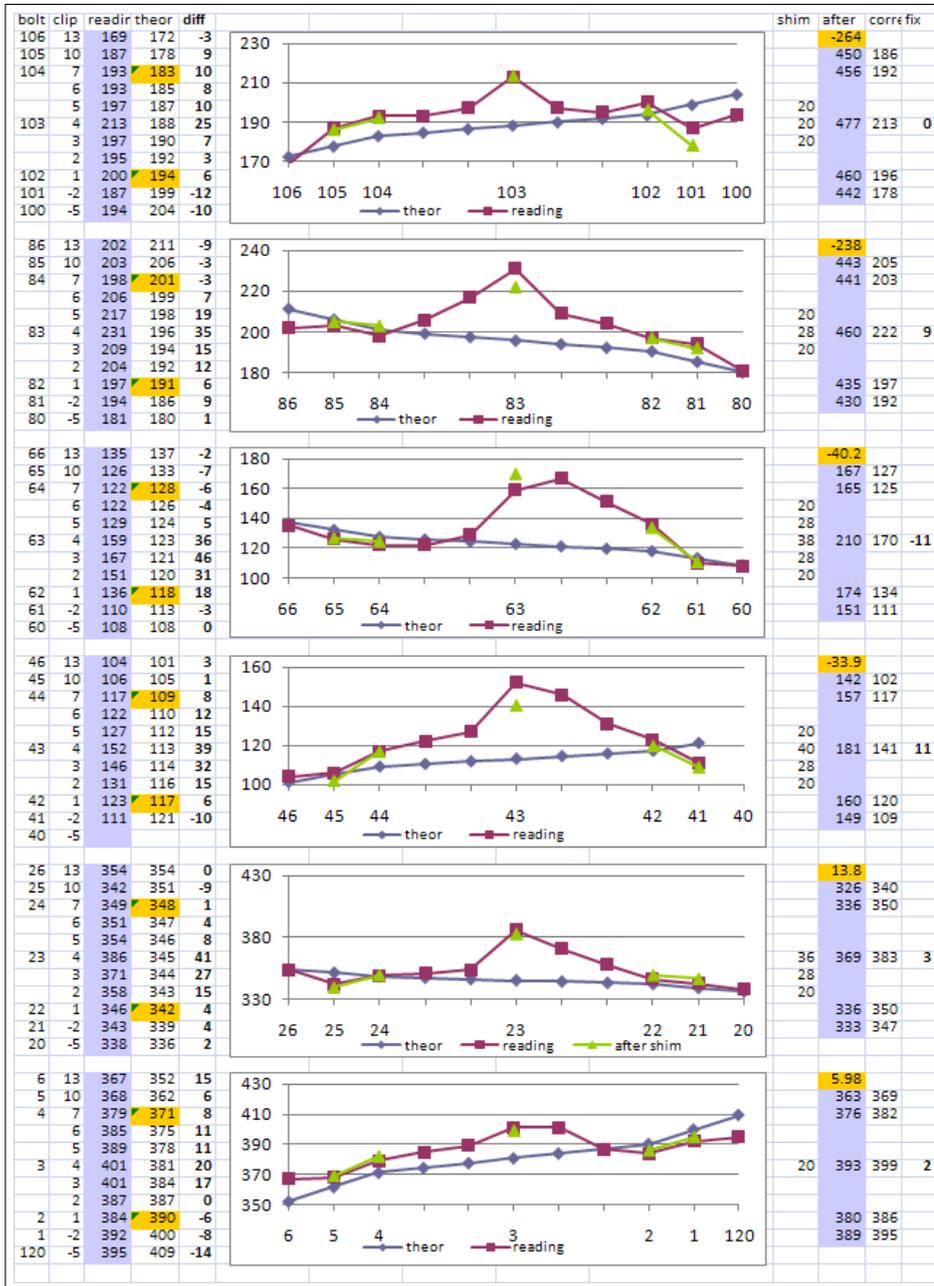
Figure 12: Low spots at splices and shimming attempts

We attempted to improve the rail flatness even more by re-shimming the splices. We took fine measurements of the loaded splice and included three bolts to each side to get an approximate slope. These measurements are plotted as the “reading” lines in figure 10. The “theor” lines are the calculated slopes. The shallower dips on these newer readings show that the new splice bars support the splices better than the cracked and broken bars.

The amount of shim we added is to the immediate right of the charts. The green triangles are the results of our efforts. Despite expending quite a bit of effort and time fitting the shims under the rail, they did not reduce the depth of the dips much. This may be a sign that the rails have worn significantly at the splices. Adding more shim would require a great deal of force and may damage the rail, so we chose not to on this trip. However, the amount of shim we added will support the rail and reduce flexing.

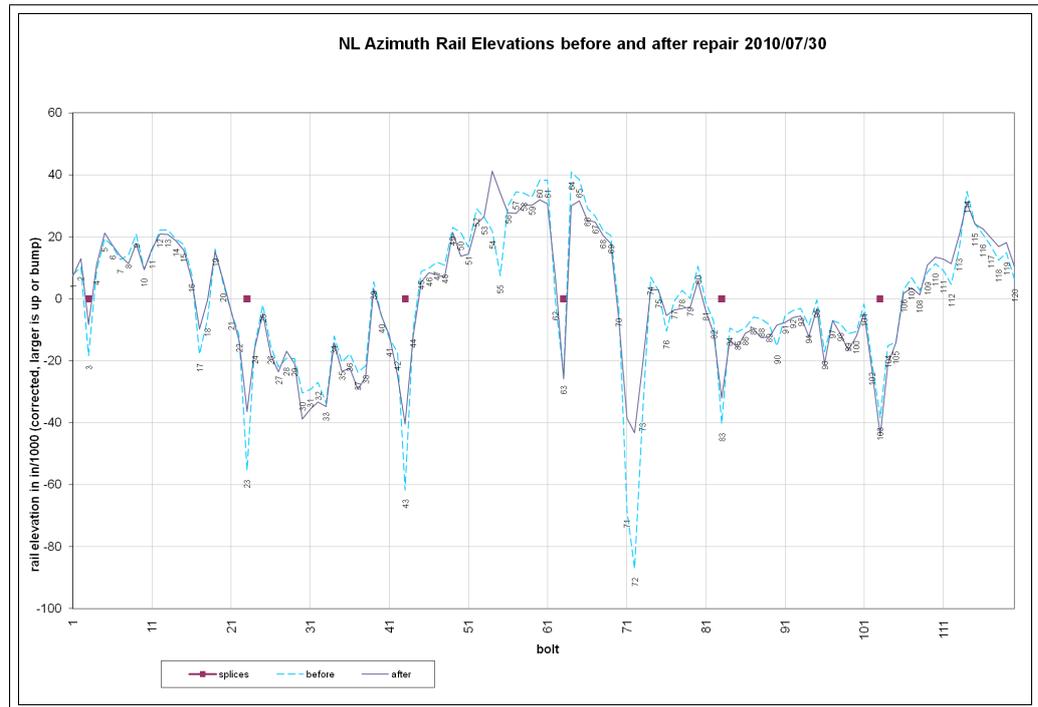
Figure 13: Rail height before and after repair

We used 28 0.5ft³ units of grout to repair 55 bolts in 4.5 days, or approximately 2 bolts/unit and 12 bolts/day. The before and after rail

elevations are in figure 13. The holes due to grout and splice deterioration have been improved to about half of their earlier depth.

The area around bolt 72 has been deformed by the wheels during the time when the old grout was not supporting it. A grouting plate similar to the type used at the Mauna Kea VLBA site might be able to correct this, but may not be worth the effort. The dip is about the same depth as the splices. The plate would take several days to install, and great care must be taken during the installation to avoid worsening the problem. For example, at Mauna Kea we had problems with thermal expansion warping the rail while the grout cured.

After the rail grout has been stabilized we should revisit these areas and attempt to correct them. Meanwhile, the next time there is a severe grout failure of this nature, we should determine where in the rail system the deformation is occurring.

The bolts with high-strength grout are 1-25, 27-41, 42-44, 51-64, 68-81, 82-97, 102-113, and 117-120. This is 95 bolts total. The bolts with original grout are 120-1, 41-42, 44-51, 64-68, 81-82, 97-102, and 113-117, or 25 total. These will need attention in the next few years. If weather allows, we will repair these on the way back from the Hancock, NH antenna in late September.
