VLBA Antenna Memo Series No. 89

Azimuth Rail Repair at Fort Davis, Texas
June 17 – June 25, 2013

J. E. Thunborg
July 10, 2013

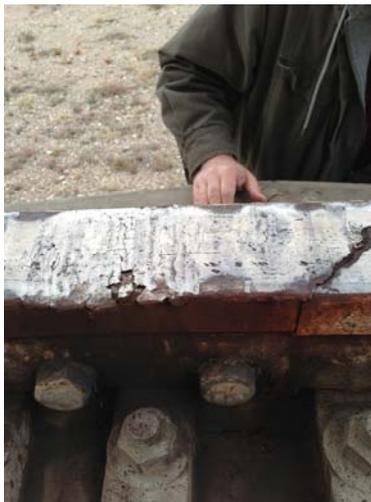
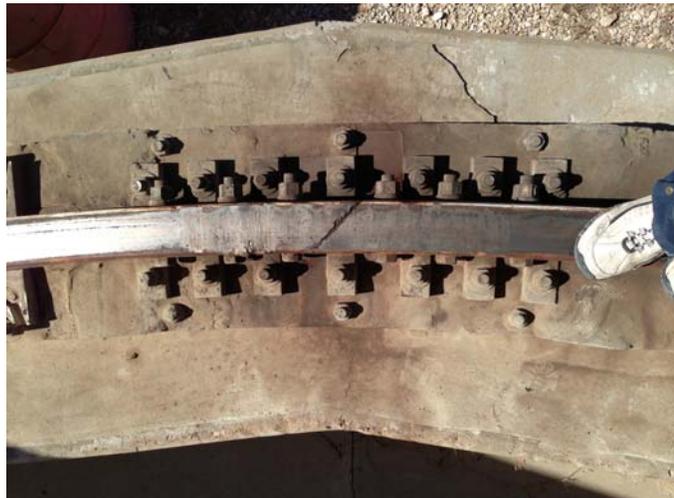
In February of 2013, the Fort Davis site technician (Jason Candelaria) reported that the surface of the azimuth rail was deteriorating as shown in the photographs below.

Further inspection revealed that the surface of the rail was failing where weld metal had previously been deposited on the surface. Presumably this weld metal was deposited during antenna construction to repair a low spot in the azimuth rail. This type of repair is subject to fatigue spalling and should be discouraged on future antenna construction projects.

A maintenance team traveled to Fort Davis to replace the two failed rail sections. This report documents the results as well as the tools and procedures used to conduct this repair.

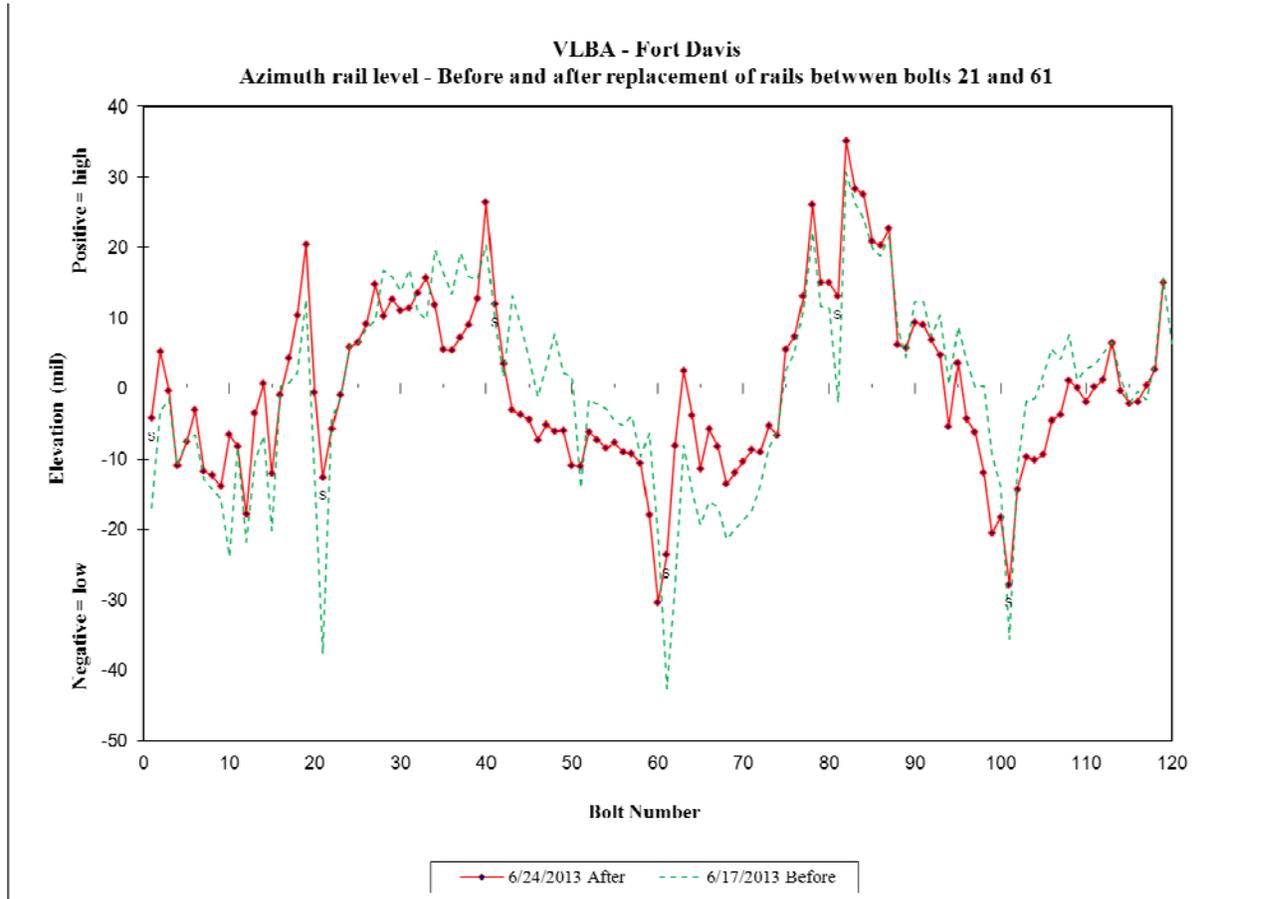
A wild N2 precision optical level was used to measure the height of the antenna wheel as it traveled over the rail. The general rail tilt was then removed using a least squares curve fit and the rail flatness at the rail bolt positions (approximately every 3 degrees) is charted below.

The two new rail segments are located between bolts 21 and 61. It is interesting to note that the two new rails were positioned without load so that the elevation error would be as near zero as possible. However, when measured under load the new rail position is remarkably similar to the original rail.

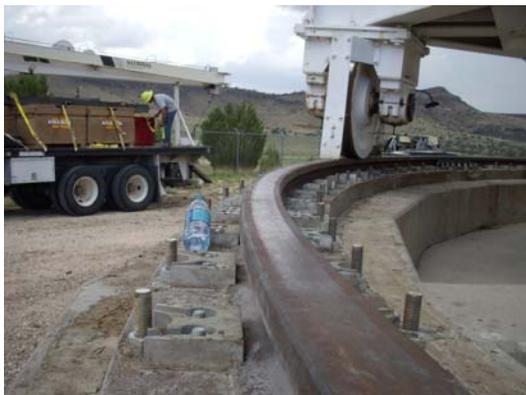
A precision level was used to set the level across the rail. This is to ensure that the wheel travels down the middle of the rail and does not run on one side or the other. The wheel path evinced by the shiny area in the attached photograph proves that the track is indeed level with the wheel.

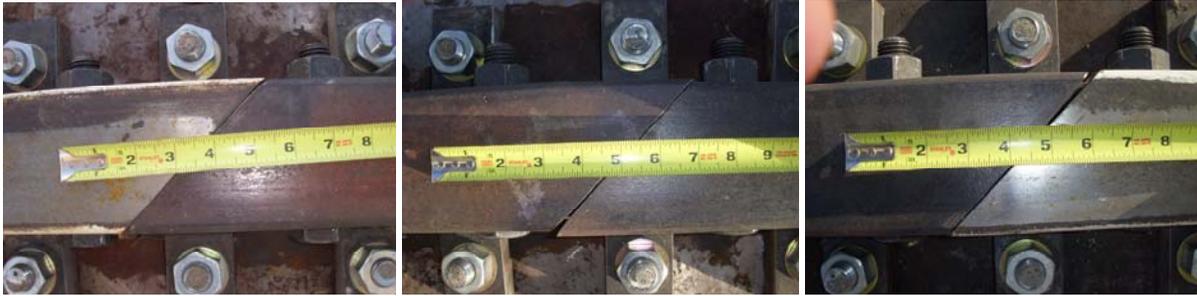
The photos below show the rail splices in order at bolts 21, 41 and 61.

The specification calls for the gap between the rails to be less than 1/16 of an inch. The gap on the third rail goes from touching on one end to almost 3/16" on the other because the angle of the two rails is not identical. Although this exceeds the specification, the part of the gap over the rail web is still less than 1/16" and therefore I do not feel that it will be problematic.

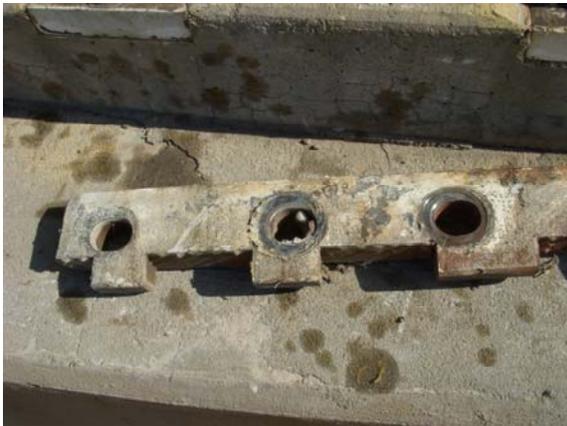
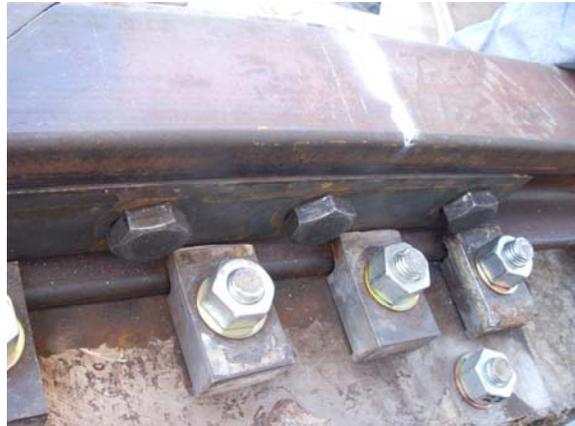
The rail splices are at bolts 1, 21, 41, 61, 81, and 101. The flatness at the rail splices is improved because new rail splice bars were installed on all the splices. The old splice bars shown below were notched to make room for the rail clamps. These bars are prone to breaking at the notches and are not stiff enough to adequately reduce rail deflection at the splices. The new design utilizes un-notched splice bars and shortened rail clips.

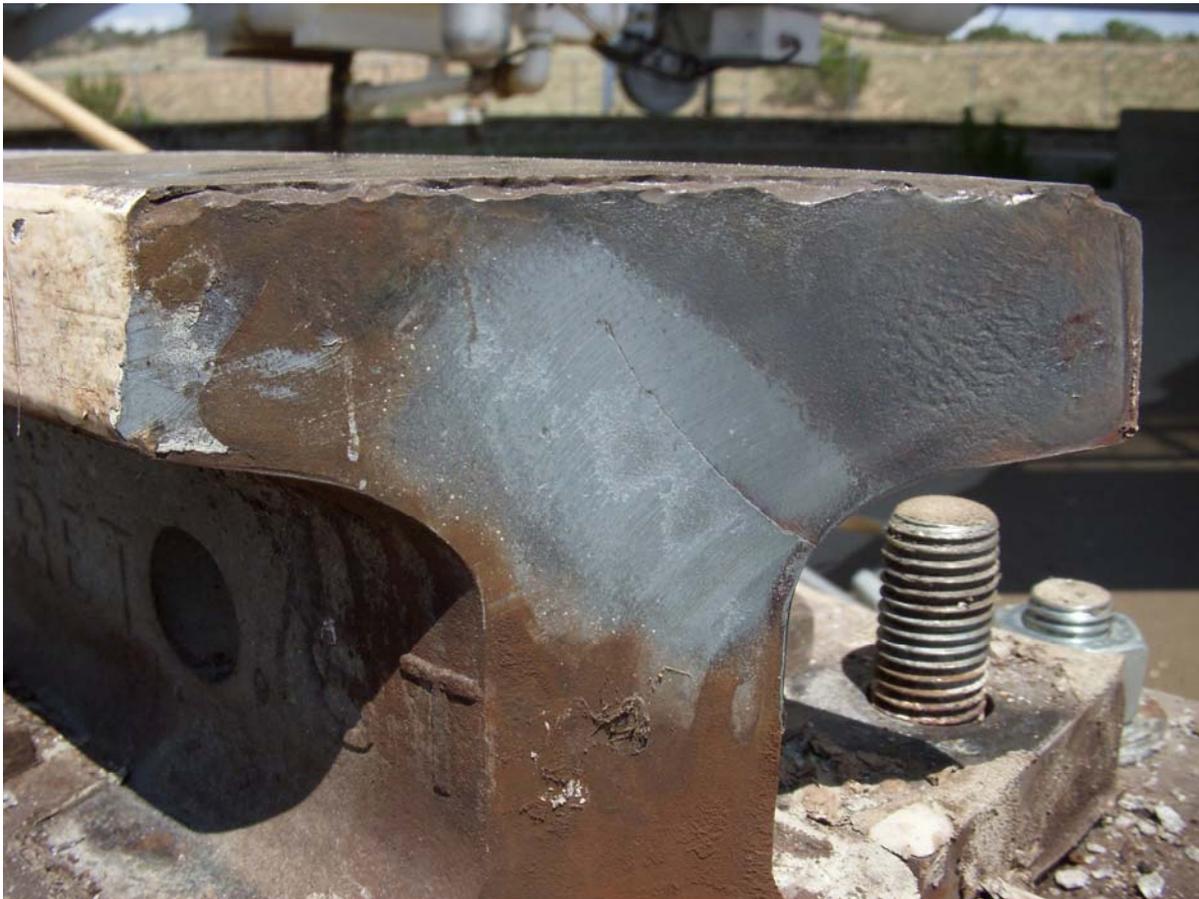
The crack shown below was revealed when a rail was removed. This particular rail was replaced. However, this may be an indication that we have other cracked rails out in the array and a detailed inspection might be warranted. A simple visual inspection is not possible because this part of the rail is hidden beneath the splice bars.

We currently have just one extra rail section that can be used if a VLBA rail fails. We have two rails that will likely need to be replaced soon and an indication that there may be cracks in some of the other rails. We should procure another 3 sections of rail in preparation for imminent rail failures. Three rail sections will cost approximately \$12,000. There is also
