VLBA ACQUISITION MEMO #229

HAYSTACK OBSERVATORY

To: VLBA Data Recording Group
From: A.E.E.Rogers, H.F.Hinteregger, D.L.Smythe, P.G.Bolis
Subject: Update on the AMPEX/MAXELL tape packing problem

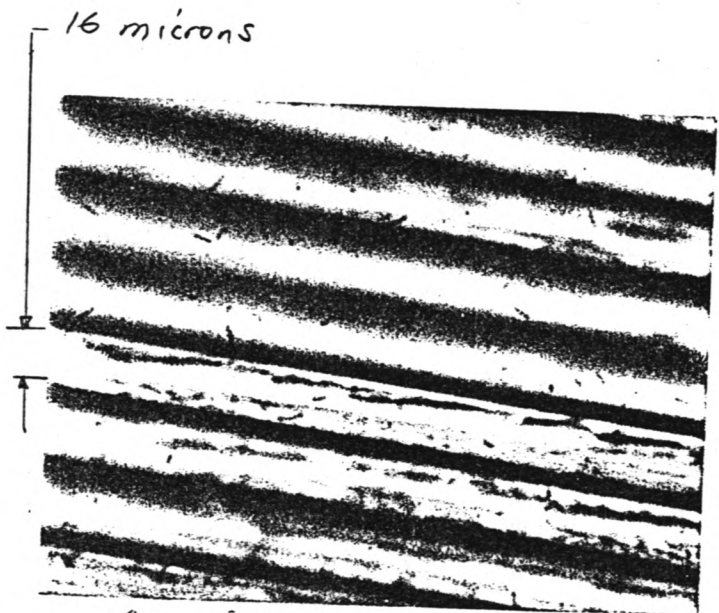
BAD MAXELL FRONT
BAD MAXELL Front

In order to examine the root cause of the edge curl seen in the tape pancakes we have photographed the tape edges with linear magnification of about 500. At this magnification the tape edge starts to look like the edge of a piece of plywood. The differences are fairly obvious and can be summarized by saying that the problem tape types have a rough edge (like rough-cut plywood) in which the saw cut pattern and some frayed edges are often visible - see attached figure.
