VLBA ACQUISITION MEMO #269

17 July 1991

Subject: Accelerated tape wear tests

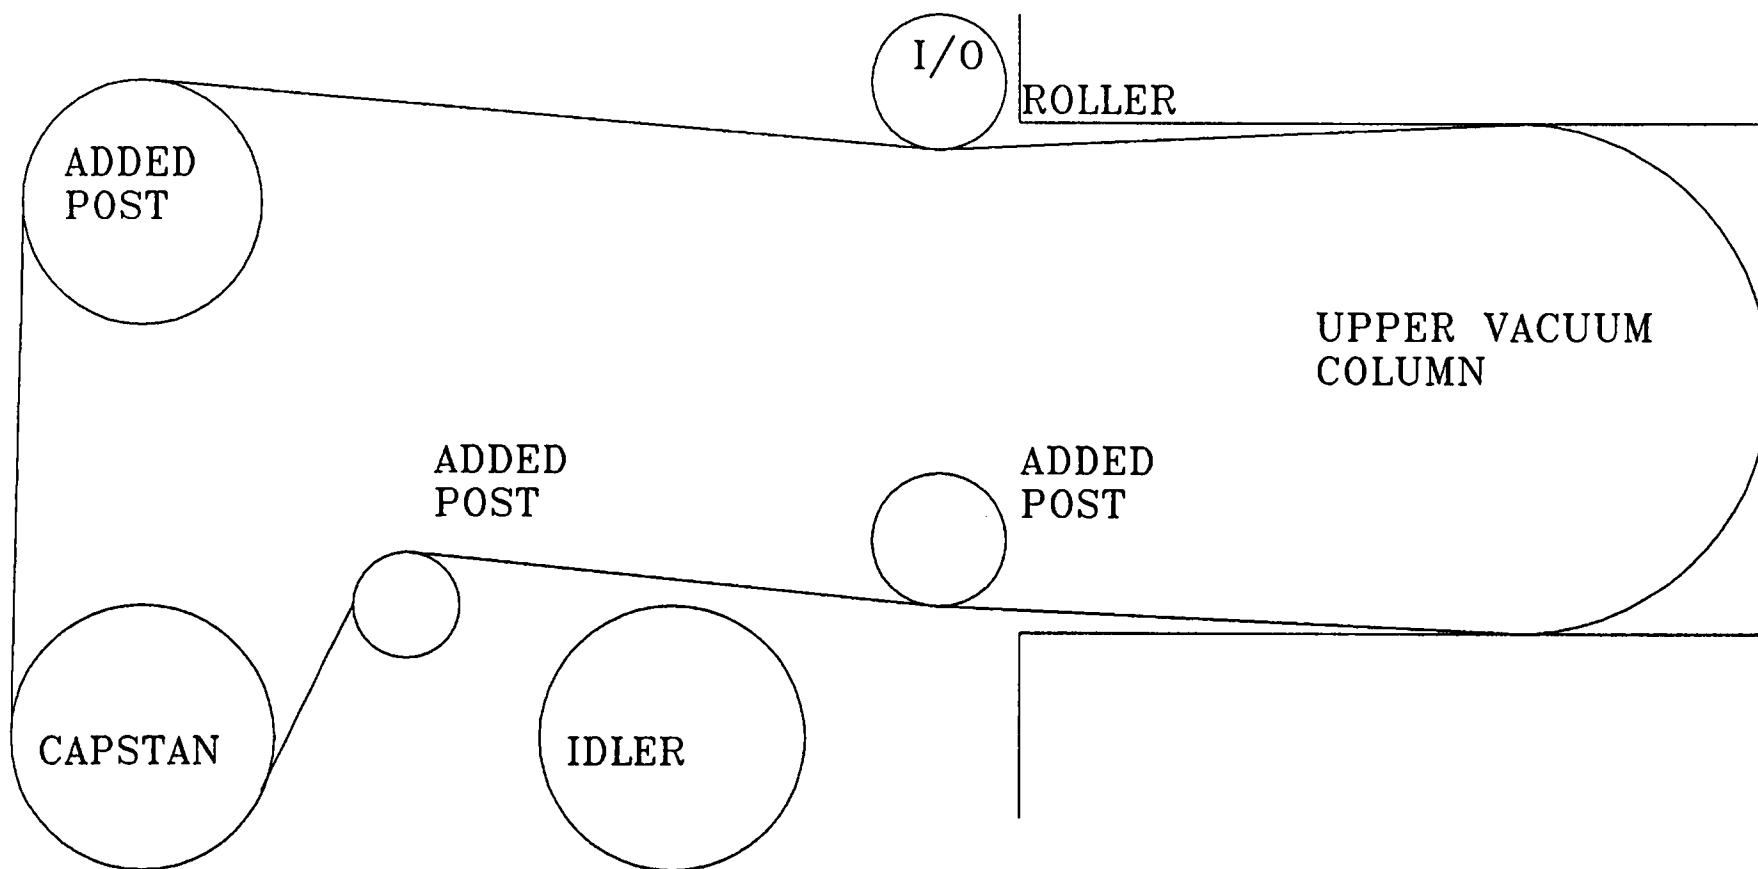
Figure 1. Schematic of tape loop

In order to try and understand the tape edge damage problem, I have run some recorder tests using a single 23" long tape loop. The geometry is shown in Figure 1. Some posts are added which act as air bearings at high tape speed (as long as they are kept clean). The reel servos are disabled by disconnecting the plug (A57 or J1) to the sensor/LED assembly.

- NOTES:
- 1] ADDED POSTS USING EXISTING TAPPED HOLES
 - 2] HEADBLOCK ASSEMBLY IS REMOVED
 - 3] LOOP SHOULD BE ABOUT 23" LONG
 - 4] LOWER VACUUM COLUMN IS SEALED WITH SMALL FIXED LOOP

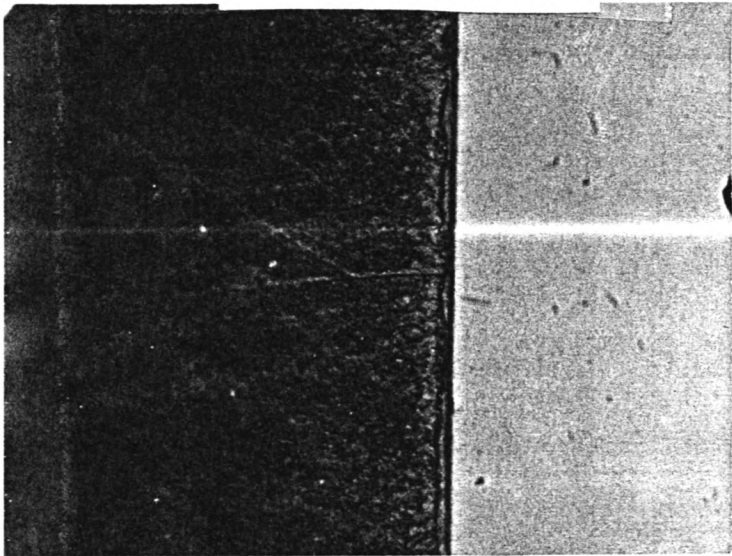
2. Running another tape until dirt forms, prior to running the loop, results in rapid failure of the loop.
3. The direction of flow of the melted tape edge is always towards the backcoat. That is, the backcoated side is thickened and has a protruding lip (see Figure 2A). Examination of edge damaged tapes shows the same trend. Reversing the loop so that the oxide is facing the vacuum reverses the flow direction.

INNER EDGE X640 BACKCOAT EDGE NEAR PP

Figure 2A. Side view of tape which developed bumpy pack in normal use.

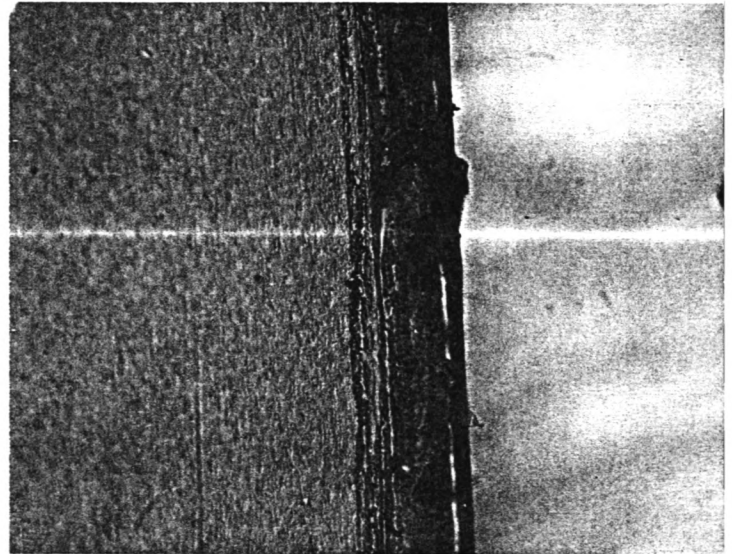
1. Sometimes the loop will suddenly fail with edge damage. Upon inspection there is some hard sticky brown dirt build-up on either the precision plate or front door. Examination with the microscope shows the edge against the dirt to be the one damaged.

3M X160 SEVERELY MELTED

Figure 2B. Side view of tape edge damaged by dirt in "loop" tests.

For the moment, keep the vacuum column edge contact areas clean (inspect them with a magnifier) and minimize high speed running. We are examining the properties of various surfaces in the hope that we can find a material that doesn't wear, has a high heat conductivity, low friction, and doesn't like to catch dirt. A thin coat of diamond is one such surface which might perform well. Another is a specially treated alumina surface known as "Tufram" (a trade name of the General Magnaplate Corp., Linden, N.J.).

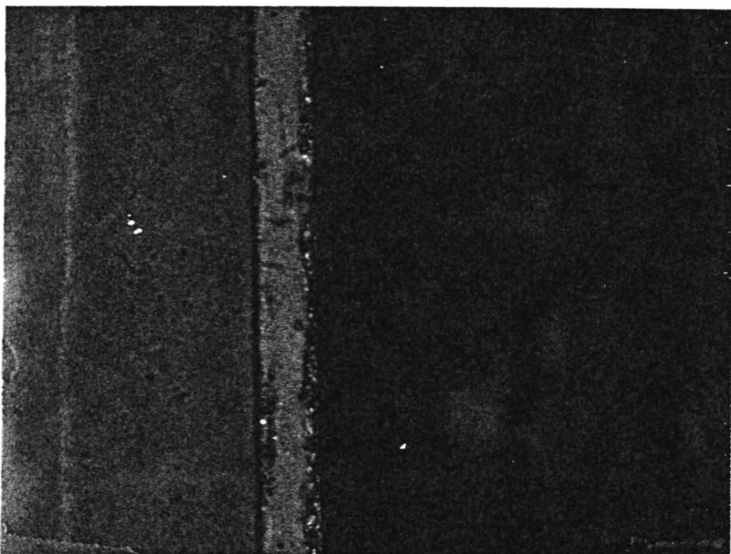
3M EDGE 12 HRS X 9000 AT 160¹⁰

Figure 2C. Top view of tape edge which was undamaged in 12 hrs. of accelerated testing.

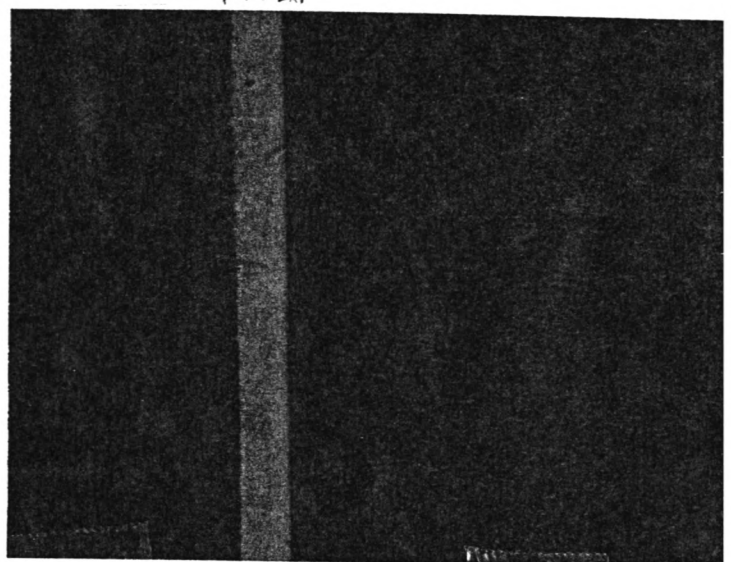
3M WITH EDGE FLOW

Figure 2D. Side view of severe edge damage showing a thickening of 3M 13 μm tape to 18 μm in "loop" tests.
