# VLBA ACQUISITION MEMO #300

To: VLBA Data Acquisition Group  
From: Alan E.E. Rogers and Hans F. Hinteregger  
Subject: Measured tolerance on reel table alignment

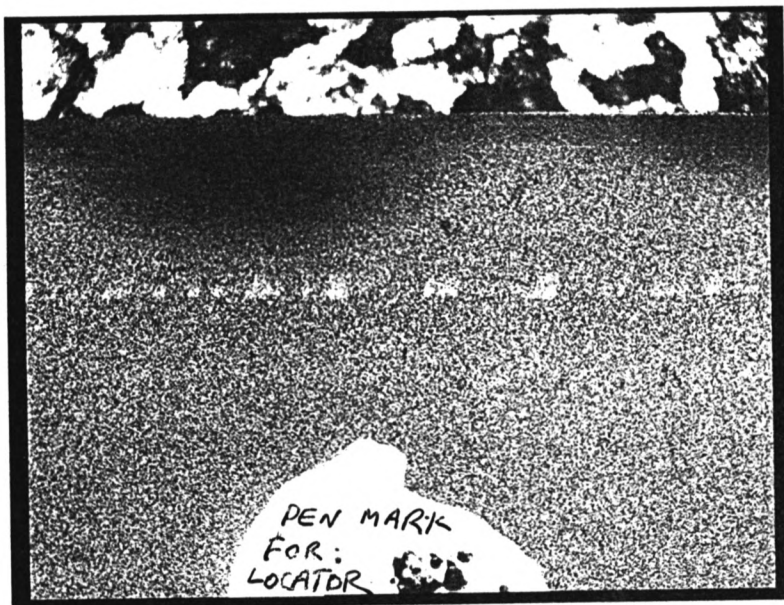
Various tapes were run on a transport (with the configuration given in VLBA Acquisition Memo #290) with deliberate misalignment of a reel table in the axial direction. With a tape mounted, the vacuum was adjusted until running at low speed produced permanent edge crinkle. Photographs 1 and 2 show the same piece of tape before and after damage. Under the microscope the damage is apparent as a gentle weaving of the edge (clearly seen without microscope) and some scuff marks on the backcoat about 600 microns in from the edge.

VIEW OF BACKLAP

light and dark regions are  
gentle ripple wave

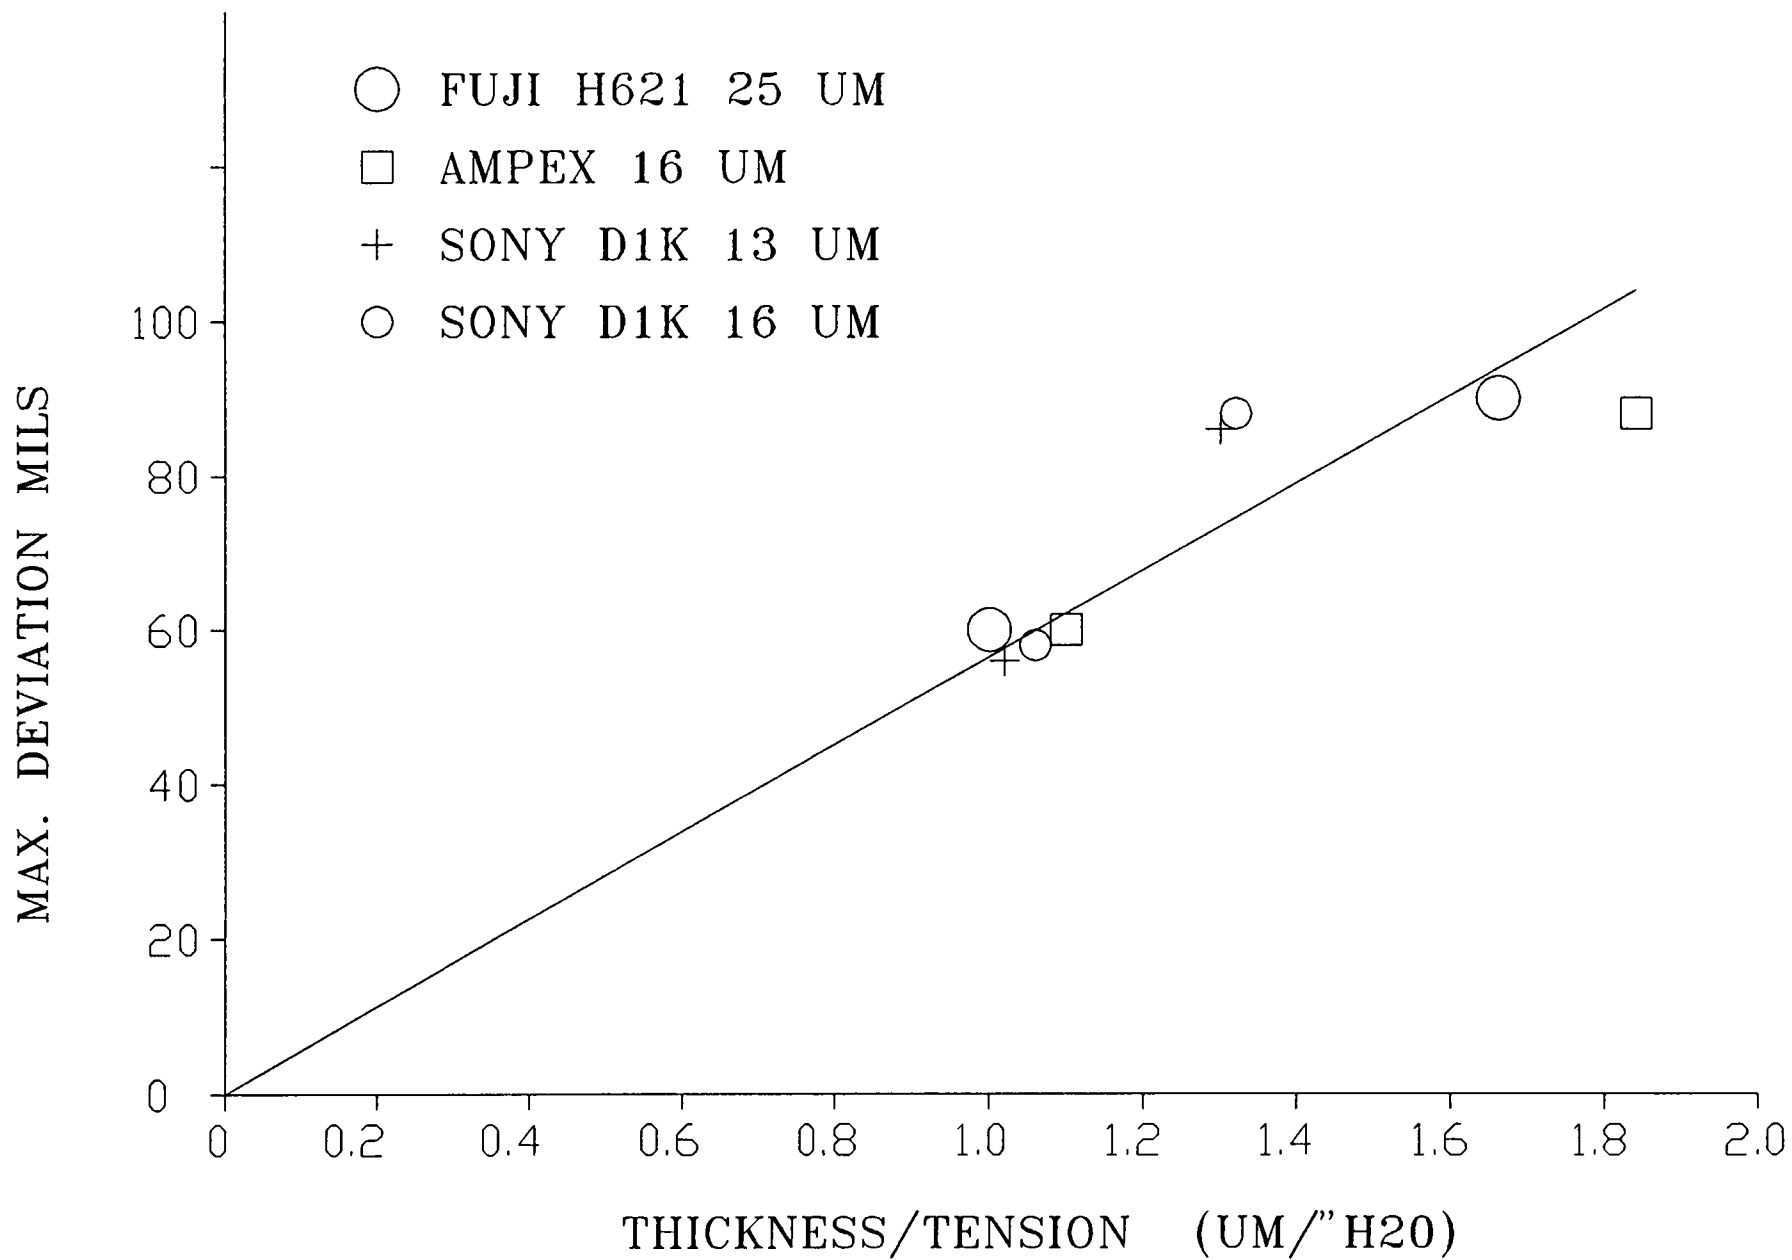
FIGURE 1. MEASURED MAXIMUM ALLOWABLE REEL TABLE TOLERANCE.

The results of the tests are plotted in Figure 1 and were found to vary in proportion to the ratio of tape thickness to tension. For 16  $\mu\text{m}$  tape run at 15", the maximum deviation before damage was 60 mils. Making allowance for some safety margin the reels should be aligned to  $\pm 50$  mils. This only accounts for misalignment along the reel axis. Any deviation in the perpendicularity of the reel and/or I/O roller axis with respect to the precision plate could also reduce the margin.
