VLBA ACQUISITION MEMO # 379

14 March 1994

Subject: Recovery of Shock-Deformed Tape

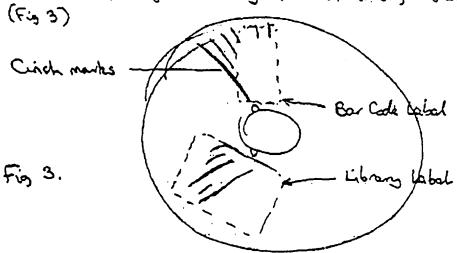
Visial Inspection - Tage packed hand against flarge with labels. Edge deformed (Fig 1), some deformation at one port of circumference (Fig. 2.)

Evidence of tops cirching visible through clear new flange

As our transports botate the label side against the reel platform, the distance between the tage edge and the deck

Would be, at worst, 19.2 mm, approximately 1.8 mm away from the normal running position. This amount of correction at the first guide would give unacceptable edge wear.
