National Radio Astronomy Observatory

Subject: Plan for corrosion problems in electronic modules at St. Croix

SALT CORROSION PROBLEM AT VLBA ST. CROIX

VLBA IF-LO MODULES

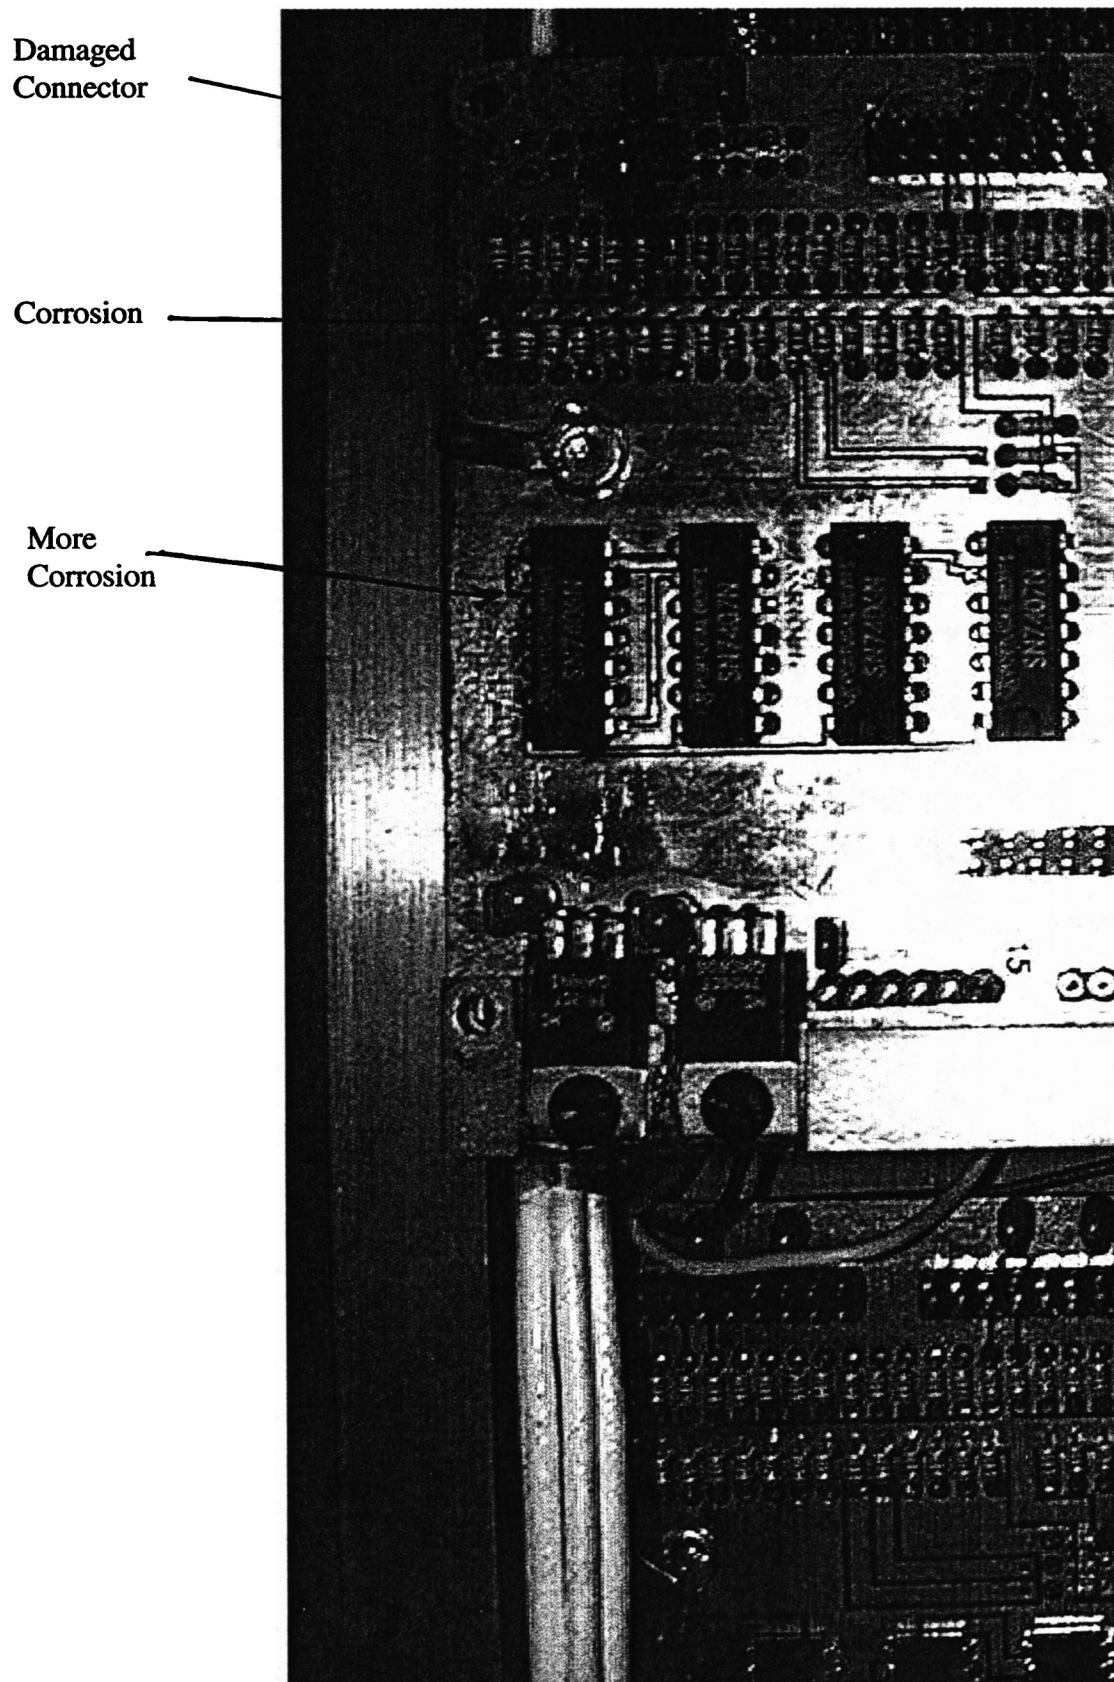
Figure 1. Damaged Board in BBC sn 29

Recently, BBC sn 29 failed at St. Croix. This module was returned to the AOC for repair. Visual inspection of this module revealed severe corrosion and possibly some fungus growth within the module. The corrosion was mainly along the bottom edge of the filter board, and the power board closest to the bottom of the module. There was also some problems along one edge (the edge at the bottom of the module) of the M & C wire wrap board.. We have subsequently learned that several BBCs at SC have this problem. On sn 29 and 144, the corrosion caused a short circuit that burned a hole on the board and damaged a connector.

I have had some discussion with Paul Rhodes concerning this problems. Paul feels that the problem is an isolated event which was caused by the most recent hurricane. He believes that because the dehumidifier was shut down and the doors to the building were left open everything was soaked with salt spray. Paul believes that all we have to do is return the BBCs to the AOC and clean them up. The main reason Paul believes that we do not have a problem is because we have not seen it up until this time. I, however; believe that we have had and will continue corrosion problems due to the salt spray environment. I believe that the hurricane greatly magnified the problem and without the hurricane the problems would have eventually shown up. We have seen some evidence in the past of small white spots in the BBCs but we did not know what they were. A photograph showing some of the corrosion of BBC sn29 is show in Figure 1.

Paul Harden, after additional BBC failures, had all BBCs and the IF distributors returned to the AOC for inspection and repair. His report is included as Attachment # 1. He has provided BBC location, time of service at St. Croix and condition of each module returned. His report shows that the worst modules were near the center of the bin at the bottom of the rack. Since the heaviest corrosion was along the bottom edge of the circuit boards in the modules, I believe that salt water must have condensed inside the rack and dripped down initiating the heavy corrosion.

at New Mexico Tech, for further analysis. Dr. Brandvold's analysis showed that sodium chloride was the primary chemical found in the corroded areas of the circuit boards. Dr. Brandvold also found some sulfates on the boards. He said that the sulfates possibly (due to the volcanic activity in the area) appeared to have caused some pitting on the boards accelerating the corrosion due to the salt. Dr. Brandvold believes that the excessive corrosion we have found at this time is more event related to the hurricane and not a long term corrosion problem. He believes a simple coating on the boards should provide all the protection we need.

I believe that the modules at St Croix need to have all exposed circuit boards (ie boards that are not in an enclosed housing) conformal coated. We are going to replace the boards that are heavily damaged and thoroughly clean all of the other exposed boards. We are then going to conformal coat these boards and initiate a program which will insure that St. Croix has modules with conformal coated boards. The problems faced here may not be indicative of long term corrosion but these modules will need to function for a long time and coating the boards is an easy and cheap solution.
