NATIONAL RADIO ASTRONOMY OBSERVATORY Socorro, New Mexico

VLBA Antenna Memo 101

Azimuth Rail Grout Repair at Brewster, Washington

J. Gallegos July 23, 2019

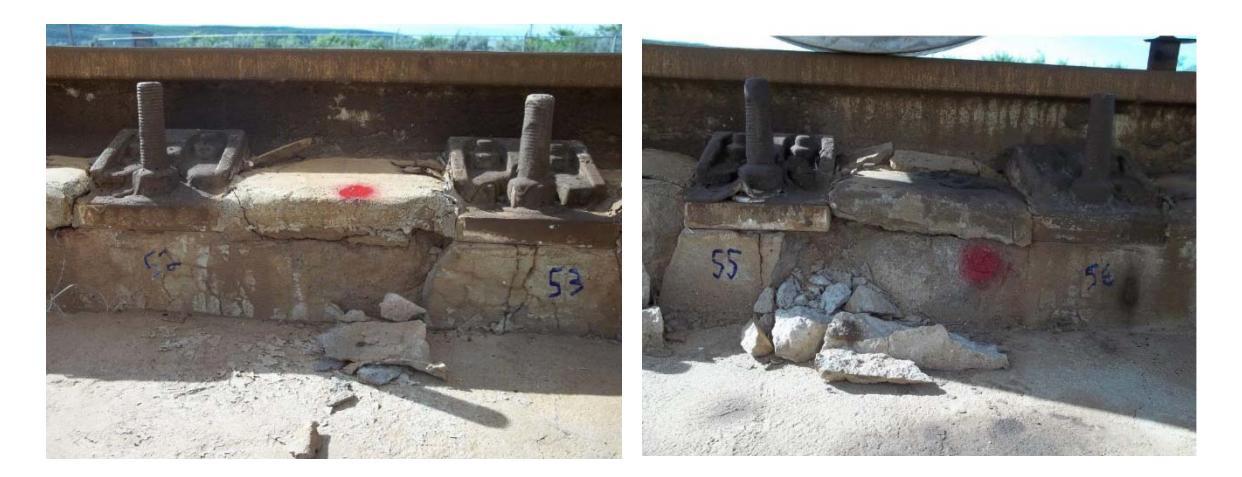
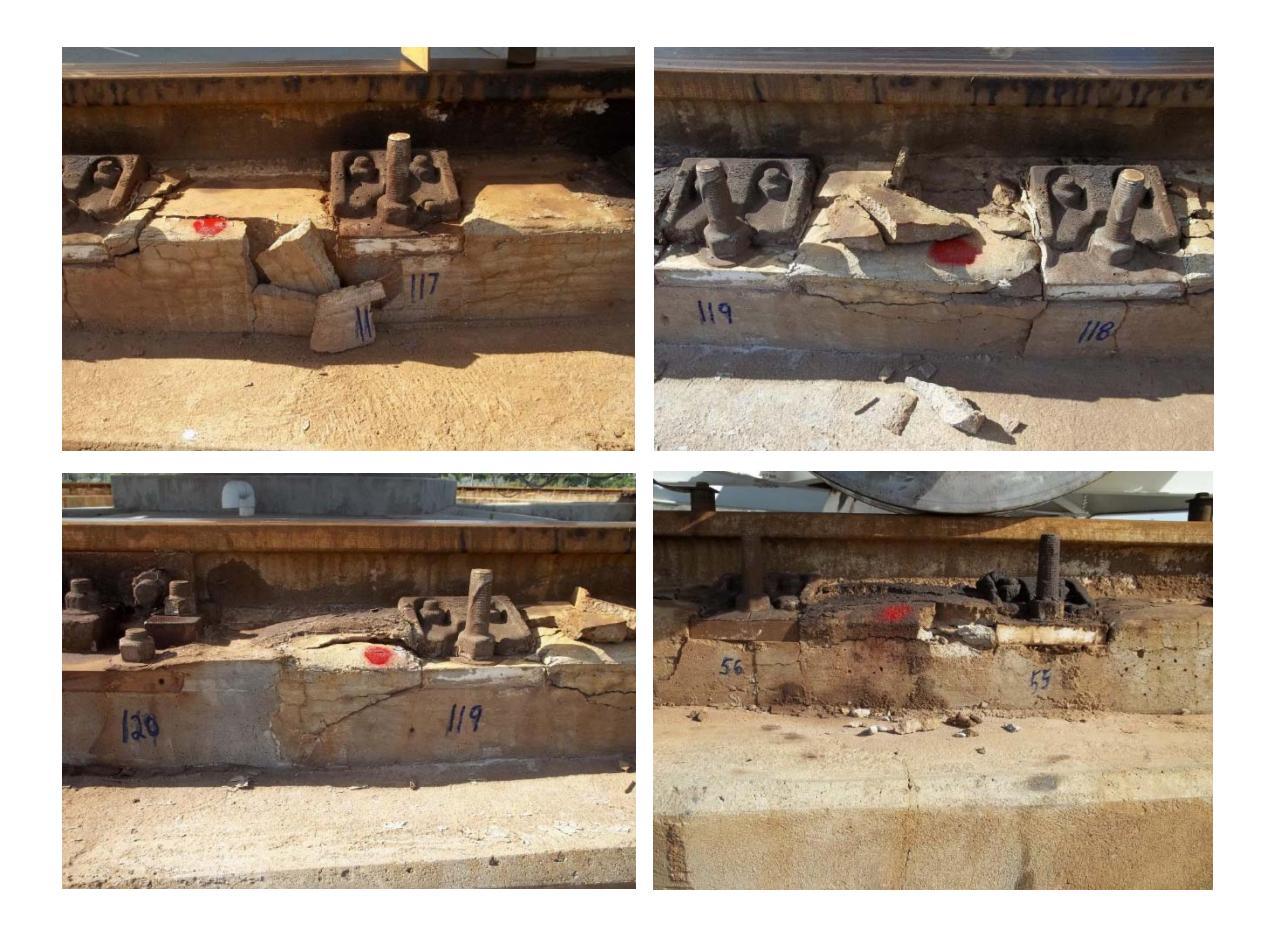
The grout directly below the Brewster VLBA azimuth rail was cracked and degrading in multiple places. A total of 25 damaged grout sections were completely and partially removed and replaced with a new grout. Spalling in the original cement grout used below the azimuth rail caused major cracks and voids between the rail and the grout. A new E-Chem epoxy grout was used in place of the old cement grout.

On the 23rd of May 2019, the site technician Jesse Fulmer reported that the grout beneath the rail was deteriorating and large cracks were forming as seen in the images below.

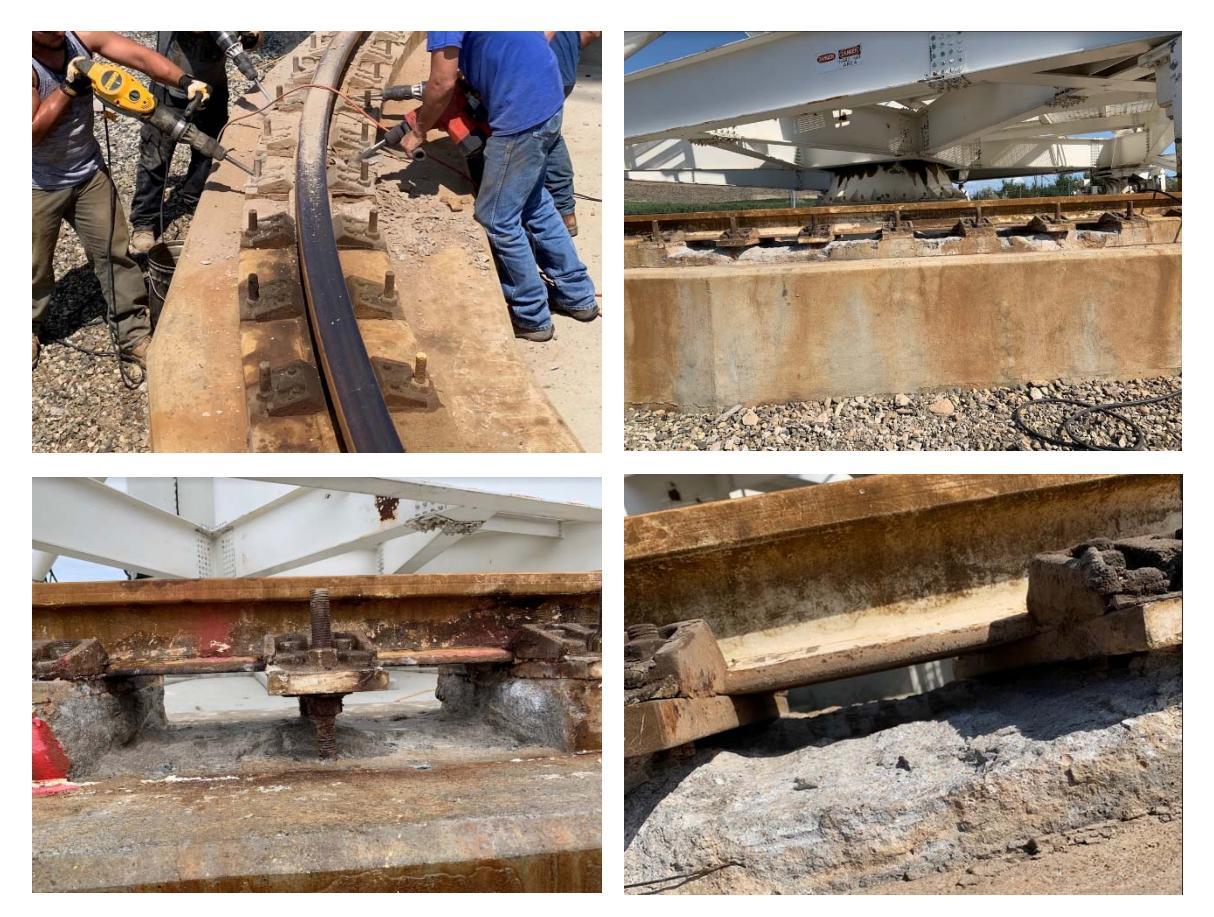
Demolition hammers were used to break out all grout sections needed to be replaced. In the worst places the grout was completely removed all the way to the lower foundation. The places where the grout was not cracked all the way through we only removed the top portion approximately 2 inches below the rail. All photos of the demolition can be seen below.
