## NATIONAL RADIO ASTRONOMY OBSERVATORY

VLBA Antenna Memo Series No.11

Los Alamos Maintenance Visit, July 13 - 17, 1998 - Trip Report

J. E. Thunborg July 28, 1998

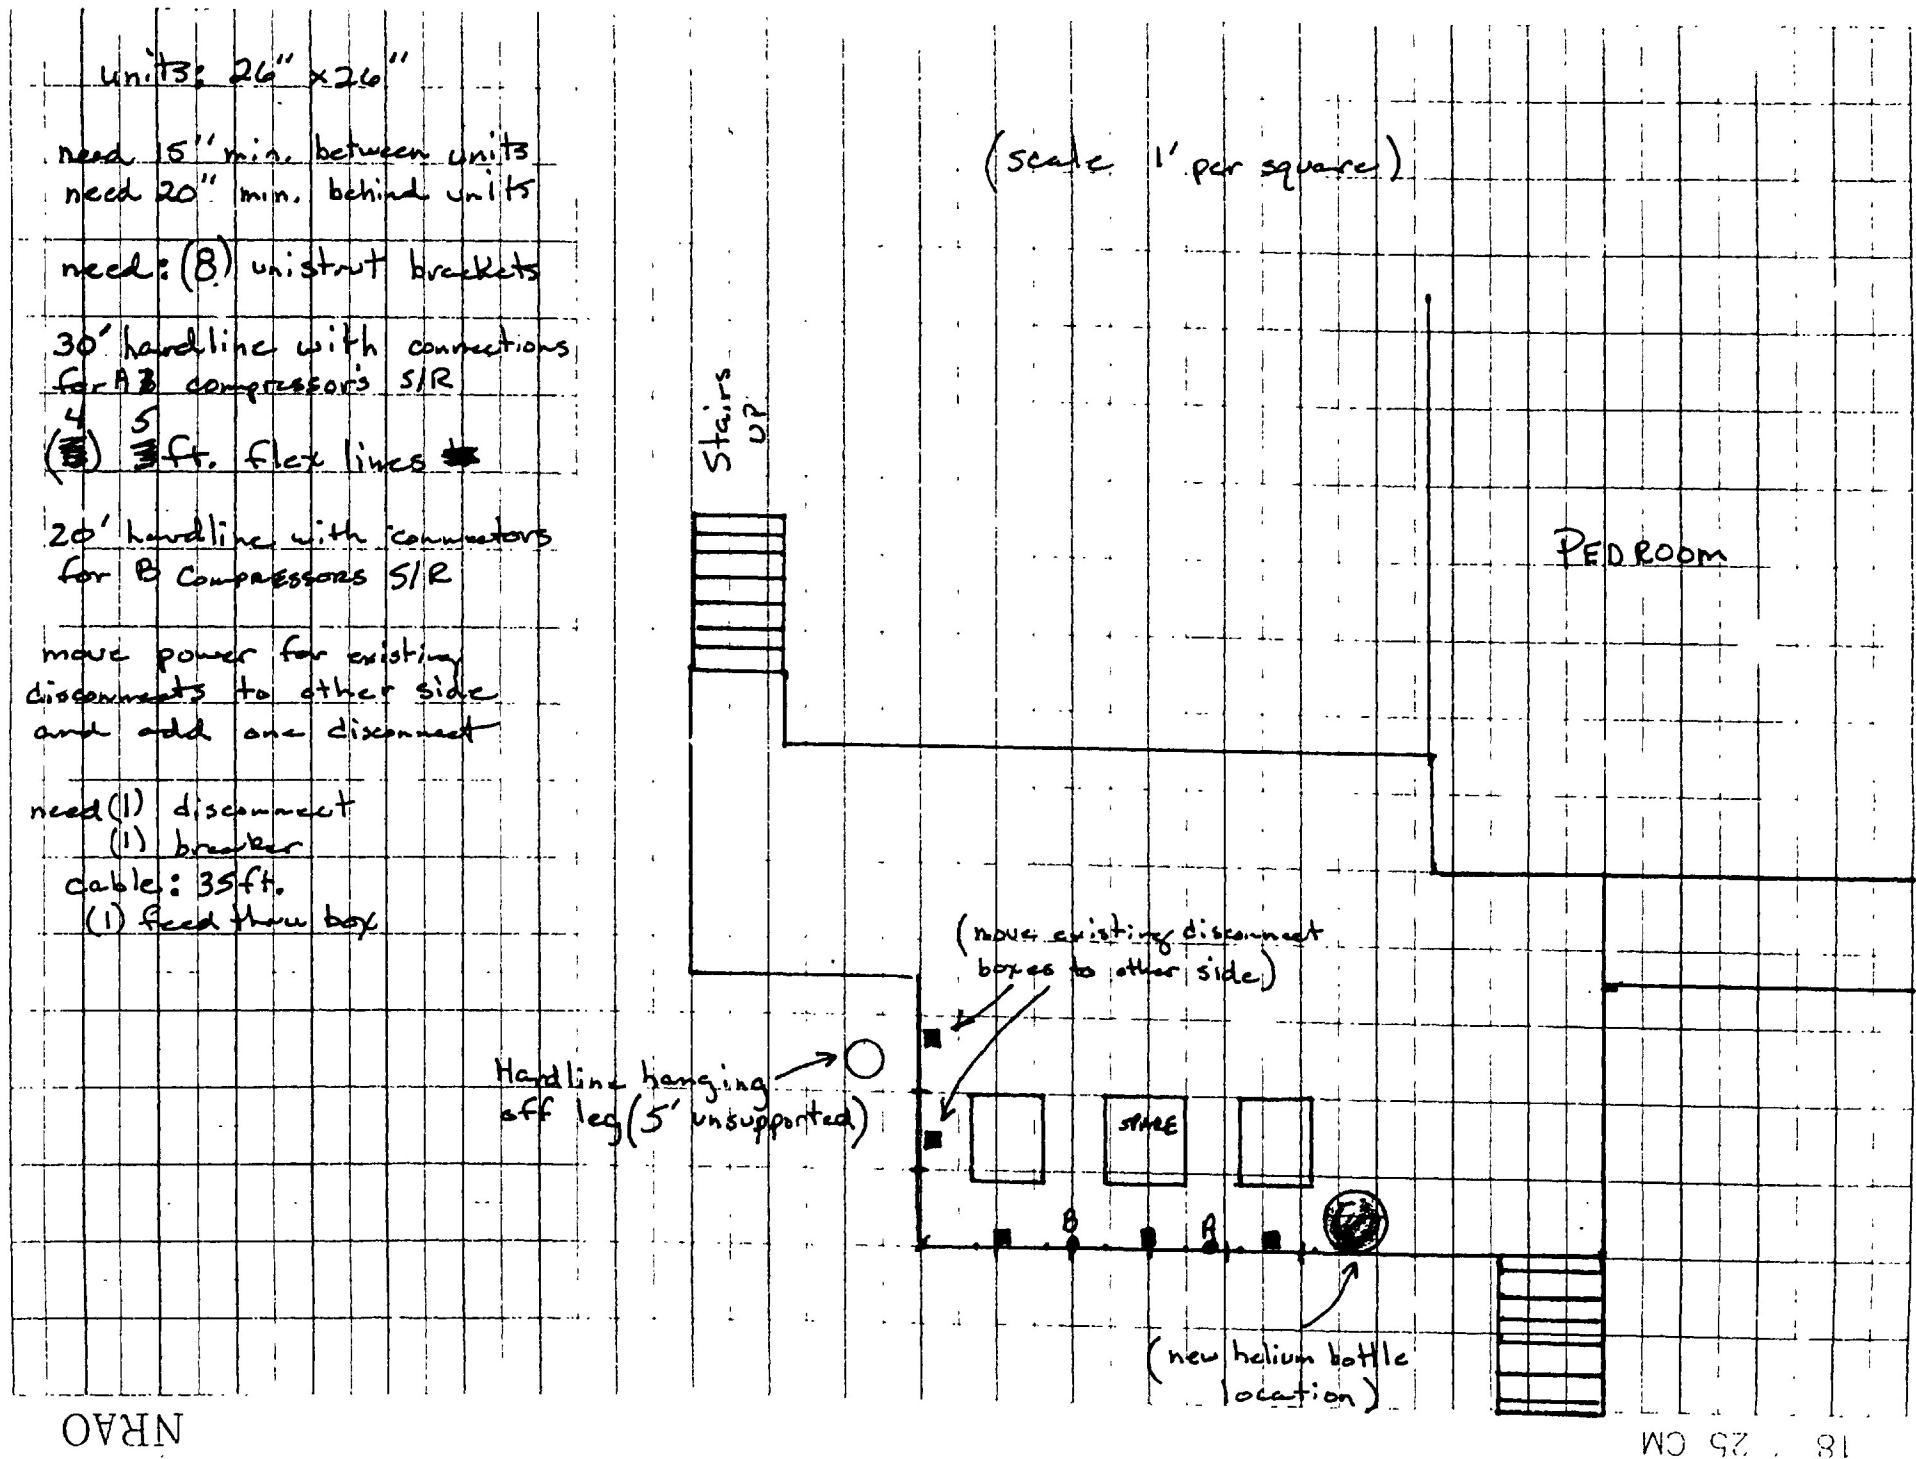
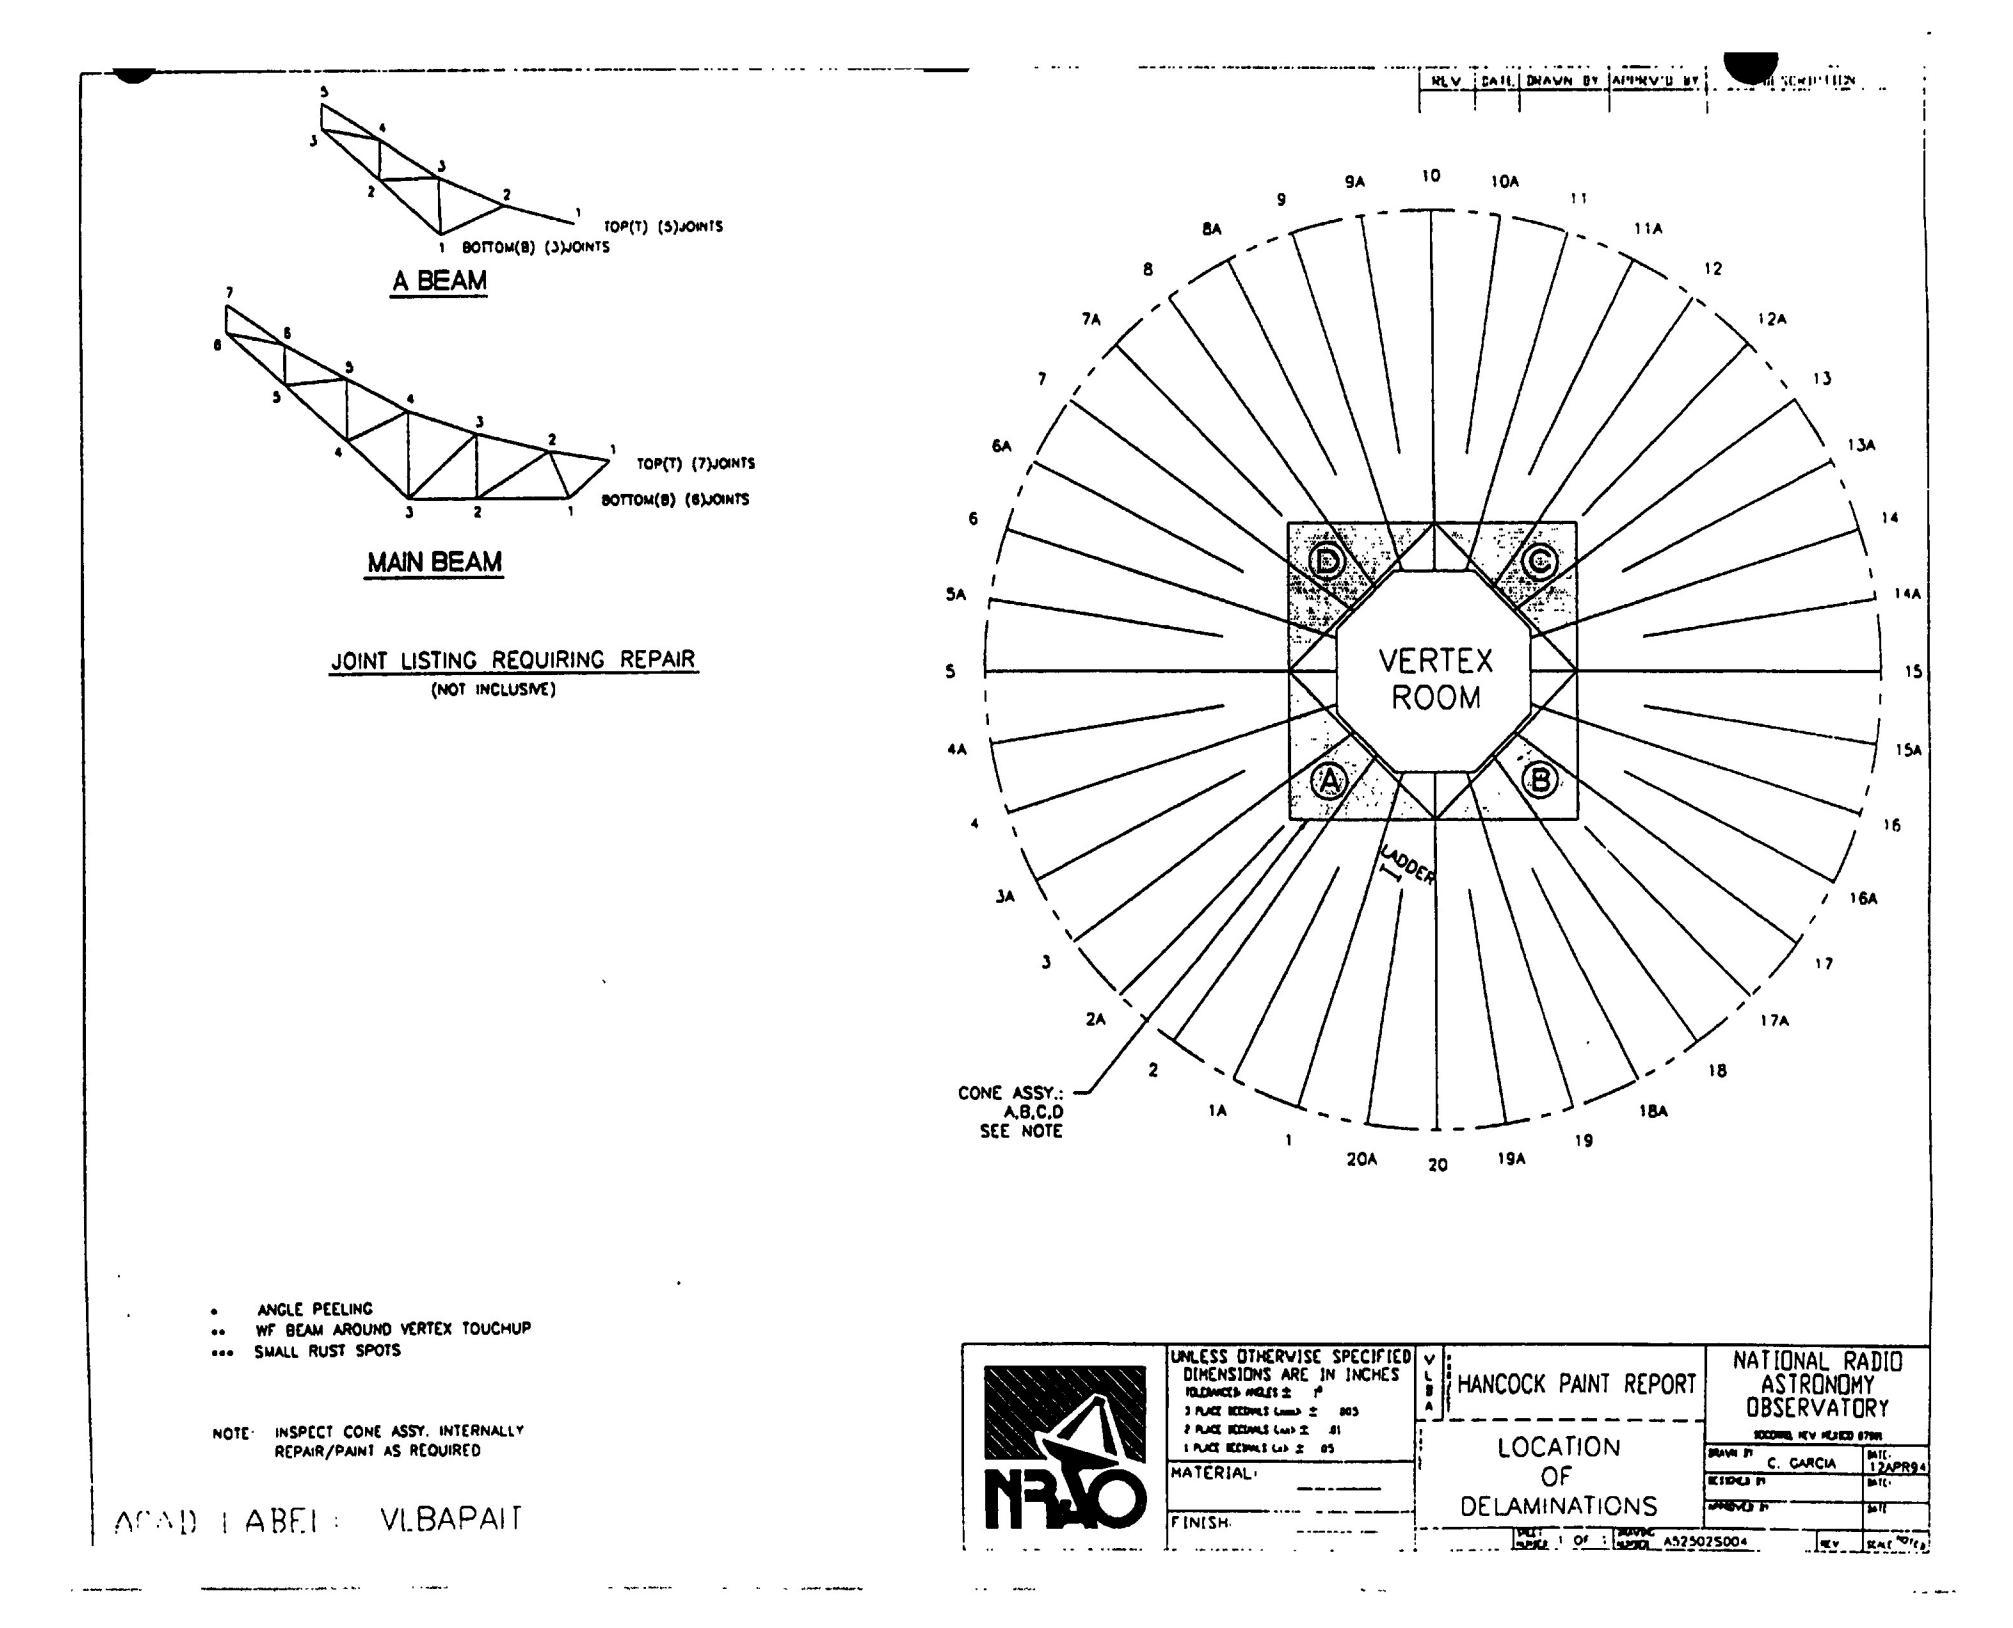
ANTENNA PAINT REPORT

ANGLE PEELING

SMALL RUST SPOTS

WF BEAM AROUND VERTEX TOUCHUP

JOINT LISTING REQUIRING REPAIR (NOT INCLUSIVE)
