NATIONAL RADIO ASTRONOMY OBSERVATORY

VLBA Antenna Memo Series No.38

North Liberty Rail Repair

J. E. Thunborg June 14, 2002

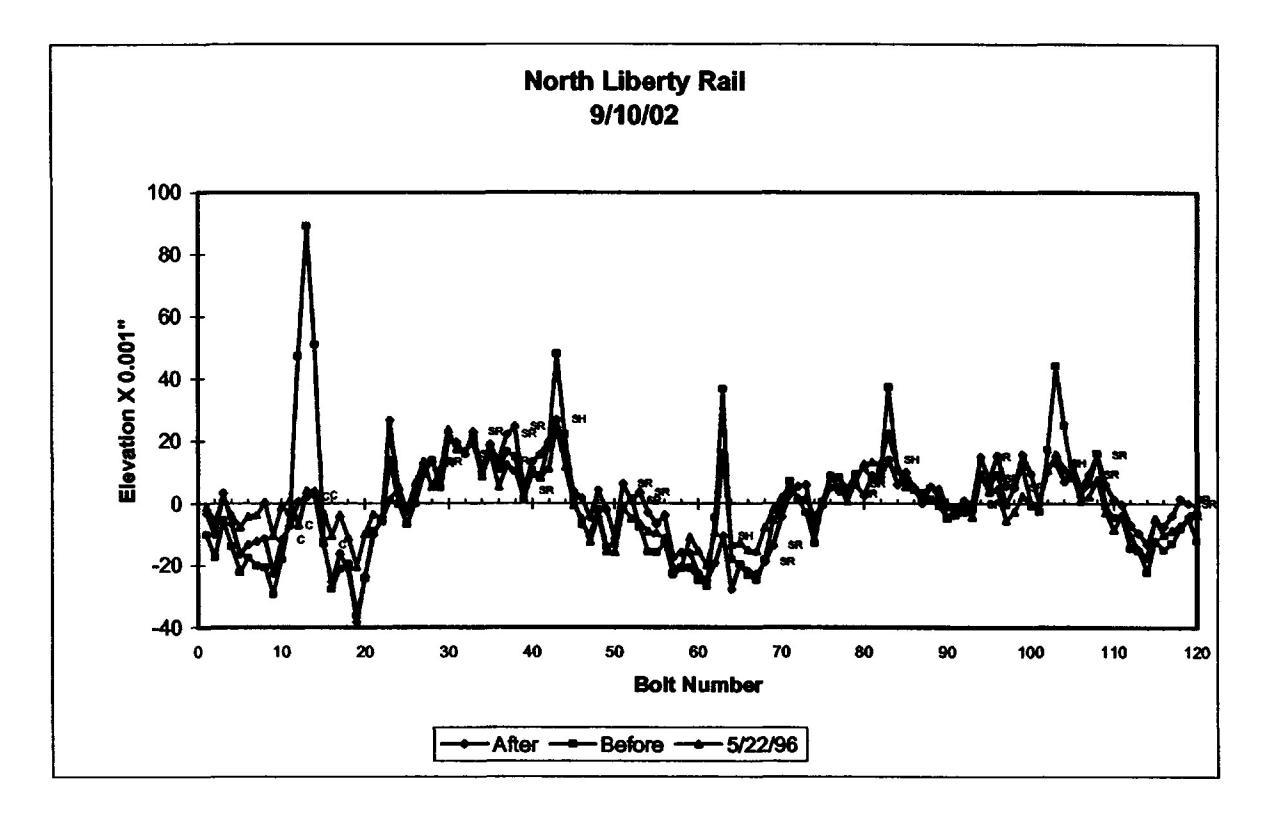
- SH Marks places where shim was added between rail and splice plates.
- SR Marks places where spot repairs were done.
- C -- Marks place where complete gout repair was done.

Rail measurements showed that the rail was deflecting at the splices under load. A dial indicator was used to determine that the movement was occurring between the splice plate and the rail. Brass shims were then placed under the rail at the splices to eliminate this movement.

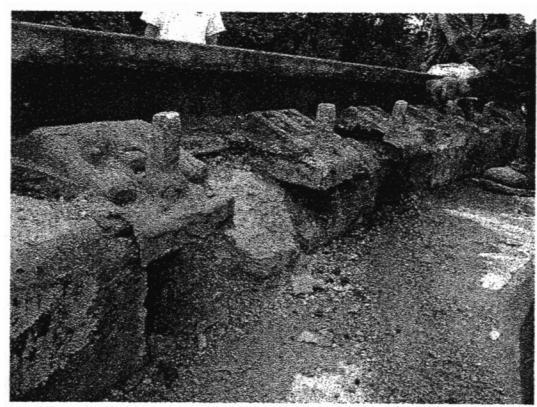
The grout under the azimuth rail on the North Liberty, Iowa VLBA antenna had degraded to such an extent that the antenna pointing was being adversely effected. On June 3 – June 9 a maintenance team consisting of Phillip Sanchez, Marlin Smith, Jon Thunborg and Adrian Zamora were dispatched to Iowa to repair the rail with the help of the site technicians D.J. Beard and Mike Burgert. An initial measurement of the rail showed that the section of rail between bolts 10 and 16 deflected excessively when under load. The grout under this section of rail was severely degraded (Figure 1). Heavy-duty hammer drills were then used to remove this section of grout (Figures 2 and 3). After the grout was removed, the anchor bolts were inspected. Three of these bolts were broken. The broken bolts were then sawed off and thread chased with a tap. Coupling nuts were used to attach new studs to the sawed off anchor bolts. The rail plates were then repositioned and Burke High Strength Epoxy Grout was poured under the rail and rail plates as shown in Figure 4.

Figure 1. Degraded grout near bolt #13.

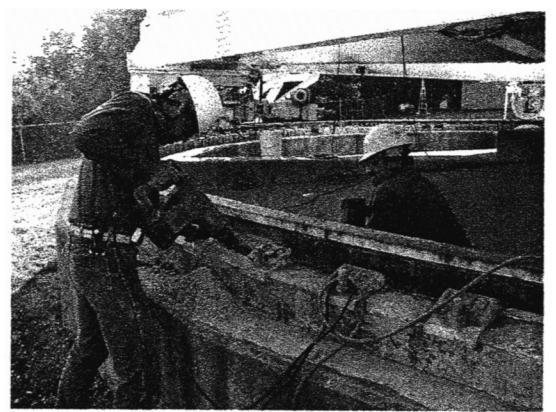
Figure 2. Hammer drills used to remove old grout.

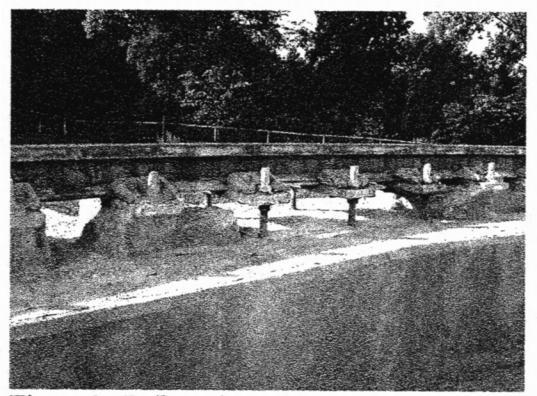
Figure 3. Rail section with grout removed.

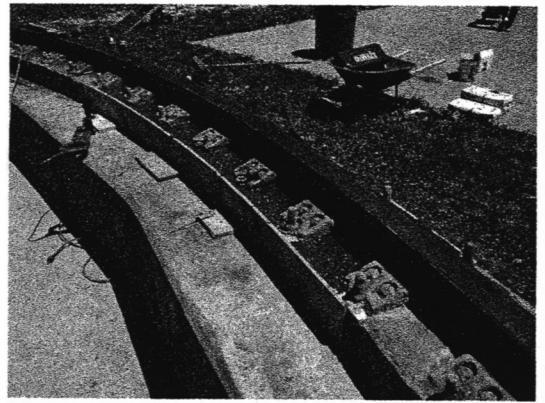
Figure 4. Rail section near bolt 13 repaired with high strength epoxy grout.

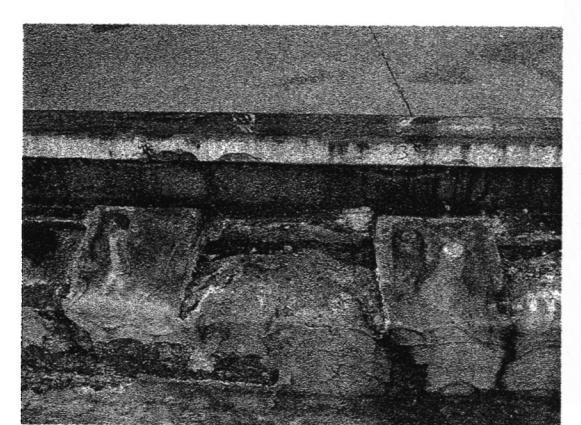
Figure 5. Candidate for spot repair.

In addition to the major repair above, the grout was spot repaired at several other locations along the rail. An example of grout in need of spot repair is shown in figure 5. In a spot repair, the old grout between the rail plates and under the rail is removed to a depth of approximately 3 inches. New grout is then poured in the hole under the rail. In a few places, the bolts that hold the rail clips to the rail plates were broken. These were repaired by removing enough grout from below the rail plate to remove the broken bolt and insert a new one. A typical spot repair is shown in figure 6. Spot repairs were made between the following bolts; 27-28, 28-29, 32-33, 33-34, 36-37, 37-38, 38-39, 39-40, 51-52, 52-53, 78-79, 79-80, 93-94, 94-95, 95-96, 98-99, 107-108, 108-109, 117-118, 118-119, 119-120.

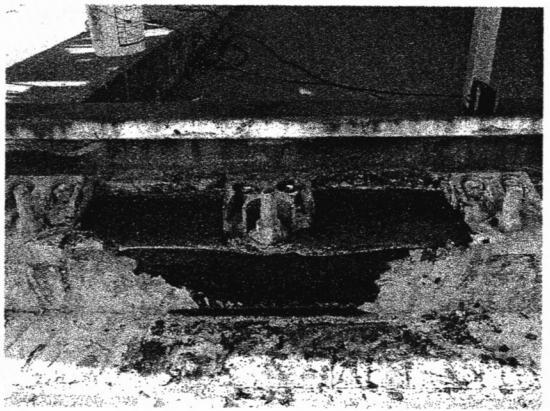
Figure 6. Typical spot repair with rail clip bolts replaced.
