NATIONAL RADIO ASTRONOMY OBSERVATORY

VLBA Antenna Memo Series No. 48

St. Croix Elevation Bearing Replacement - Trip Report

J. E. Thunborg September 10, 2003

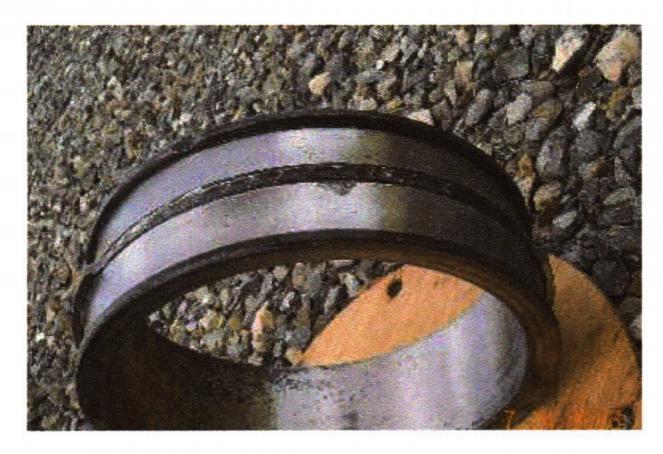
The original bearing's inner ring center guide flange was fractured. According to engineers at Torrington Bearing, this kind of fracture is due to excessive thrust load on the bearing.

One possible reason for the excessive thrust load is the way the bearing was initially installed. The slots on the bearing pillow block and the slots on the elevation platform both go in the same direction. This allows for misalignment

perpendicular to the axle. However it does not allow for misalignment along the axle. This means that great care must be used to position the bearing correctly on the axle to prevent thrust loads that could develop between the axle and the elevation bearing pillow block. During disassembly we found that the original bearing was positioned such that these thrust loads were present.

The thrust loads induced during assembly would have been alleviated if the slots on the pillow block went in a direction perpendicular to the slots in the elevation platform. A careful check of the AUI VLBA drawings showed that both the platform and the bearing pillow block were fabricated according to the drawings but the slots shown on the drawings were specified in the same direction. Since all of the VLBA antennas were built using these drawings, it is reasonable to believe that they all have the same problem. This is probably why the Las Alamos elevation bearing failed.
