WEATHER CONDITIONS AT THE POTENTIAL
MMA SITE ON MAUNA KEA

Peter J. Napier
NRAO, Socorro
April, 1994

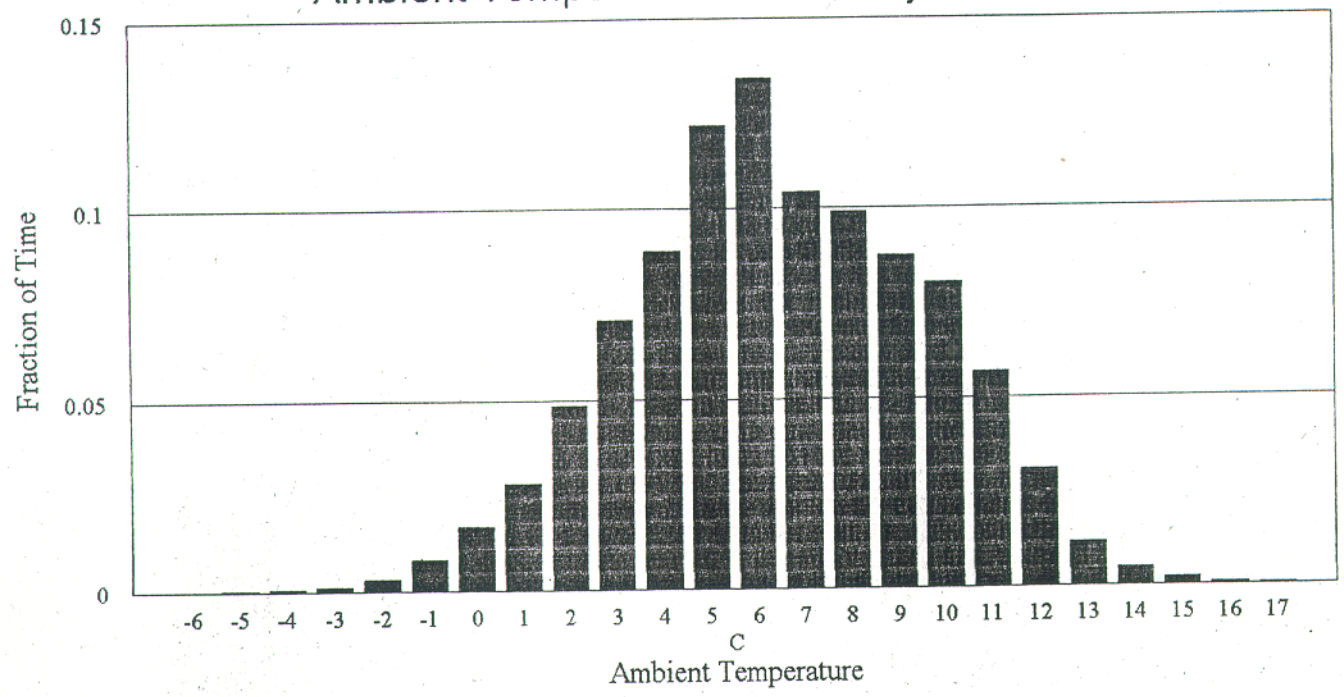
Figure 3. Ambient temperature probability distribution. The bar for temperature T shows the fraction of the 8130 measurements lying in the range T to T+1.

A plot of all 8130 hourly median ambient temperatures is shown in Figure 2. The relatively small annual and diurnal temperature variations typical of a tropical island location can be seen in Figure 2. Figure 3 shows the probability distribution for the data in Figure 2. To show how temperature varies diurnally, for each hour of the day Figure 4 shows the temperature averaged over all 339 days. An estimate of rate of change of temperature can be obtained by taking the difference between temperature samples adjacent in time. Figure 5 shows the distribution of rates of change of temperature computed in this way. The principal temperature statistics are shown in Table 2. Note that the average and range of temperatures reported here are in good agreement with long term temperature versus elevation data for Hawaii (pg 64, Armstrong 1983), so it is reasonable to assume that this one year data sample of temperatures is typical for the site.

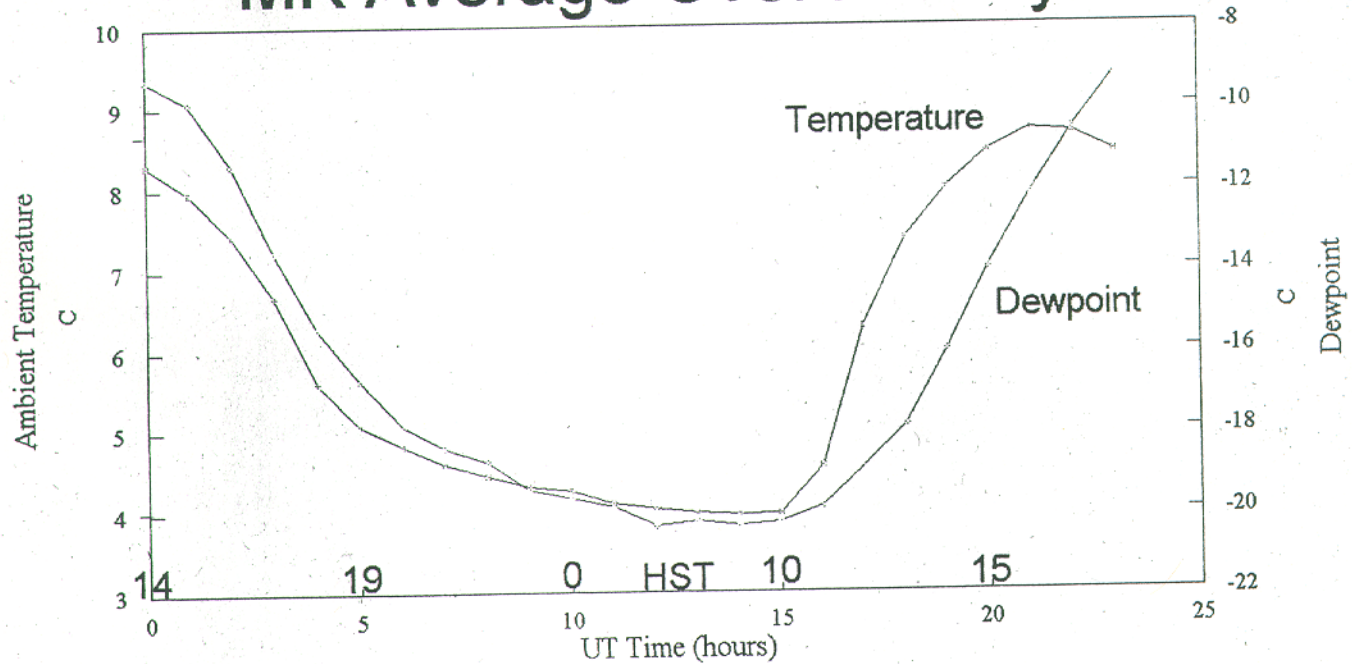
Figure 4. Ambient temperature and dewpoint for each hour of the day, averaged over all 339 days.

The probability of condensation or precipitation increases as the difference between ambient temperature and dewpoint decreases. In Figure 6 we plot all 8130 values of the quantity (hourly median ambient temperature - hourly median dewpoint) and Figure 7 shows the distribution of this data. Figure 7 shows that the site is very dry with ambient temperature being more than 1°C above the dewpoint 96% of the time. Figure 4 shows the average diurnal variation of dewpoint.

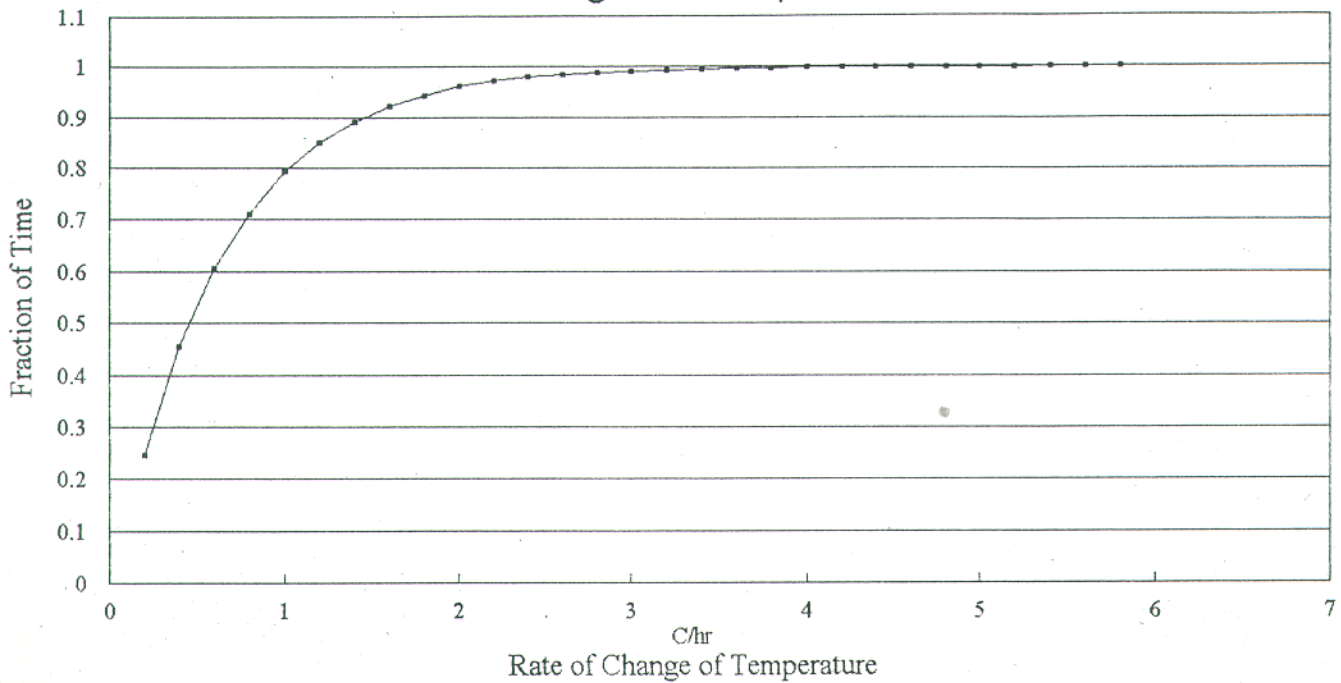
Figure 5. Cumulative probability distribution of rate of change of temperature computed for a time scale of 1 hour. Rate of change of temperature at time t_n is computed as $(T_n - T_{n-1}) / (t_n - t_{n-1})$, where T_n is the temperature measured at time t_n . The curve shows the distribution of 8129 rates computed for $n = 2$ to 8130.

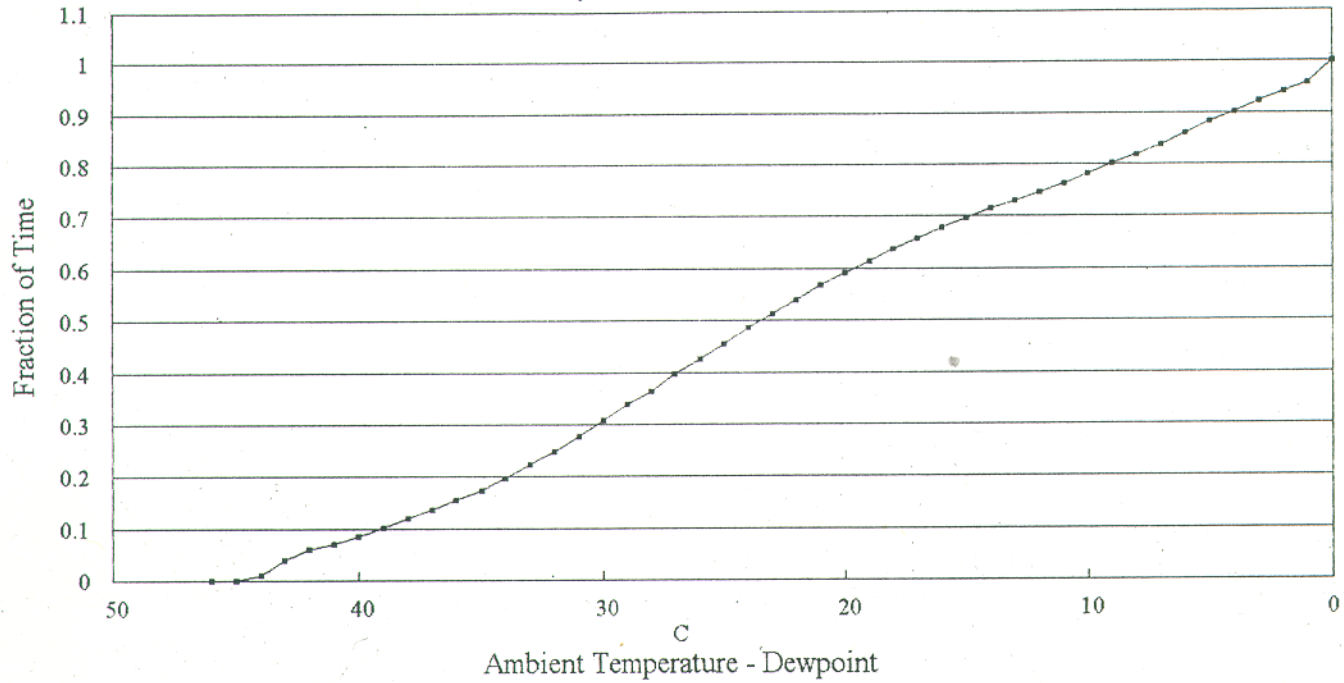
Figure 7. Cumulative probability distribution for the difference ambient temperature - dewpoint.

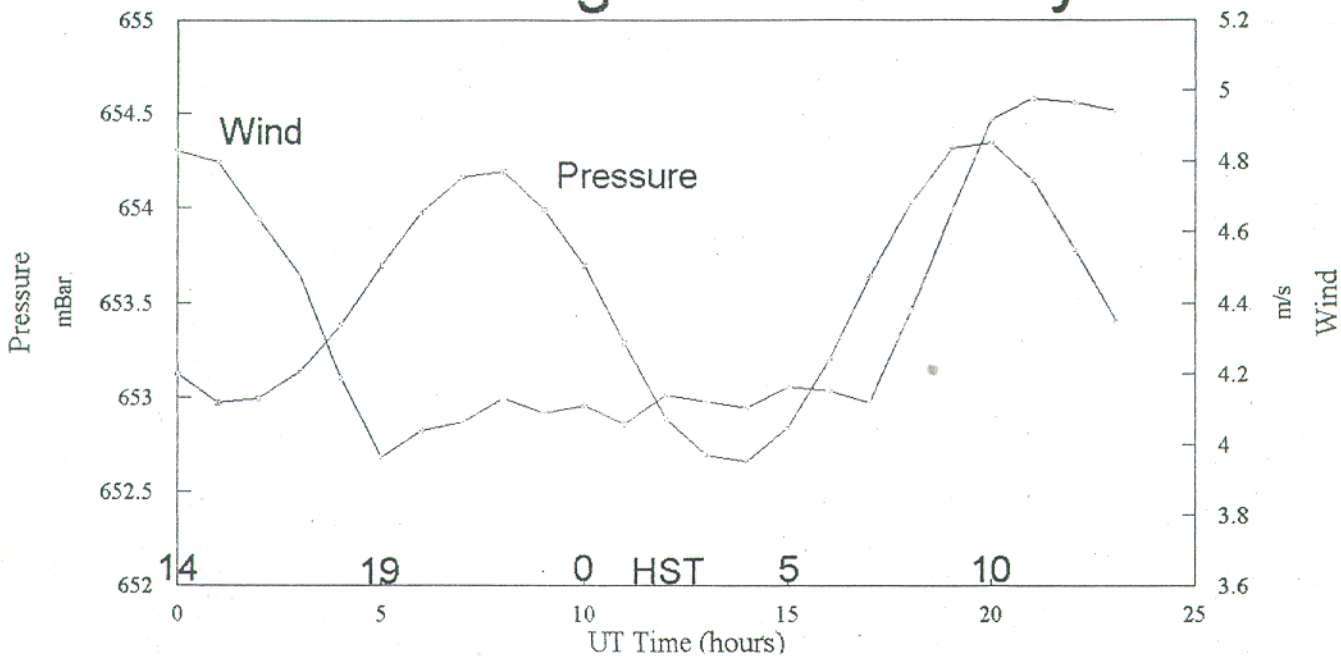
Figure 9. Average diurnal variation of pressure and wind speed.

Figure 8 is a plot of all 8130 values of barometric pressure versus time. The average pressure is 654 mBar (65% of sea level pressure). Figure 9 shows for each hour of the day the pressure averaged over all 339 days. The 1.5 mBar peak-to-peak sinusoidal variation with a 12 hour period, seen in Figure 9, is the signature of a solar thermally driven atmospheric tide (Lindzen, 1990).

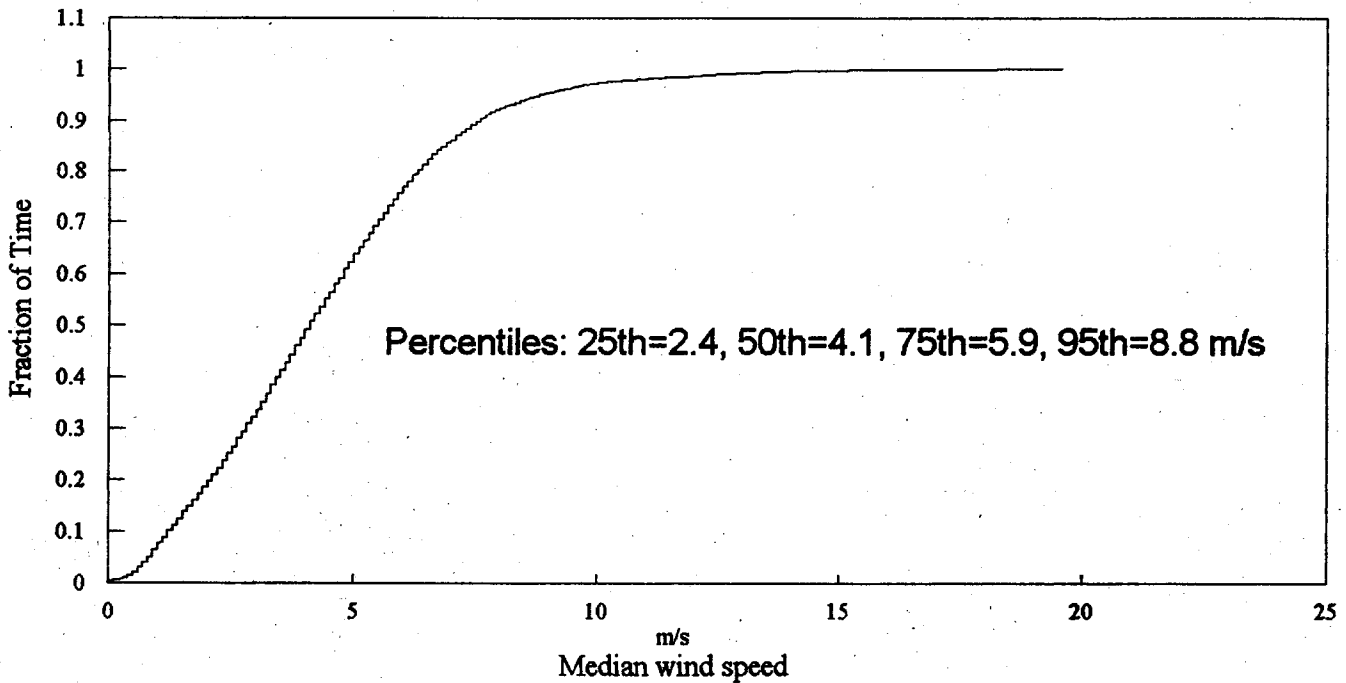
Figure 12. Cumulative probability distribution for hourly median wind speed.

Plots versus time of all 8130 values of hourly median wind speed and hourly peak wind speed are shown in Figures 10 and 11. Cumulative probability distributions for hourly median wind speed and hourly peak wind speed are shown in Figures 12 and 13. Wind statistics are summarized in Table 3. Average diurnal variation of wind is shown in Figure 9. Information on wind direction is given in Figure 14 where each of the 8130 hourly median wind measurements is plotted resolved into its E-W and N-S components (note that the direction recorded and plotted is the direction the wind is blowing FROM). The direction of the dominant wind in Hawaii, the Trade Winds out of the Northeast, do not stand out particularly clearly in Figure 14, presumably because other wind patterns are also significant. Other wind directions to be expected at this site are (pg 65, Armstrong

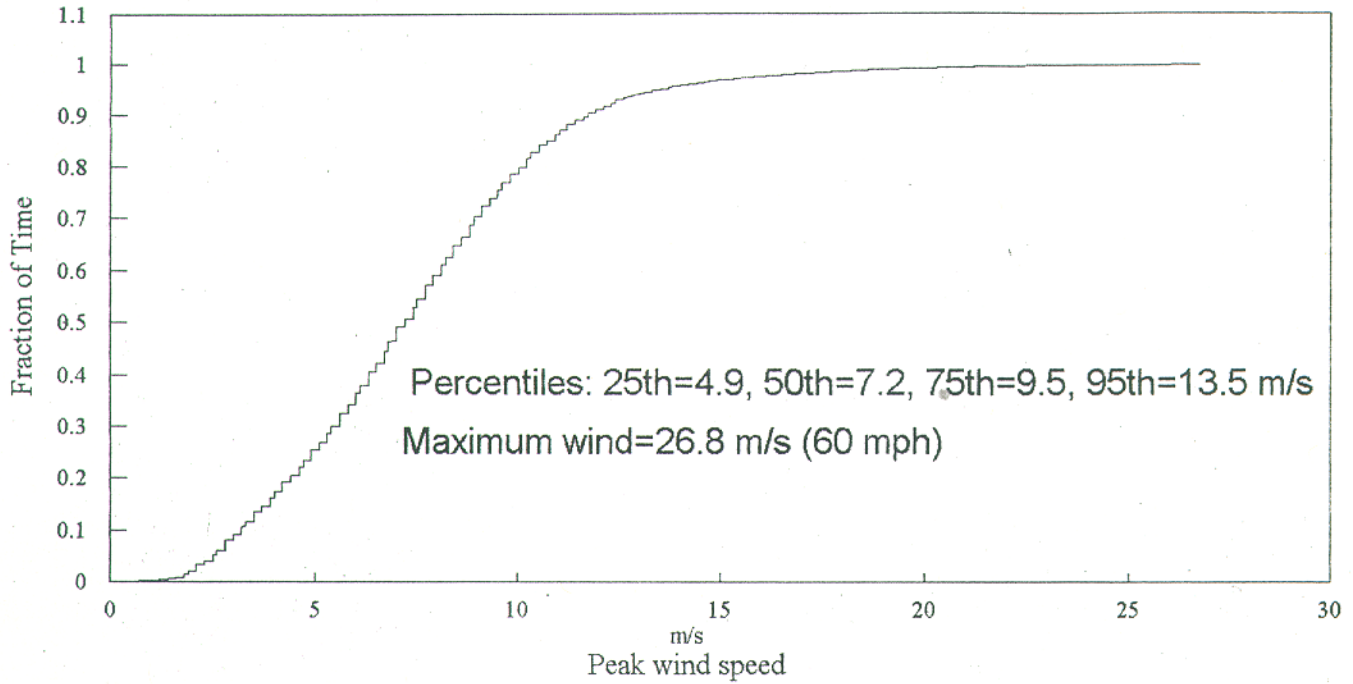
Figure 13. Cumulative probability distribution for hourly peak wind speed.

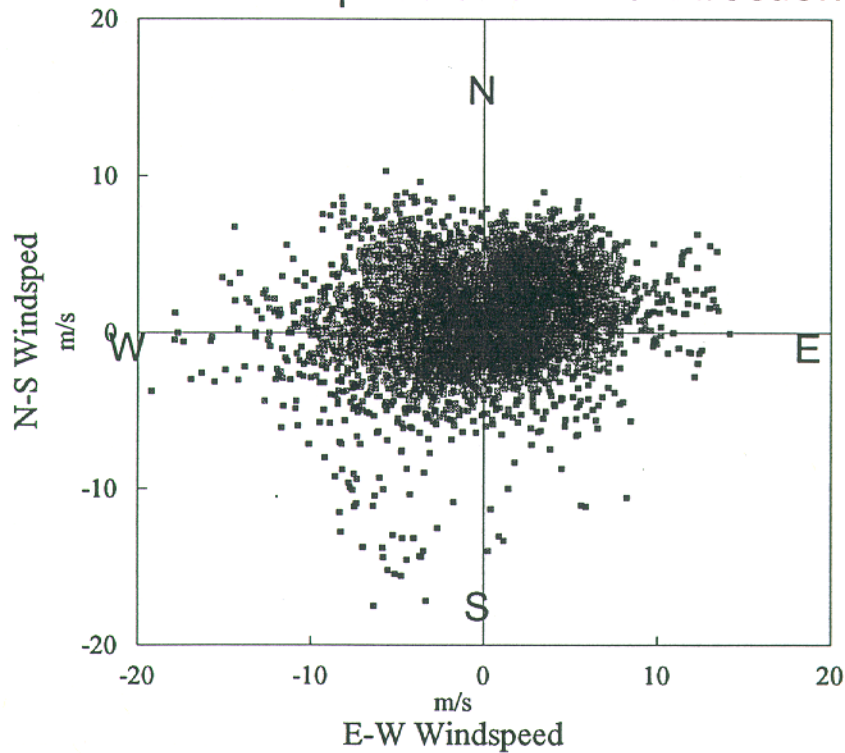
Figure 14. Hourly median wind speed measurements resolved into E-W and N-S components.

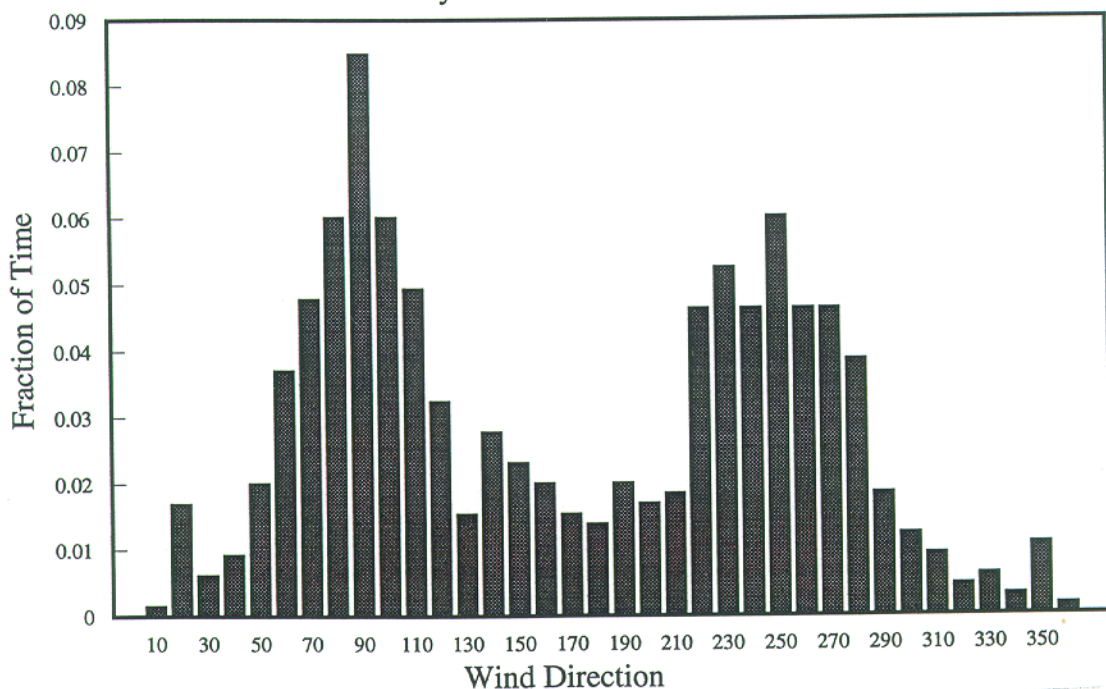
Figure 16. Wind direction probability distribution, whole year, daytime hours, 12-14 hrs HST.

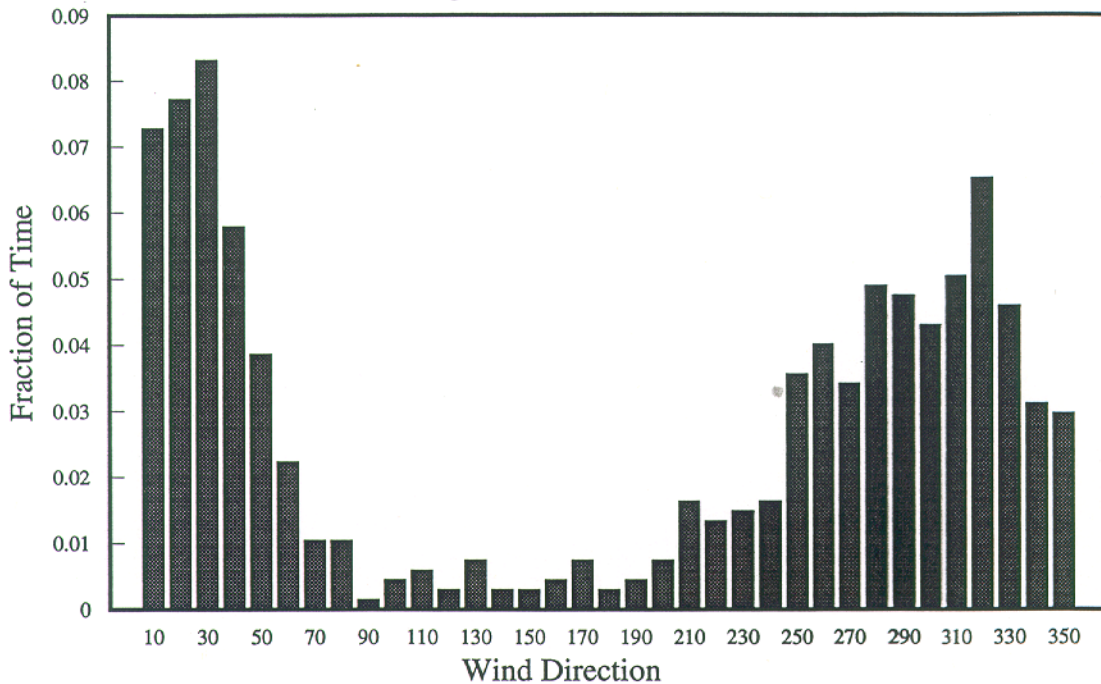
Figure 17. Wind direction probability distribution, whole year, nighttime hours, 00-02 hrs HST.

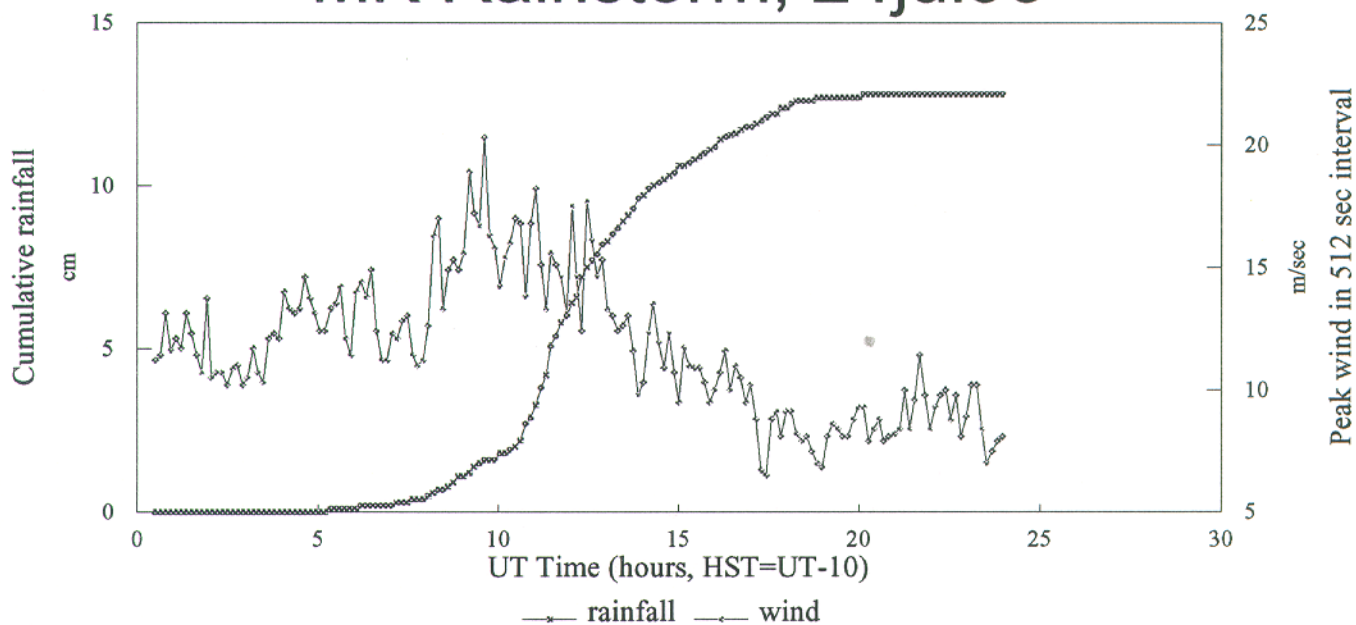
Figure 19. Cumulative rainfall and wind during the heavy rainstorm of 24 July, 1994.

extremely heavy driving rain as demonstrated by the 24 July 93 storm which is detailed in Figure 19. During this storm 12.5 cm of rain fell in a period of about 8 hours while the wind was blowing at more than 15 m/s. The peak rain rate during this storm, determined as the steepest slope on the cumulative rainfall plot in Figure 19, is 6.3 cm/hr. This storm washed out the MKO access road at an elevation of 3350 m and trapped the VLBA technicians on the mountain (see Appendix A). This high rainfall rate combined with the high wind speed will require careful design of MMA weatherproofing enclosures. Precipitation statistics are summarized in Table 4. Note that the total annual precipitation for the year is somewhat more than the 51 cm predicted for the site from long term annual rainfall contours for the island (pg 63, Armstrong 1983). Also, the storms were more spasmodic and more intense than usual (Schnell, 1994).

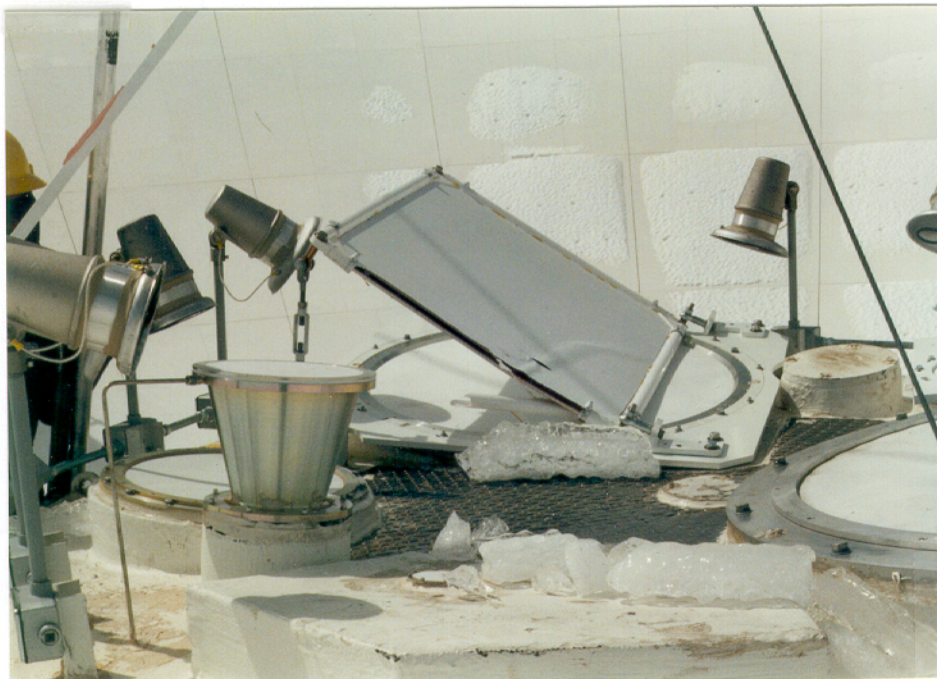
Figure 20. Ice damage to the dichroic plate during the winter storm of 14mar93.

To aid in quantifying the bad weather conditions likely to be experienced by the MMA on this site the VLBA site technicians maintain a Severe Weather Log which is reproduced as Appendix A. From this log it can be seen that during the year 5 winter storms occurred, with some of the precipitation in the form of snow and/or ice, on 15 Mar 93, 19 Dec 93, 24 Jan 94, 9-10 Feb 94 and 14-16 Feb 94. Some statistics concerning snow and ice, determined from the log, are given in Table 5. These numbers can only be considered as rough guidelines because of the small number of events. During the storm of 14 Mar 93 5 cm of ice formed on the upwind surfaces of the antenna and other structures. Some of this ice fell from the antenna quadruped guy rods and damaged the dichroic plate at the antenna secondary focus (Figure 20).

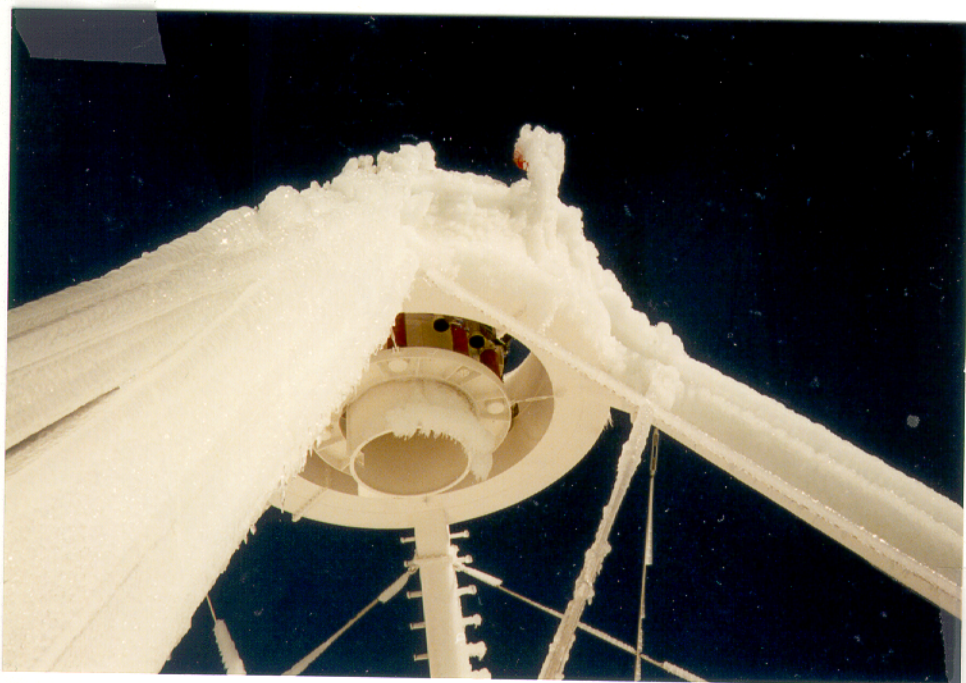
Figure 23. Ice buildup on antenna quadruped, 6 Jan 93.

Although it is not within the one year data base reported here, the ice storm of 6 Jan 93 will be included because of its severity. During this storm ice up to 12 cm thick formed on all upwind surfaces (Figures 21-24) and ice falling from the quadroped damaged 17 antenna reflector panels, necessitating their replacement. The mechanism of ice formation during these ice storms is identical to the mechanism which causes ice formation on aircraft wings (Schnell, 1994). Supercooled liquid water is carried by the wind onto the structure where it instantly turns to ice on impact. Little information on wind during these ice storms is available because the anemometer usually freezes solid. It is clear that the wind comes out of the SW and W. During the winter storm of 14-16 Feb 94 the wind averaged 14 m/s for sustained periods and had peaks over 20 m/s. A good strategy for the MMA antennas would be to design them to take their survival wind pointing at the horizon. During winter storms they could then be oriented with their backs to the SW so that the ice is kept off of the main reflector surface and the subreflector.

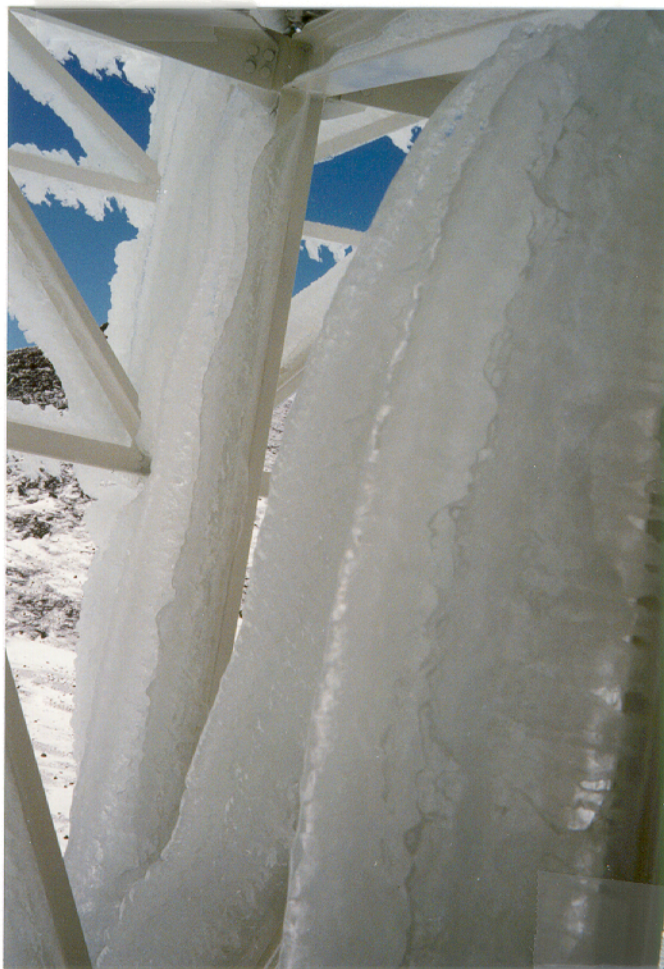
Figure 24. 12 cm of ice buildup in the reflector backup structure, 6 Jan 93.
