# Demonstration of the mechanism driving the GBT track movement

David H. Parker

July 26, 2001

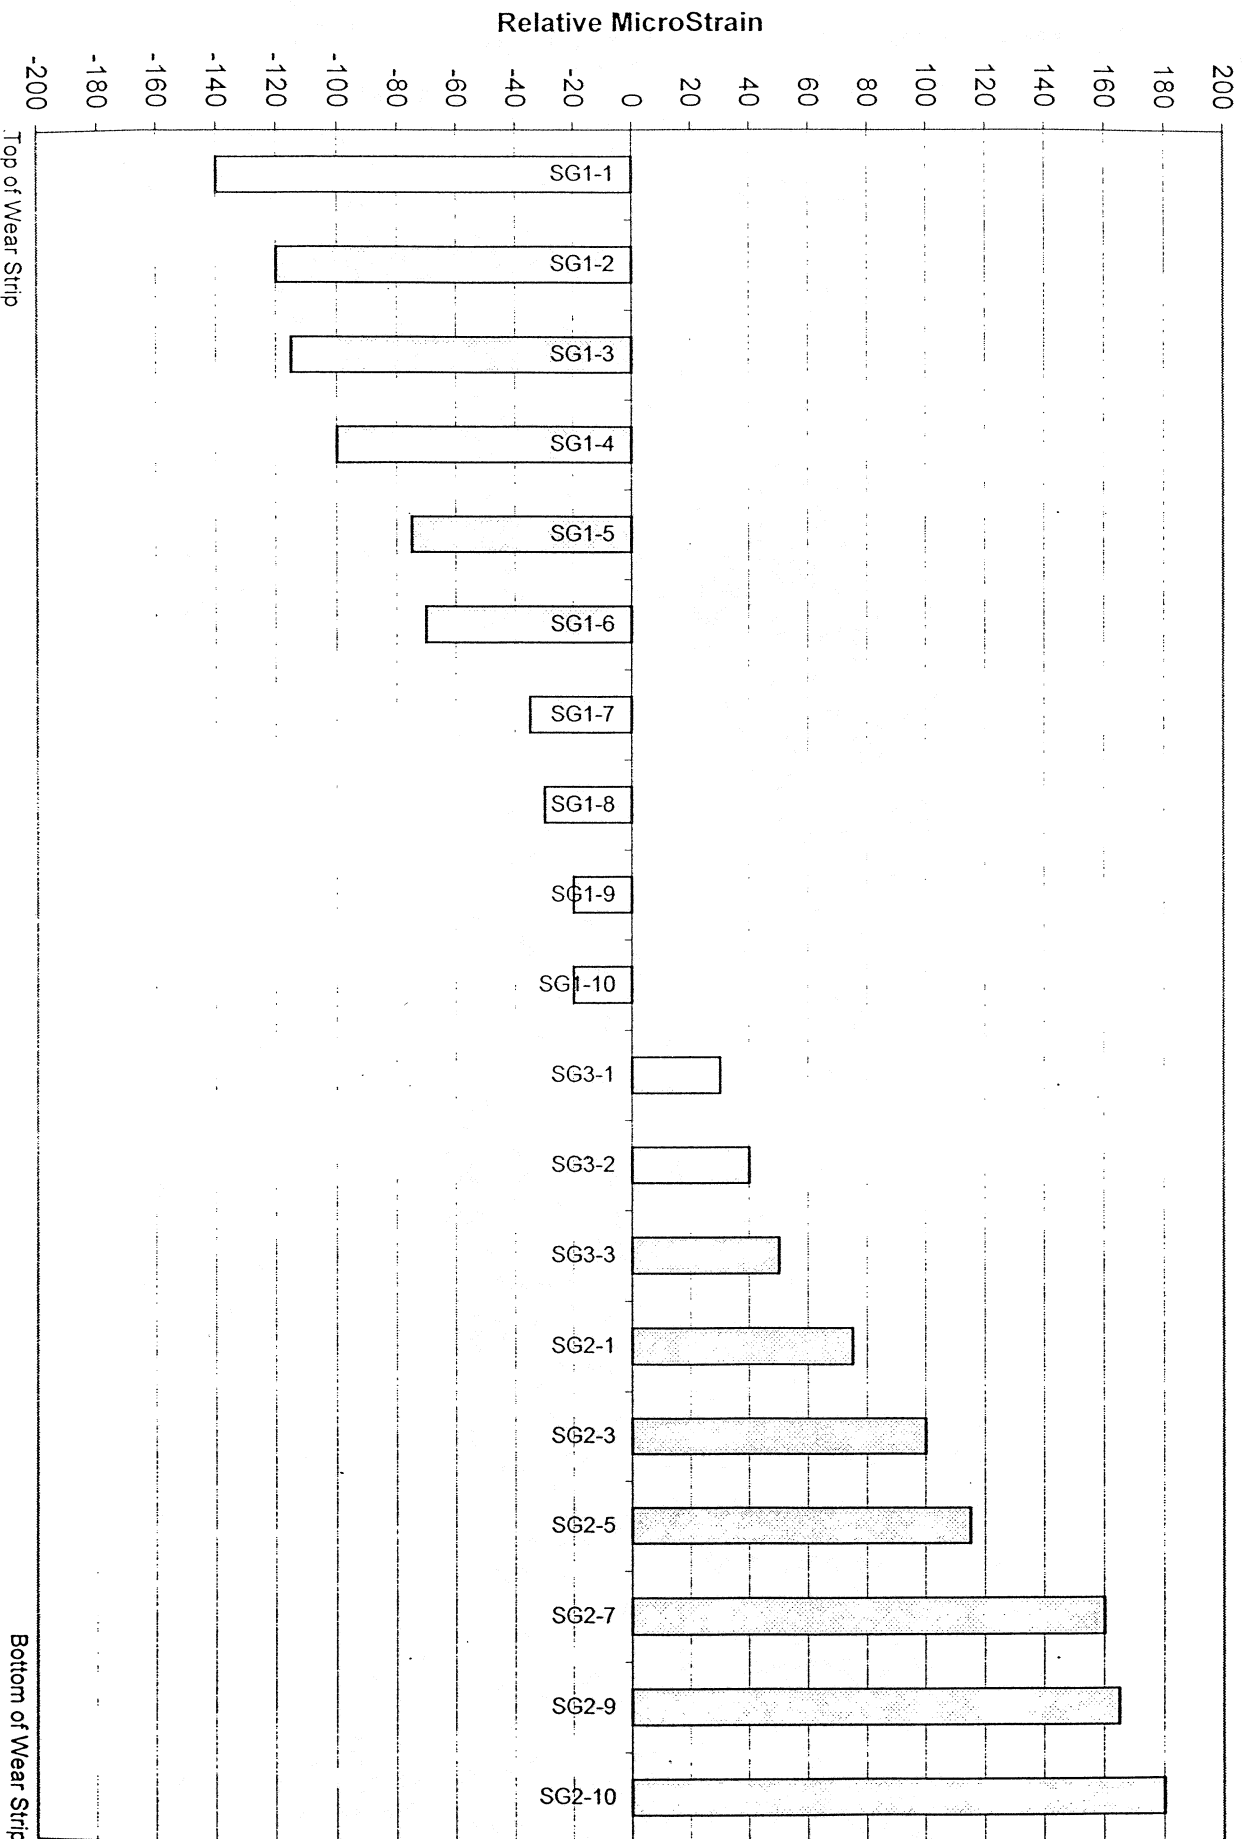
# Wheel On MicroStrain - Wheel Off MicroStrain vs Strain Gauge Number

Much to our surprise, we discovered that, under the wheel the strain was in compression at the top of the wear strip, and in *tension* at the bottom of the wear strip. The attached plot, taken from report A0234, looks like the strain pattern for a bending beam. Everyone was expecting the wear strip and base plate to act together as a laminated beam—which should have produced strain in compression down to about the middle of the assembly, i.e., about 5-6 inches. Subsequent measurements on the base plate confirmed that it too was in compression at the top.

So, given that the strain on the bottom of the wear strip was 180 degrees out of phase with the top of the base plate, a mechanism for relative movement at the interface was clear. This is demonstrated by a simple experiment.

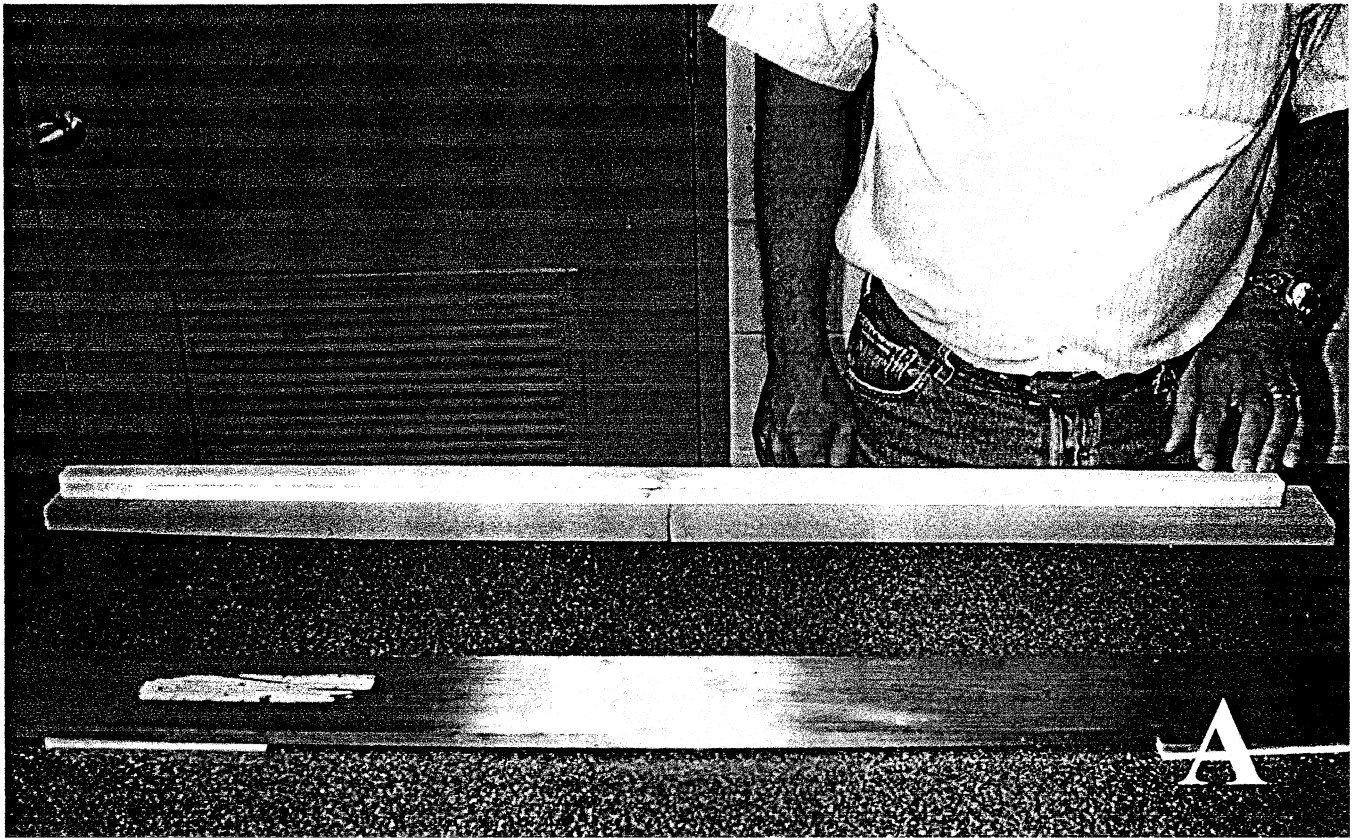
Figure A shows two strips of wood. The upper strip is about 1/4 inch thick and the lower strip is about 7/16 inch thick. Figure B shows a clamp holding the right end of the assembly. Note that the assembly is free to slide, except at the clamp, and thus the beams are delaminated and act independently. Figure C illustrates the assembly bending under a load. Under this bending condition, Figure D clearly shows that, at the interface, the bottom of the upper beam is longer than the top of the lower beam.

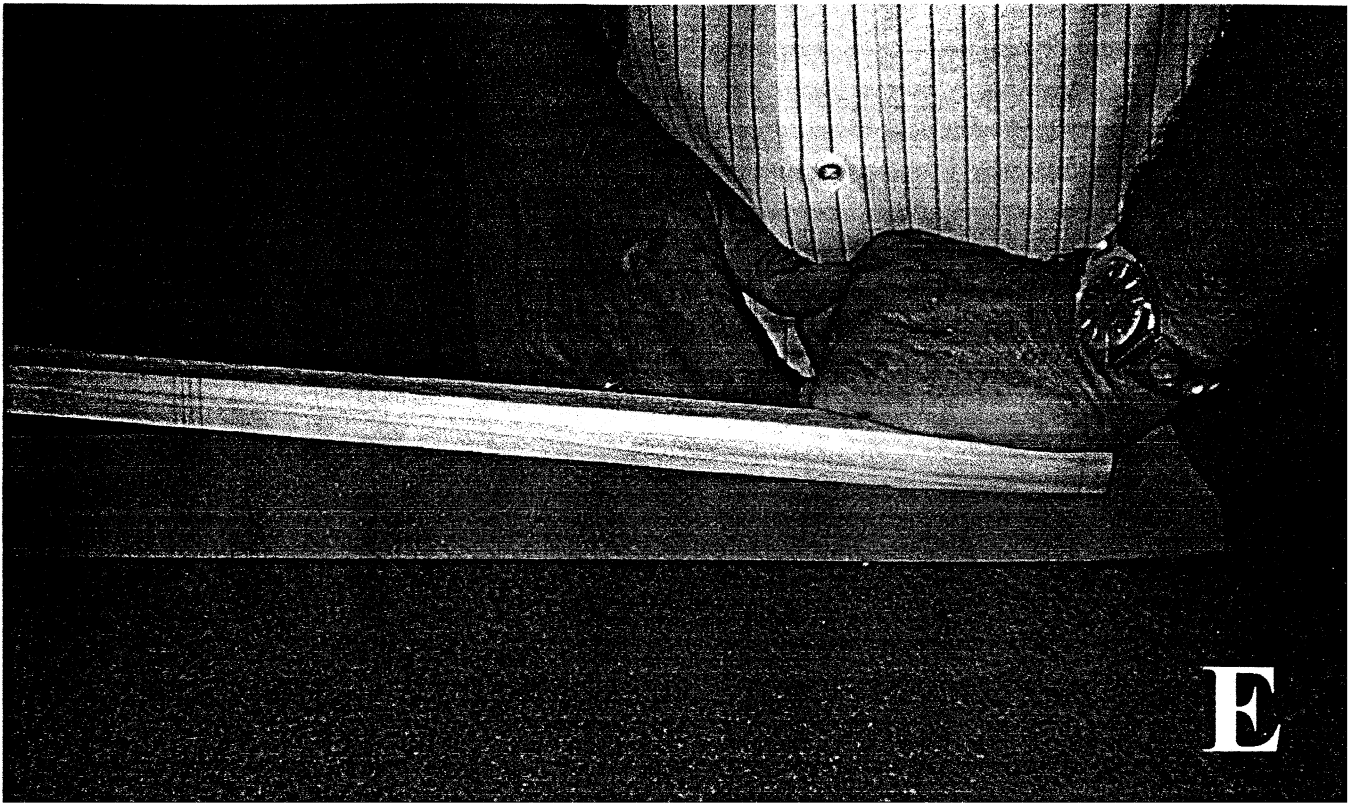
Figure E shows the two strips resting on two keyboard wrist pads. By applying pressure, starting at the right side and stepping across as shown in figures F-I, a load migrates across the beam. A wheel can be thought of as the same process where the incremental steps become smaller. Figure J shows the characteristic motion in the direction of travel.
