NATIONAL RADIO ASTRONOMY OBSERVATORY
Socorro, New Mexico

VLBA Antenna Memo 96
VLBA Owens Valley Gearbox Repair

December 9th-12th 2014.

Prepared by
Michael Romero
12/17/14

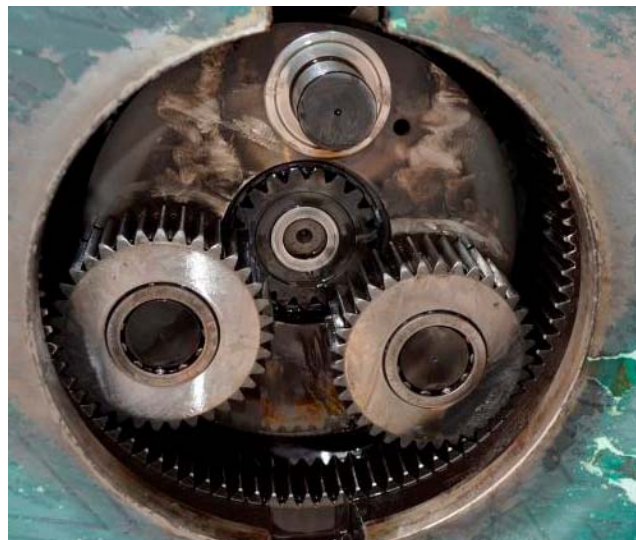
Figure 2.2: Second Stage

The first stage was removed and the second stage inspected. The second stage gears were removed and inspected. No abnormal wear or problems were found when inspecting the second stage. With the second stage removed, the remaining stages were inspected visually for signs of wear or failure. There were no problems found during inspection. Figure 2.2 details the second stage with the sun gear and upper planetary gear removed.

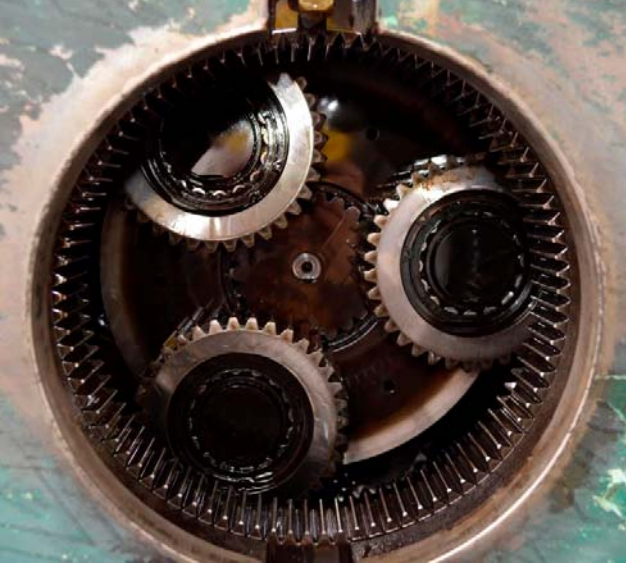
Figure 2.3: Inside Gearbox w/o Second Stage.

The inner stages were cleaned and searched for metal or other foreign material. A small amount of foreign material was found and removed, but no metal from the thrust washer was found. Figure 2.3 details the gearbox with the second stage removed.

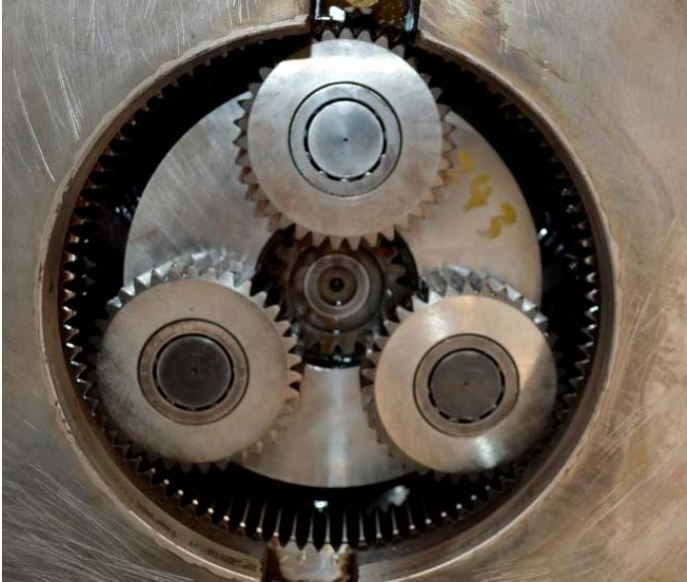
Figure 3.1: Second Stage Re-Installed

The second stage was cleaned and re-installed in the gearbox using a new thrust bearing. Figure 3.1 details the second stage re-installed in the gearbox.

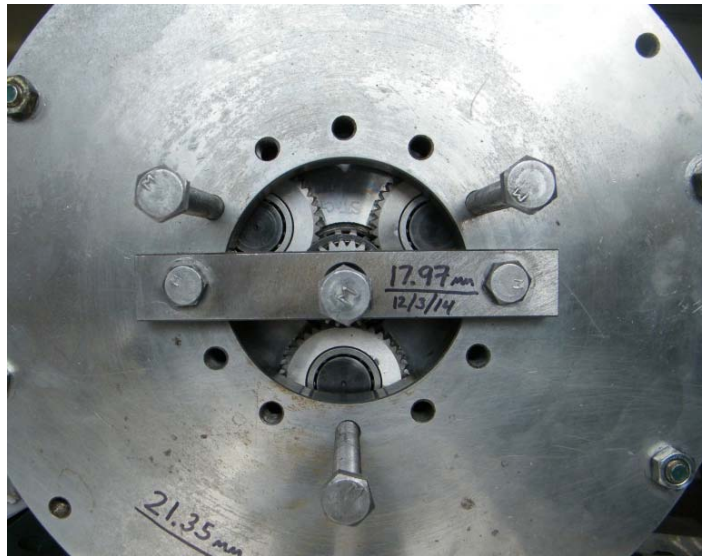
Figure 3.3: Installed Measurement tool

Due to excessive scoring in the thrust ring groove, the spare first stage housing, with input shaft and bearings, would be used. Once the new first stage gears were installed, the measurement tool was installed following procedures outlined in the VLBA Compower Gearbox Axial Clearance Adjustment Procedure Measurements Calculation Sheet (see Appendix A). Figure 3.3 details the measurement tool on the first stage.

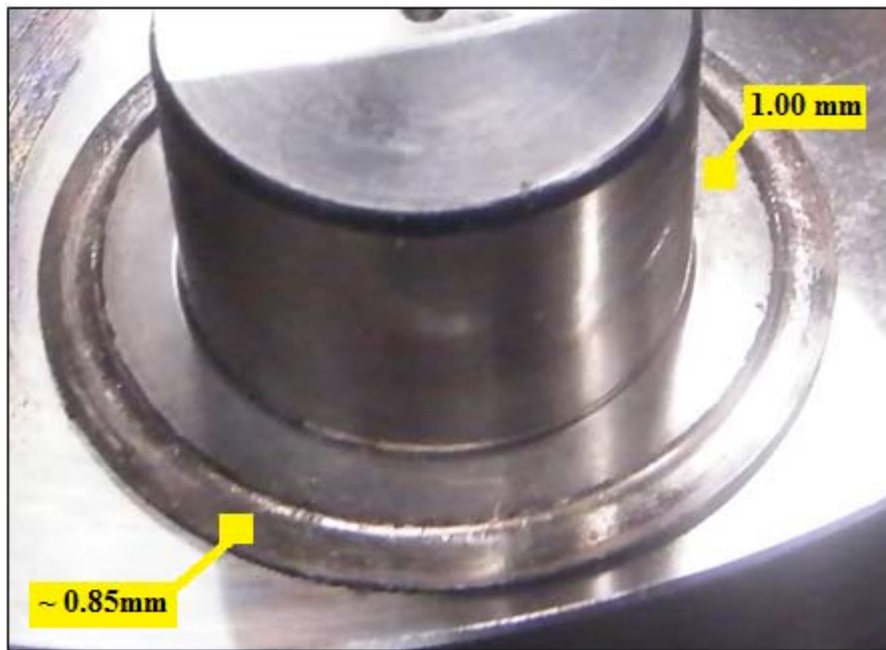
Figure 5.1: Flattened Thrust Washer Example

The first stage failure point showed that excessive pressure was applied to the first stage planetary gears. This is seen in the broken or flattened thrust washers. The two remaining thrust washers were flattened to approximately 0.85 mm or 0.15 mm smaller than the original 1.00 mm. Figure 5.1 and 5.2 detail the flattened thrust washers. Note that non-flattened portion was positioned under bearing.

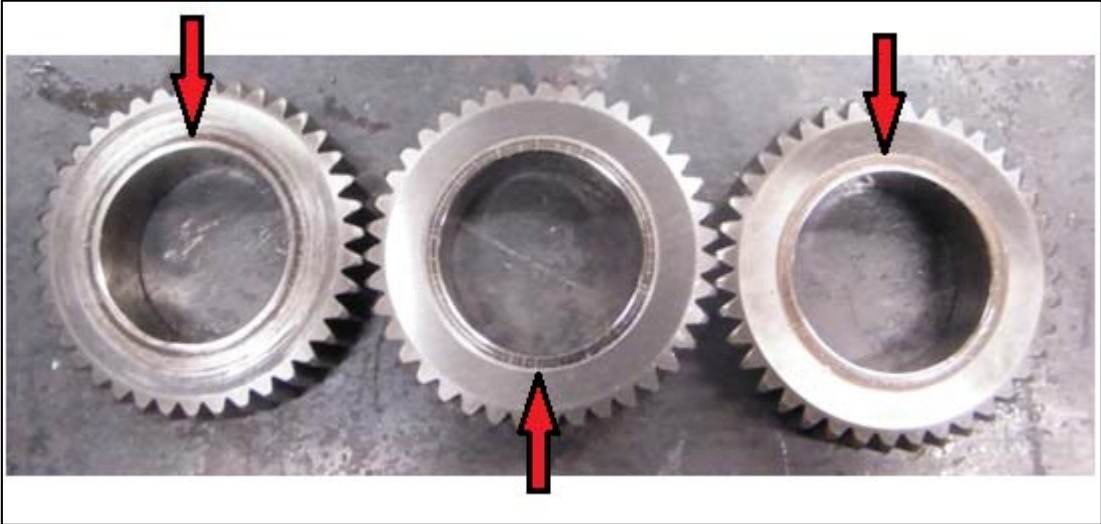
Figure 5.3: First Stage Gears w/ Wear Marks

The wear marks can further be seen on the back side of the first stage planetary gears. All of the gears showed a groove where they were eating into the thrust bearings. Figure 5.3 details the gears and inside wear marks detailed by red arrows.

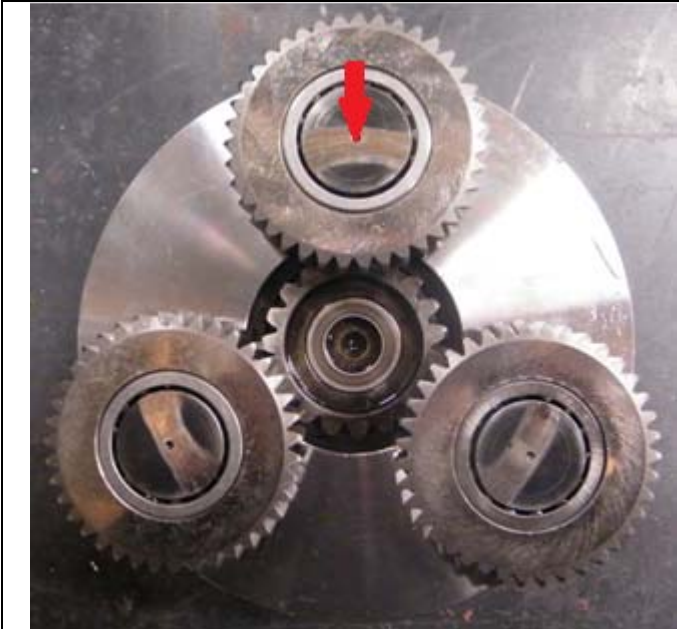
Figure 5.4: First Stage Thrust Ring Wear Marks

In addition to the thrust washer failure, the planetary gear spindles also showed signs of excessive wear. The three spindles detail the outline of the thrust ring. Figure 5.4 and 5.5 detail the wear marks on the first stage spindles by the thrust ring.

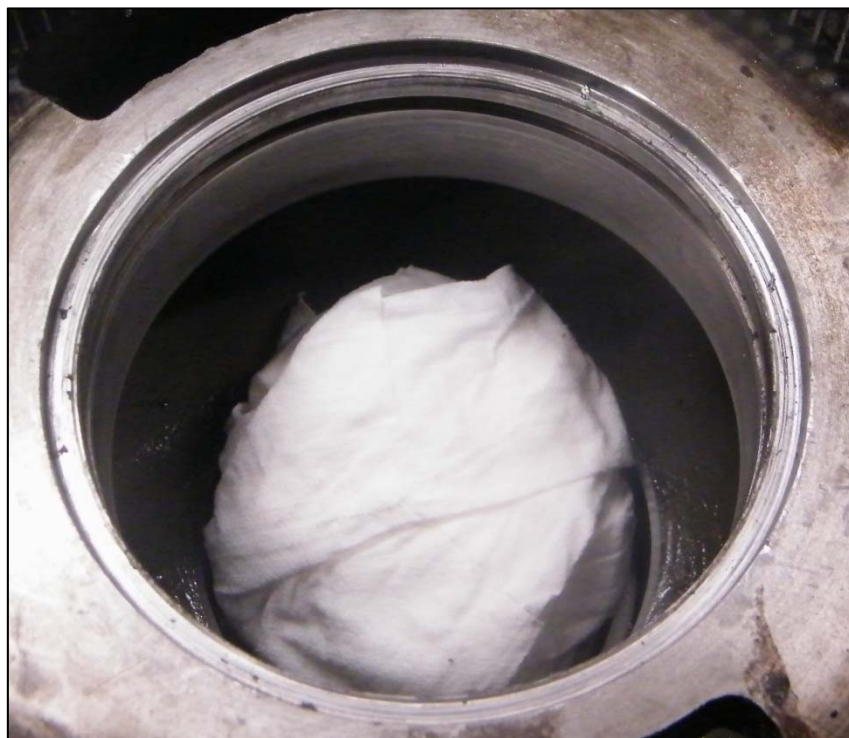
Figure 5.6: Scored and Scratched Thrust Ring Groove.

The thrust ring rides along the three first stage gears and sits in a groove on the front stage cover. Inspection of the front cover and thrust ring showed that the thrust ring appeared to be spinning within the case itself. The spinning caused both the ring and the case to be pitted and scored. The scarring on the front cover was deep enough that the spare cover was used for the repair. Figure 5.6 and 5.7 detail the wear on the back side of thrust ring and front cover.

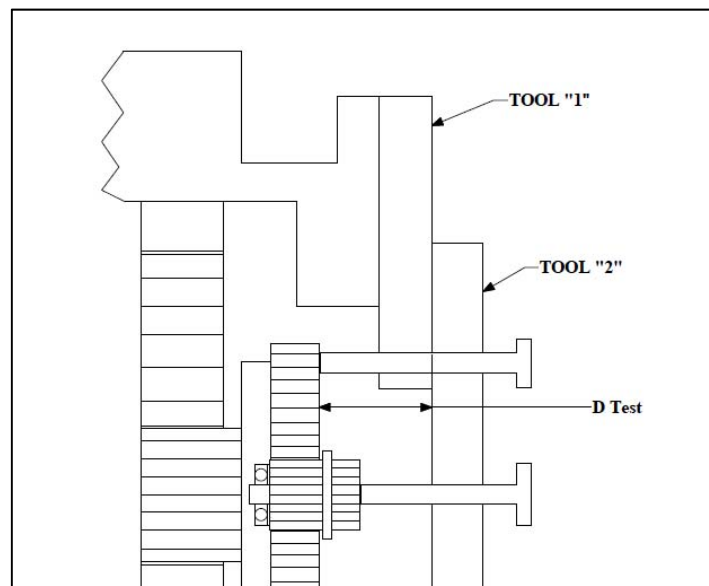
Figure 3.2: "D TEST" Measurement

"D TEST" = TOOL "1" flange to face of planetary gear.

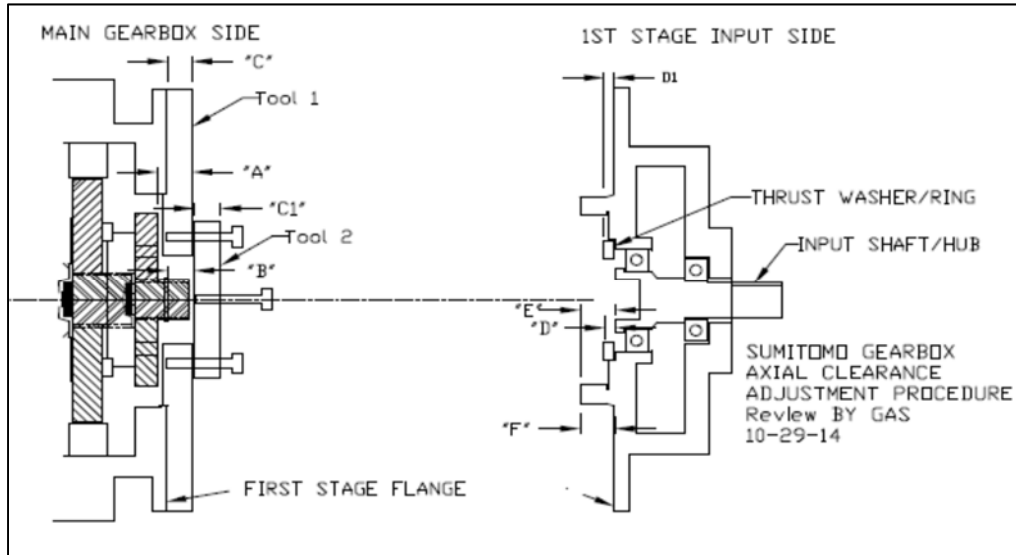
Figure C.1: Original Schematic

Figure C.1 details the original schematic used for measurement. Use figures located in document to reference dimensions below.

Original Schematic Dimensions	Document Schematic Dimensions
A	D
B	E-T2
C	T1
C1	T2
D	A
E	A+B
F	C
D1	D1'
G1	G
X	H
