**VLBA ACQUISITION MEMO #288**  
**MASSACHUSETTS INSTITUTE OF TECHNOLOGY**  
**HAYSTACK OBSERVATORY**  
*WESTFORD, MASSACHUSETTS 01886*

Subject: Progress Report on the Solution to the Tape Edge Heating Problem

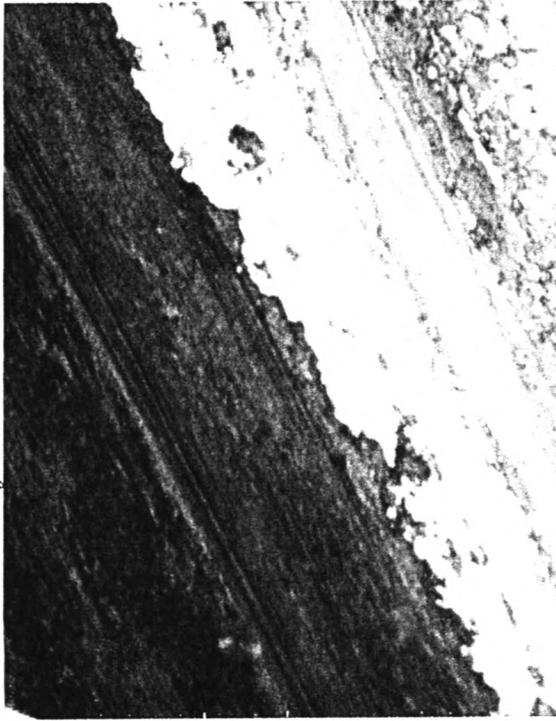
B. Tungsten without heat cond. paste.

High friction build-up.

Figure 2. Examples of potentially destructive deposits on alumina(A) and tungsten(B).  
 Wear marks on alumina(C) after several months of intermittent use.  
 "Incoherent" deposits on diamond(D).  
 Deposits and wear on diamond-like coating(E) (approx. 2 microns thick).  
 Wear scar(F) and deposits on silicon carbide(G).  
 Deep wear scars on copper(H).

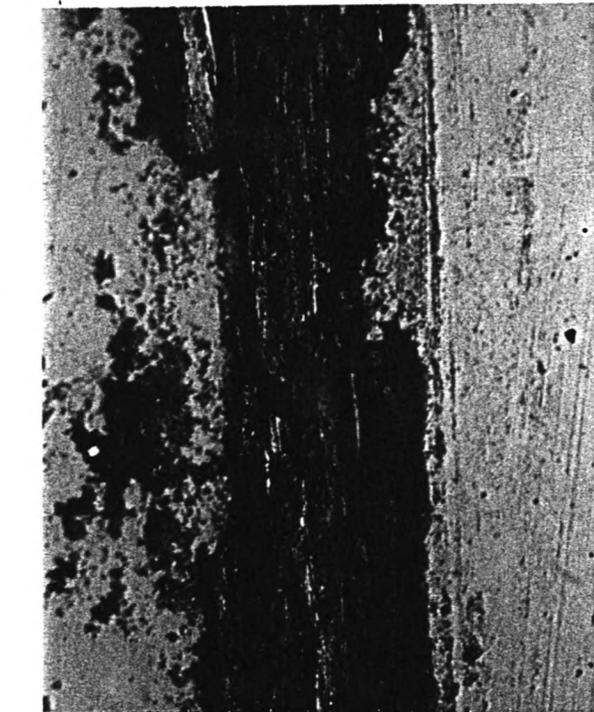
A. X160 Deposit on alumina. X160
