VLBA ACQUISITION MEMO #368  
MKIV MEMO #163

MASSACHUSETTS INSTITUTE OF TECHNOLOGY  
HAYSTACK OBSERVATORY  
WESTFORD, MASSACHUSETTS 01886

Subject: Wear Rates, Head Flying and Performance of the Current  
Head Design at Various Operating Tensions

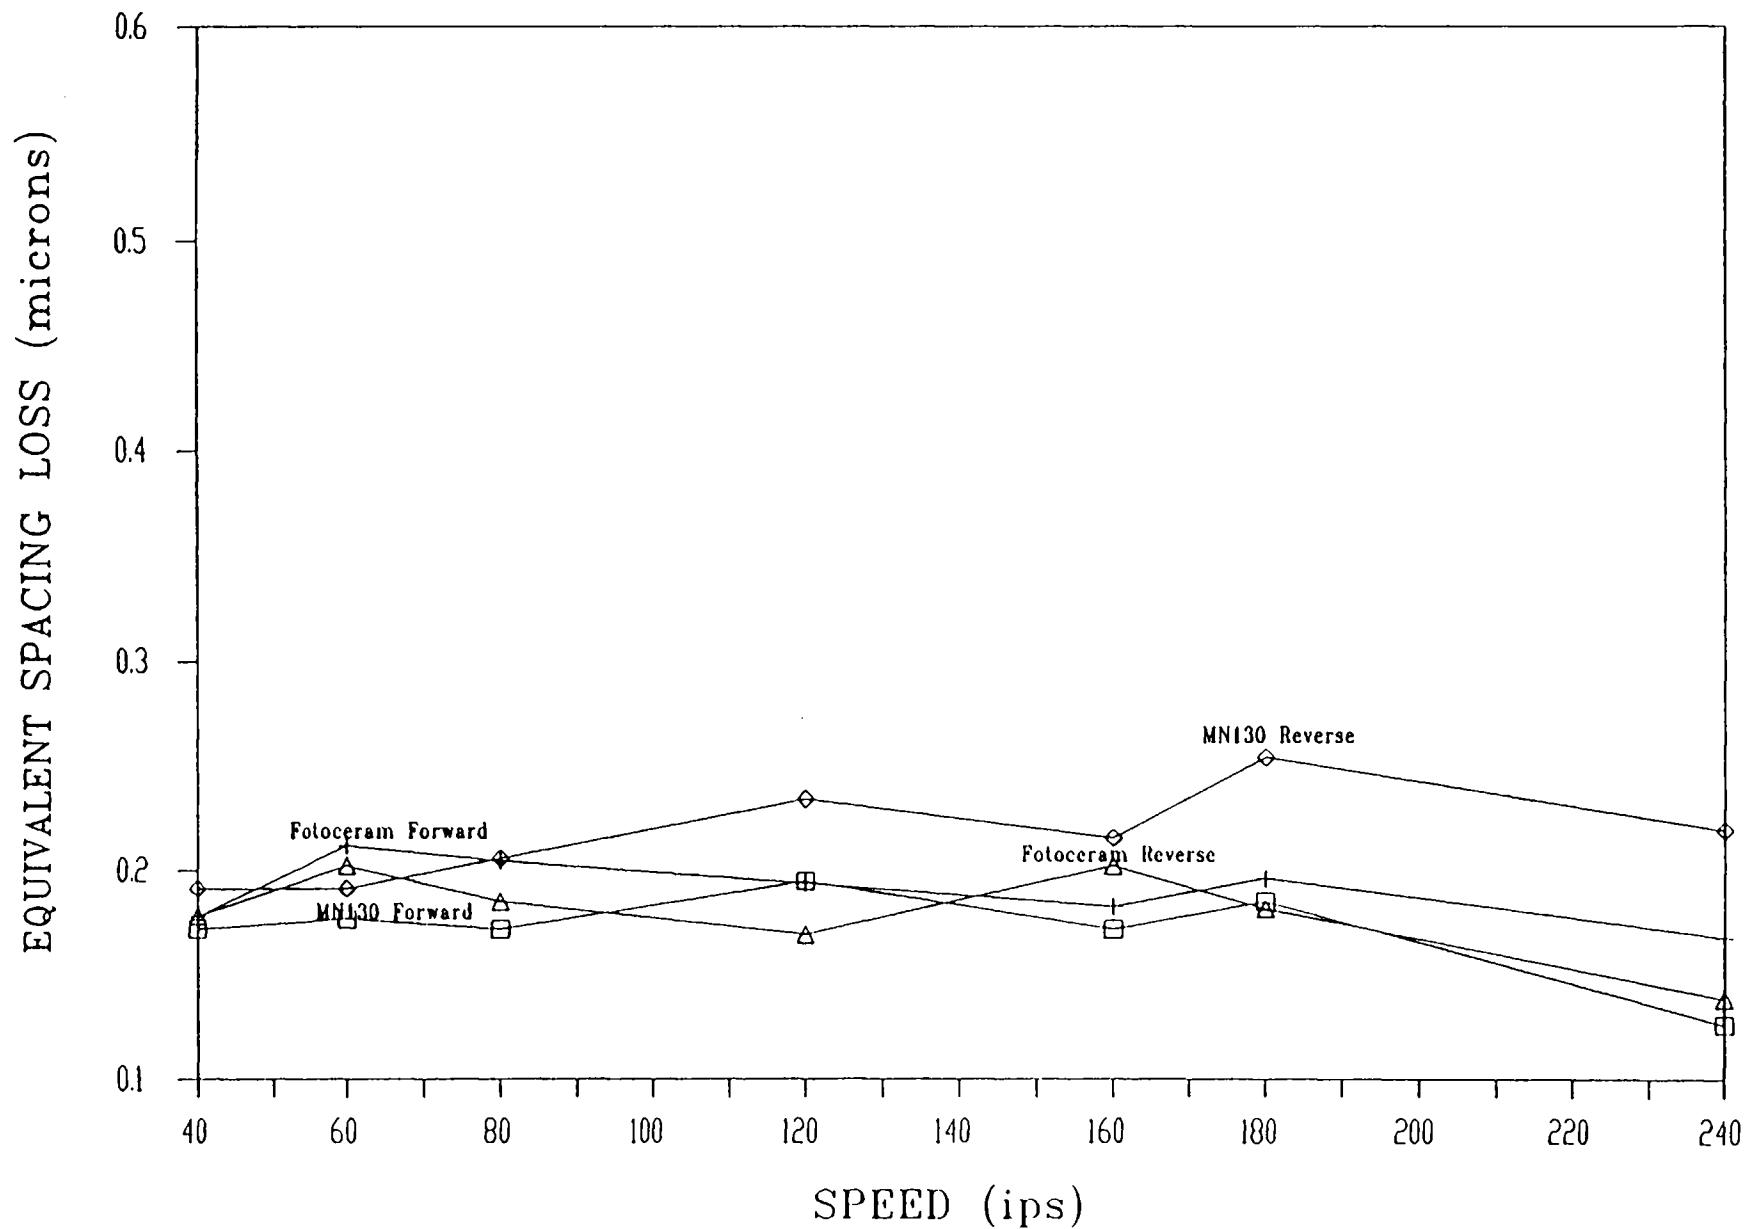
Figure 2: Flying Height at 6.0" Vacuum

The vacuum was then increased to 6" and spacing loss vs. speed is graphed in Figure 2. The reverse direction of the MN130 headstack has improved its spacing loss since its maximum spacing loss is 0.25  $\mu\text{m}$  at 180 ips. The fotoceram headstack in both directions and the MN130 headstack in the forward direction have reduced spacing loss as well compared to the 4.75" vacuum.

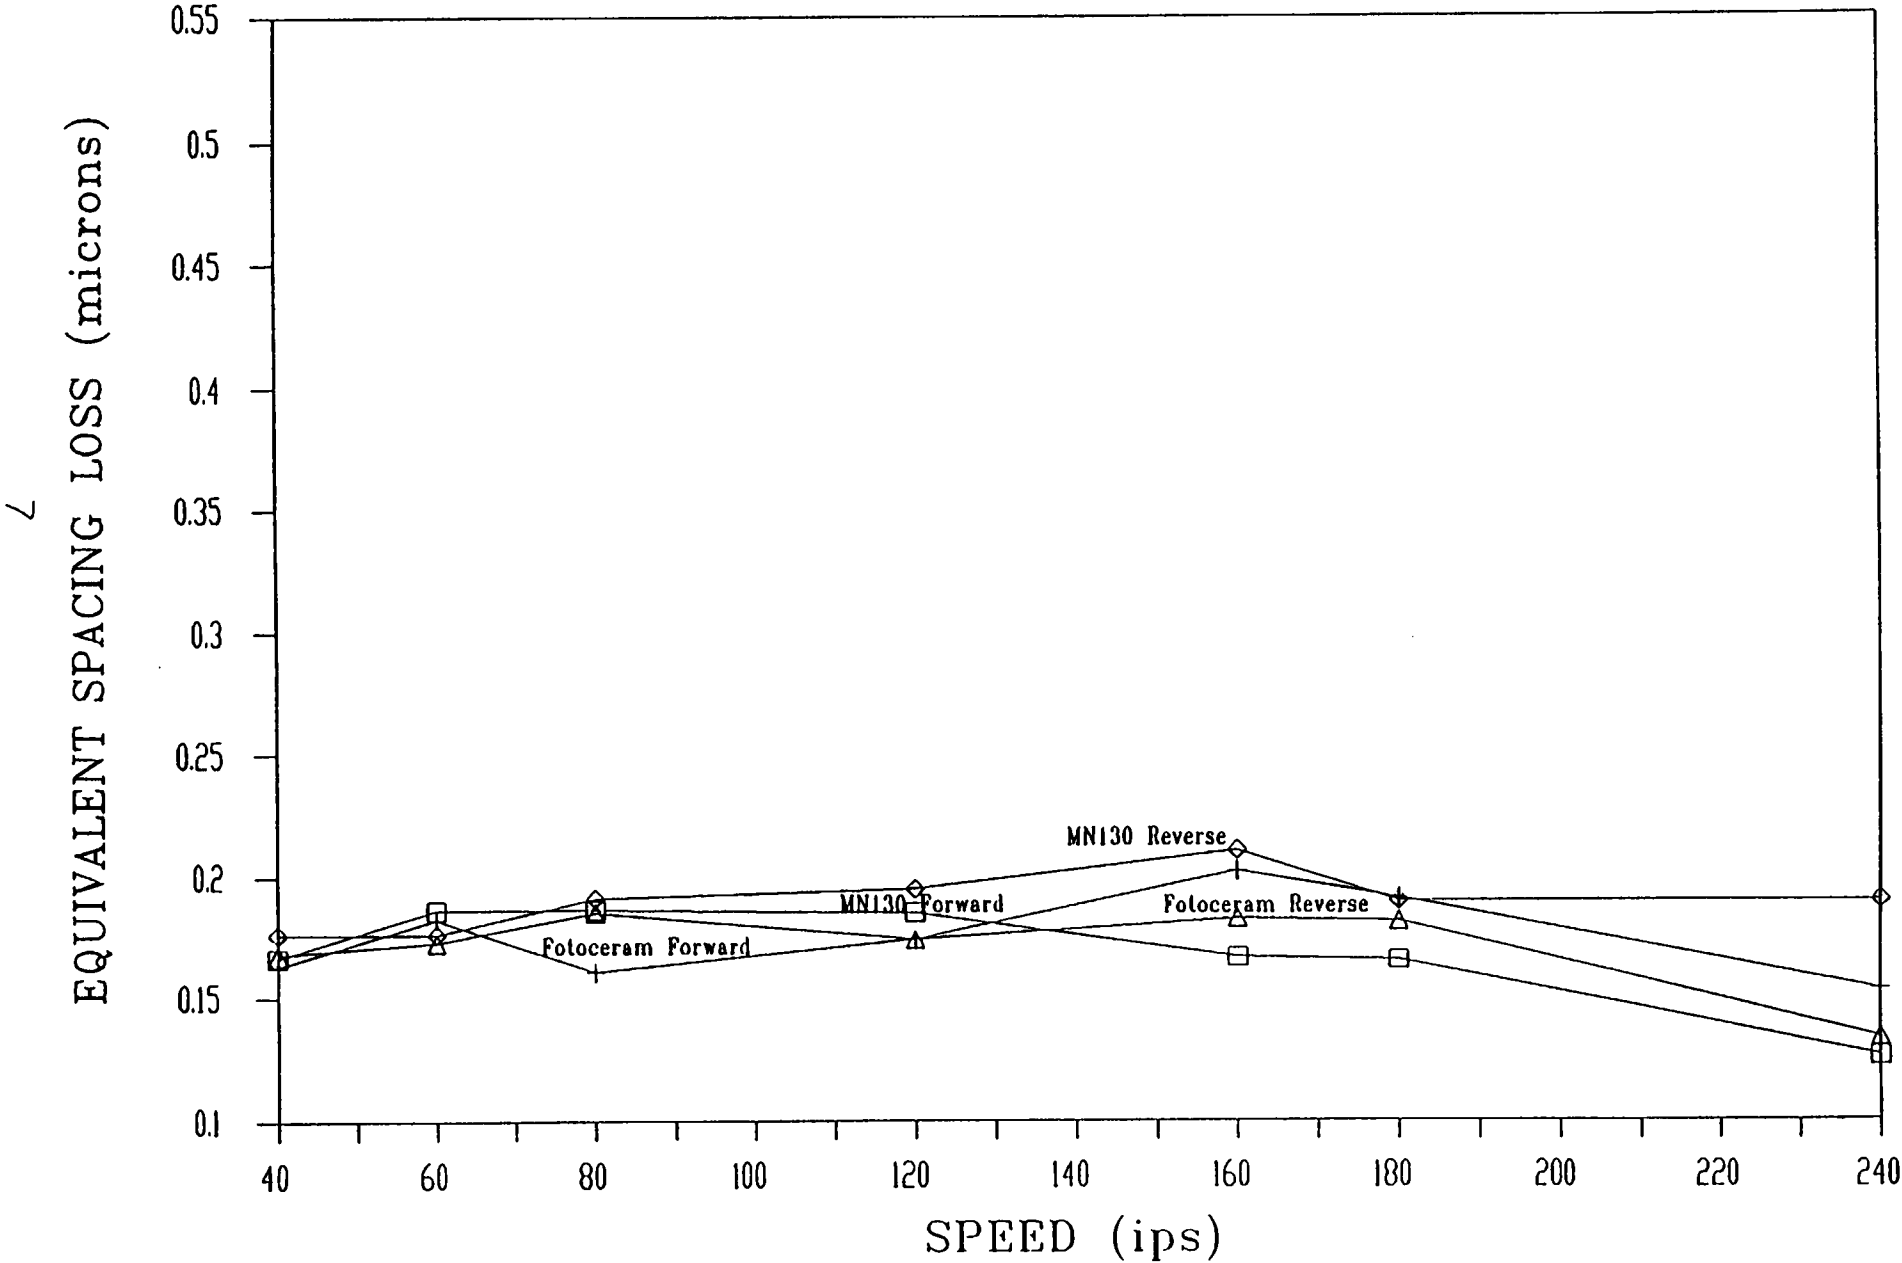
Figure 3: Flying Height at 10" Vacuum

Figure 3 shows the spacing loss at 10" vacuum for various tape speeds. At this tension the performance is uniform, within the measurement and calibration errors, and there is no evidence of flying. The spacing loss at this tension is even less than at 6". Also at this vacuum the performance is maintained without degradation as the heads wear.

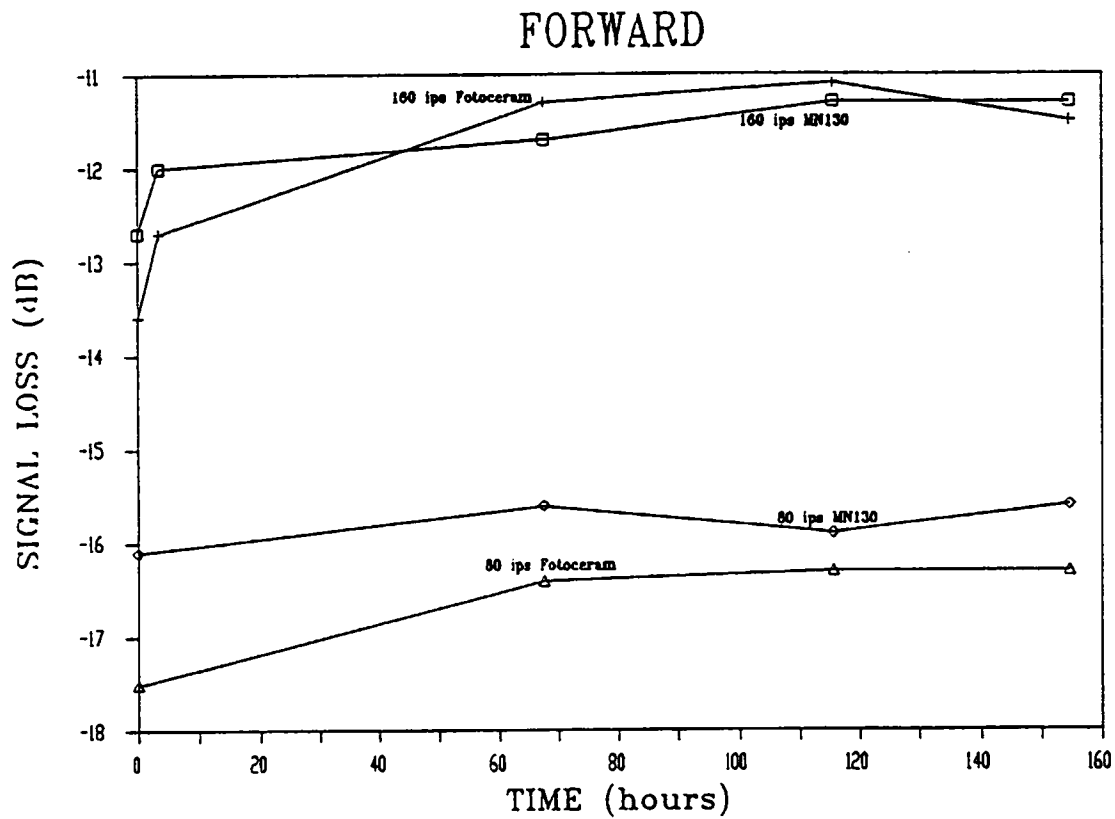
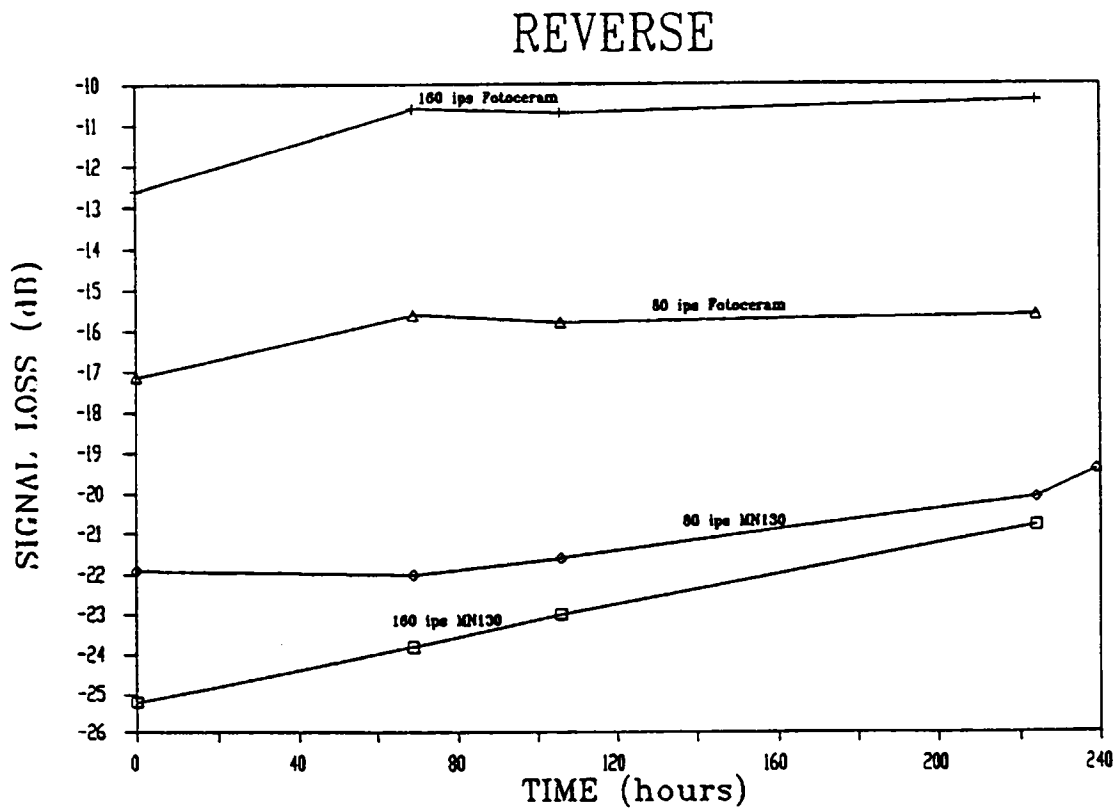
Figure 5: Recovery Rate at 7.5" Vacuum  
From a 10" Contour

Figure 5 shows the time vs. the signal(dB) for 80 and 160 ips in the forward and reverse direction. The signals recovered at a

higher rate in the reverse direction. The tape was shuttled for about 7 days to reestablish the 7.5" contour but even after this time the signals still has not fully recovered. If we assume the contour would have fully recovered in about 500 hours, which is approximately consistent with figure 5, the calculated wear rate for the removal of 0.17  $\mu\text{m}$  is approximately 0.0003  $\mu\text{m}$  per hour or a headlife (assuming a 38  $\mu\text{m}$  depth of gap) of  $10^5$  hours.
