**ALMA Memo # 418**

**GEOTECHNICAL STUDY  
CHAJNANTOR SITE, II REGION  
2002 CAMPAIGN**

**ATACAMA LARGE MILLIMETER ARRAY  
SITE CHARACTERIZATION AND DEVELOPMENT  
CERRO CHASCON SCIENCE PRESERVE**

**(Geo Ambiental Consultores Ltda.)**

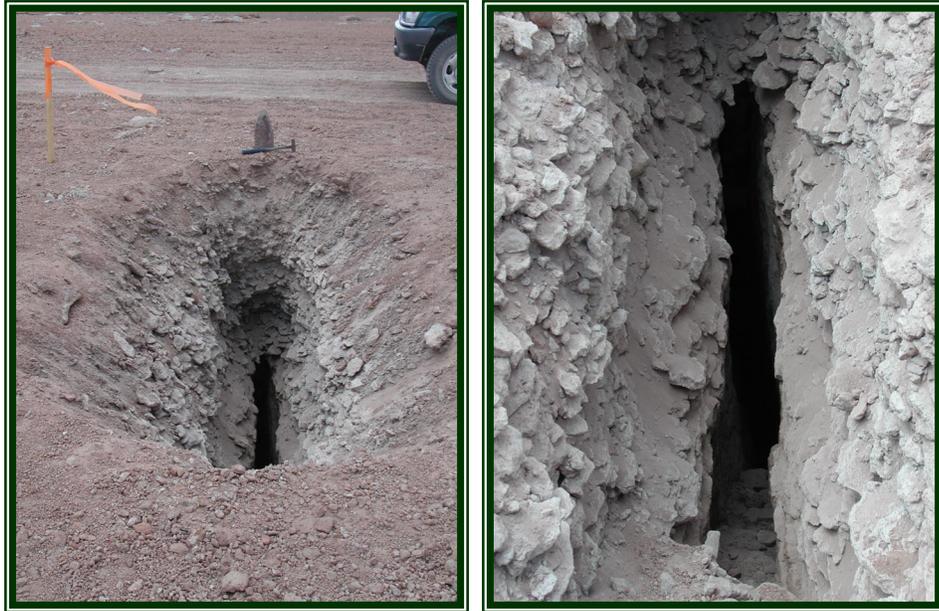
**Figure 3.** Open Fracture N 30° W At N 7,453,350; E 627,007

An open fracture was observed with a width of approximately 20 cm and magnetic bearing of N 30° W which developed with light truck traffic (Figure 3). In the vicinity and at about 800 m to the North-West, another cavity was observed with a circular shape and magnetic bearing N 20° W (Figure 4). Within the same zone, but approximately 400 m to the South, another crack is forming (it can be detected due to a depression on the surface as seen in Figure 5).

It is estimated that the origin of these discontinuities is thermal contraction after deposition and cooling of the welded tuff. It could also be due to a fracturing as a response to tectonic effects. In any case, these fractures do not seem to present movement at this time and their discovery is due to the collapse of the surface cover on vehicle traffic.

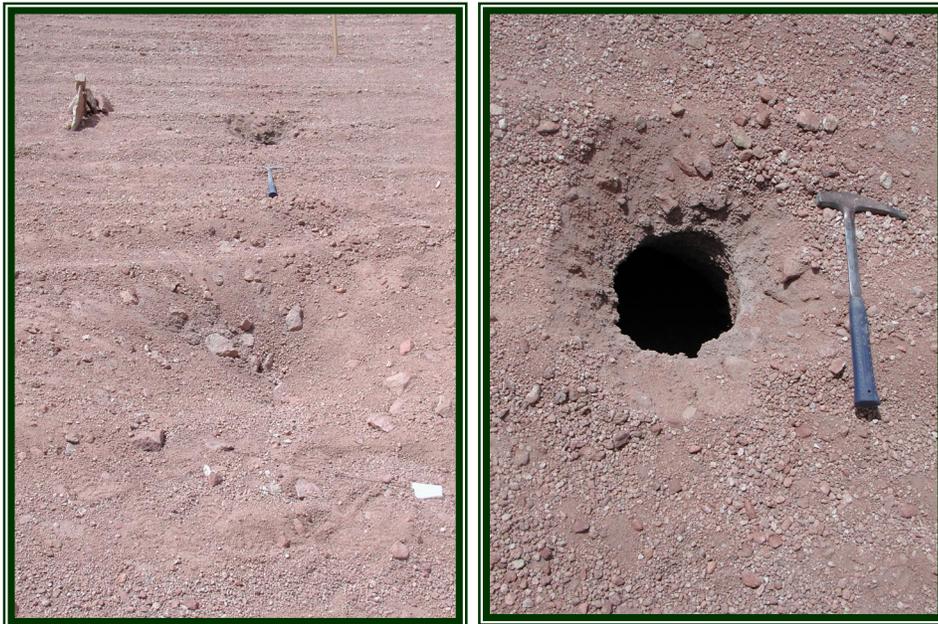
**Figure 4.** Open Fracture N20°W At N 7,453,291; E 627,657

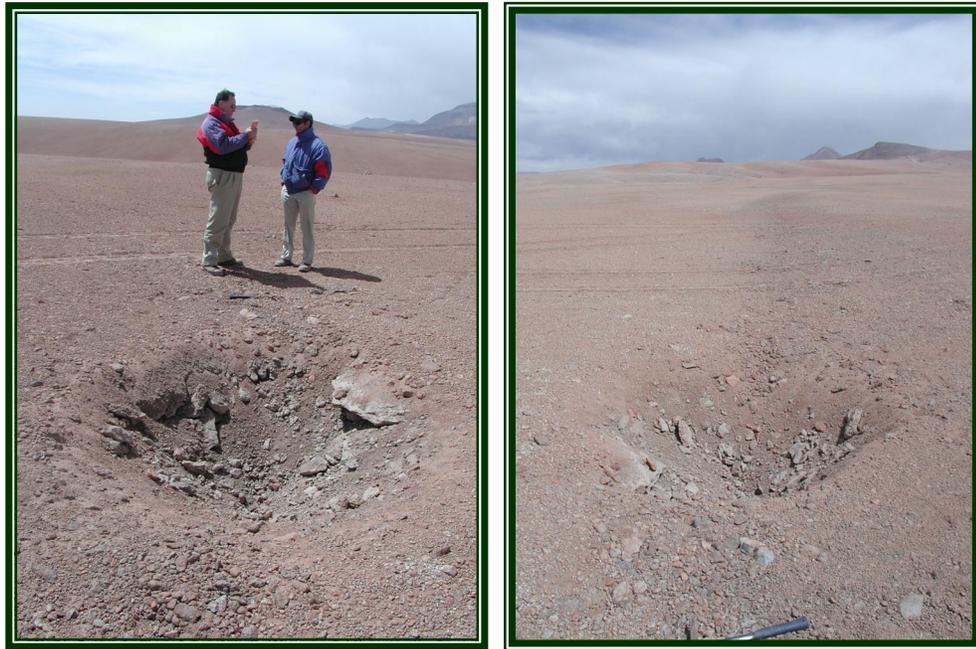
**Figure 5.** Forming Crack At N 7,453,291; E 627,657

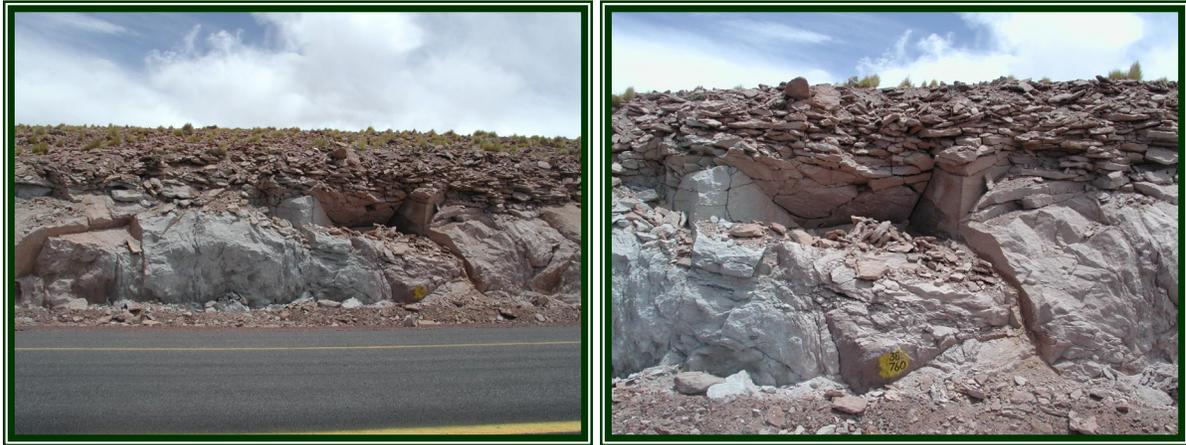
**Figure 6.** Slope Cut on the Road (km 38,6)

According to observations on the road (km 38.6) and by the cores of some borings (P20, P24, C180 and C183, among others), the ignimbrite shows a meteorized cover of about one meter, formed by small fragments over massive rock (Figure 6 and 7) with little or no fractures. As an example, boring P20 recognized 7,5 m of unfractured rock under a cover of 1,0 m of highly fractured rock.

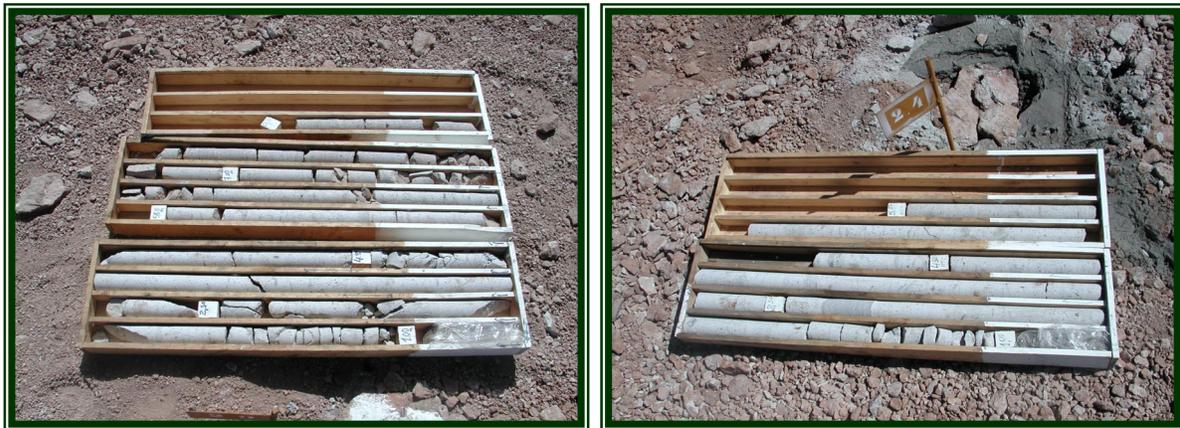
**Figure 7.** Example Rock Cores, Borings P20 and P24

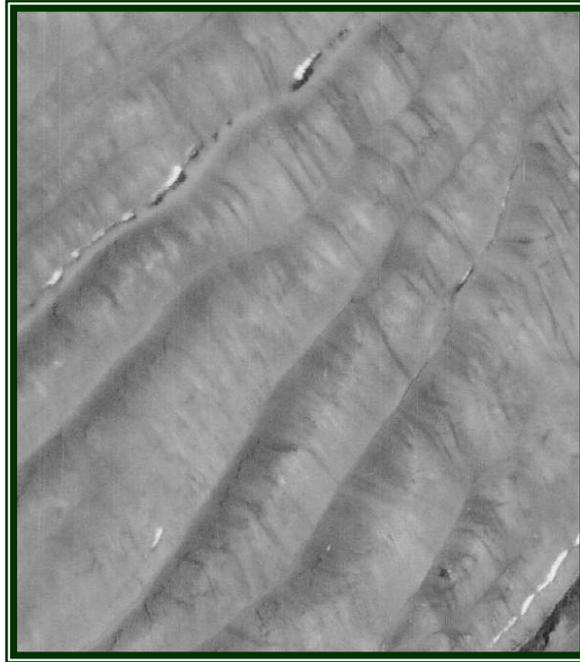
**Figure 9.** Feature A: Parallel “Bands”

Observing the aerial photographs, two distinctive features are observed: a parallel set of “bands” and a rectangular “grid”. They are shown in Figures 8, 9 and 10, and could reflect sets of fractures. These fractures are present in the entire area of study and are reflected in the boring samples and road cuts in the vicinity (see Figure 6 and 7). It is believed that these fractures were formed during the deposition time due to heat release

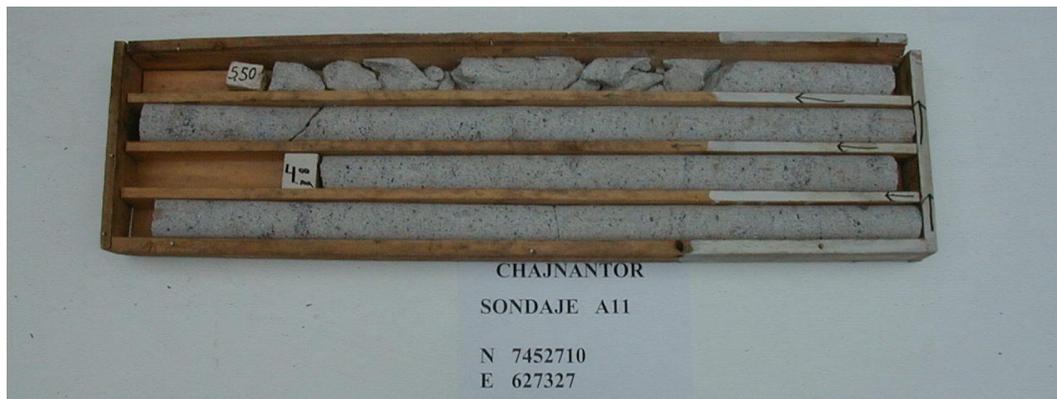
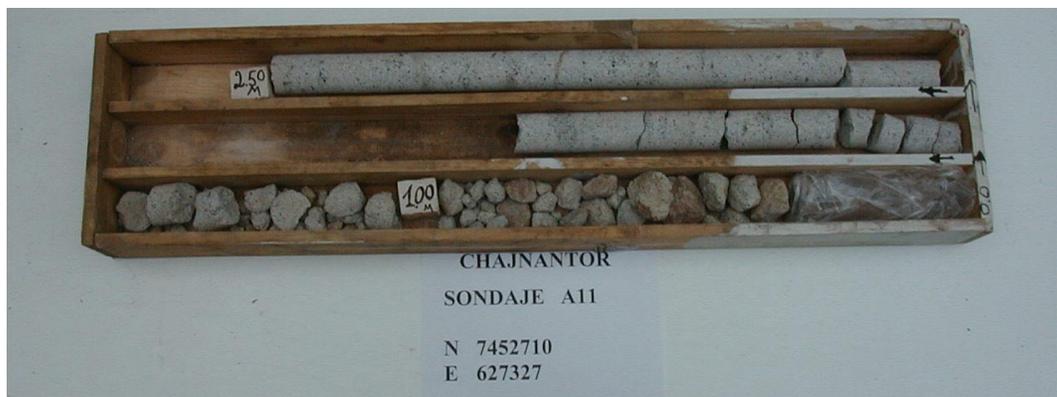
## BORING A11

DEPTH (m)	RECOVERY (%)	RQD (%)
0.0 – 1.0	30	0
1.0 – 2.5	54	34.3
2.5 – 4.0	100	10
4.0 – 5.5	100	86.6

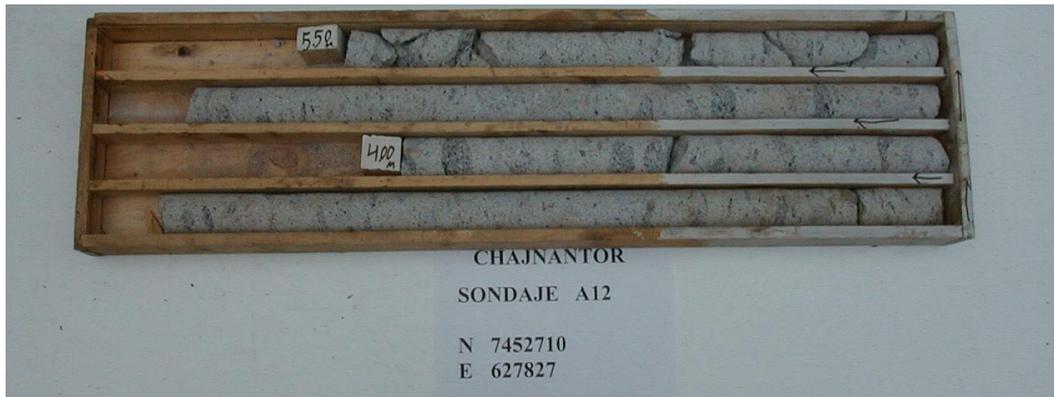
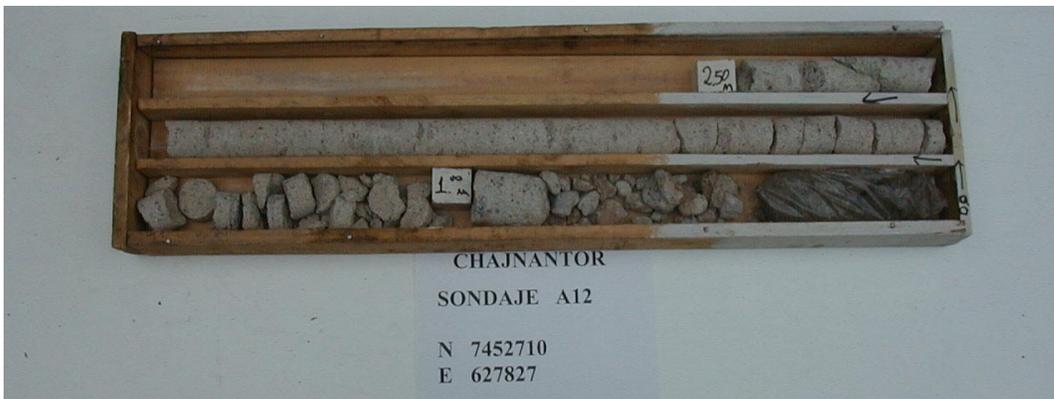
## BORING A12

DEPTH (m)	RECOVERY (%)	RQD (%)
0.0 – 1.0	18.6	0
1.0 – 2.5	100	86.6
2.5 – 4.0	100	100
4.0 – 5.5	100	76.6

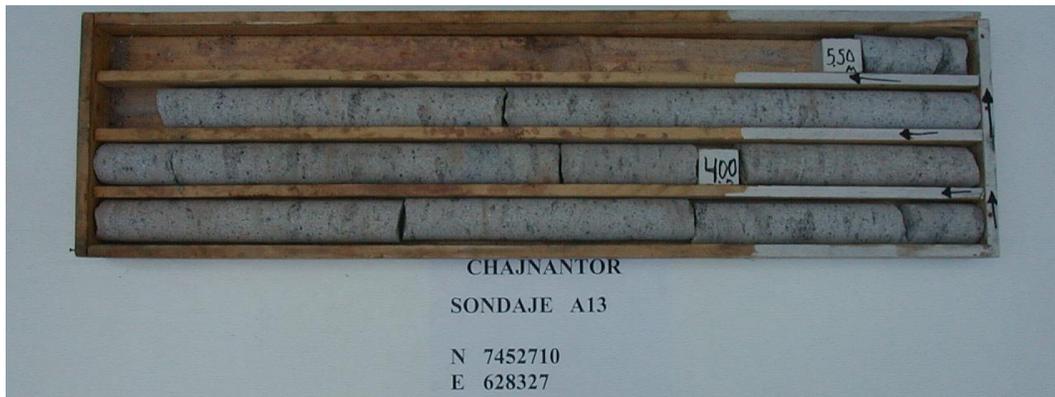
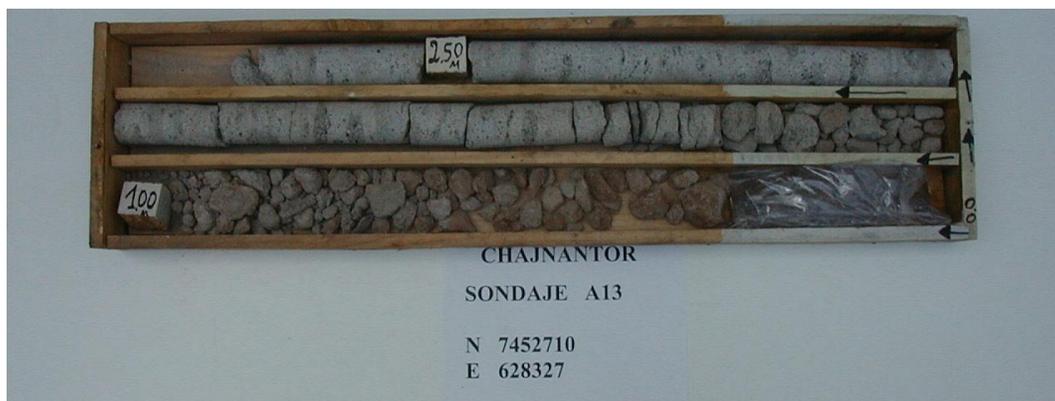
## BORING A13

DEPTH (m)	RECOVERY (%)	RQD (%)
0.0 – 1.0	33.3	0
1.0 – 2.5	97.3	71.6
2.5 – 4.0	93.3	93.3
4.0 – 5.5	100	100

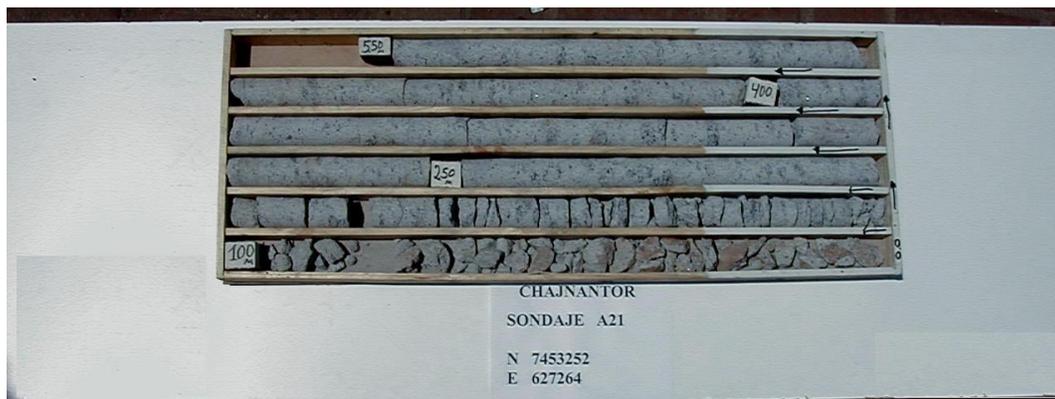
## BORING A21

DEPTH (m)	RECOVERY (%)	RQD (%)
0.0 – 1.0	60	0
1.0 – 2.5	100	89.2
2.5 – 4.0	100	100
4.0 – 5.5	100	100

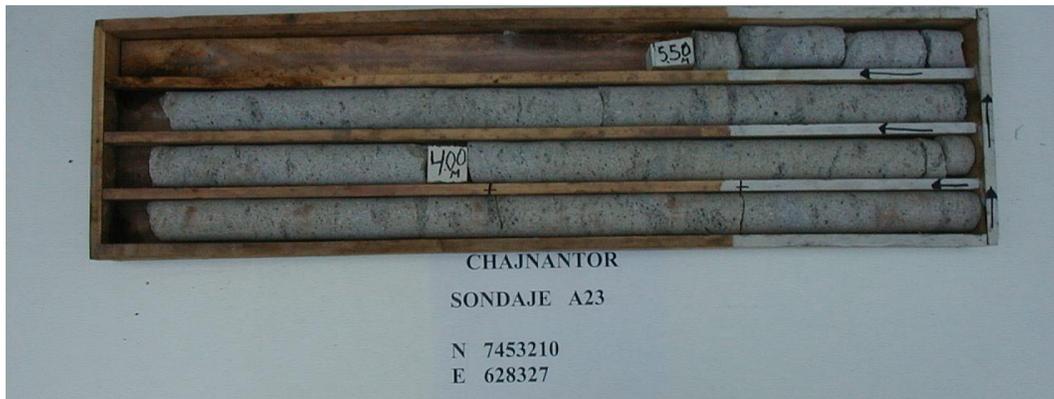
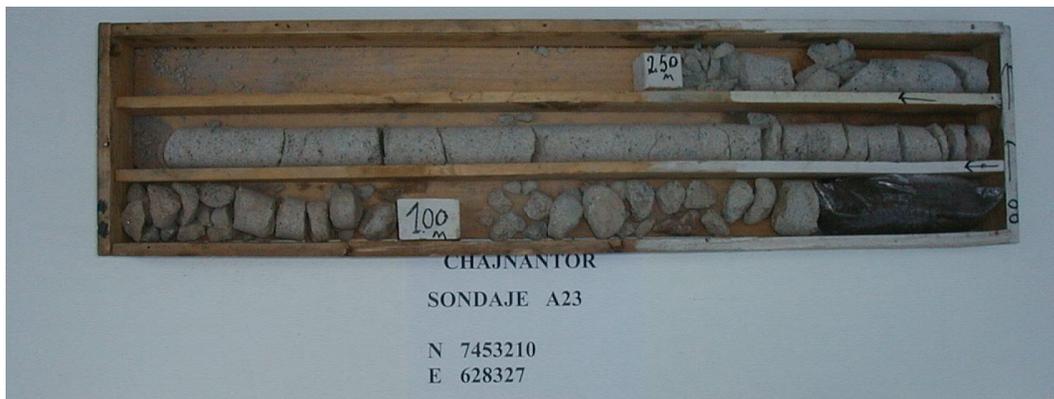
## BORING A23

DEPTH (m)	RECOVERY (%)	RQD (%)
0.0 – 1.0	24.6	0
1.0 – 2.5	100	56
2.5 – 4.0	100	100
4.0 – 5.5	100	95.5

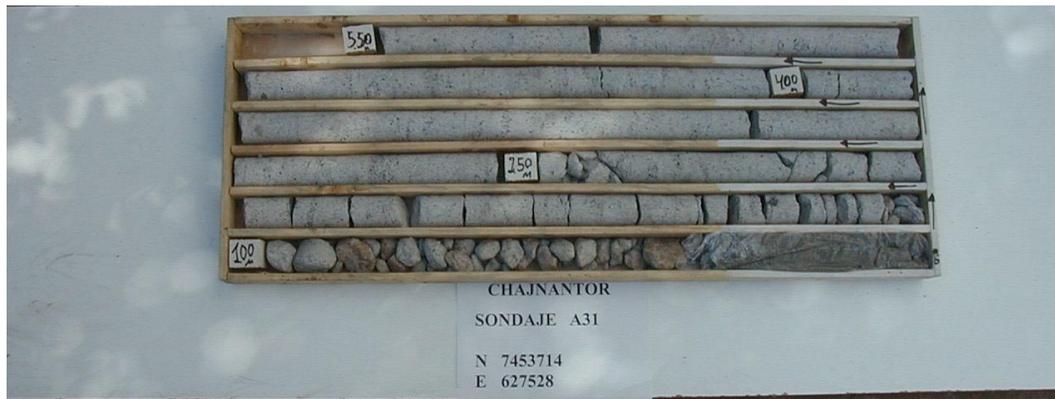
## BORING A31

DEPTH (m)	RECOVERY (%)	RQD (%)
0.0 – 1.0	40	0
1.0 – 2.5	98	67.3
2.5 – 4.0	100	100
4.0 – 5.5	100	100

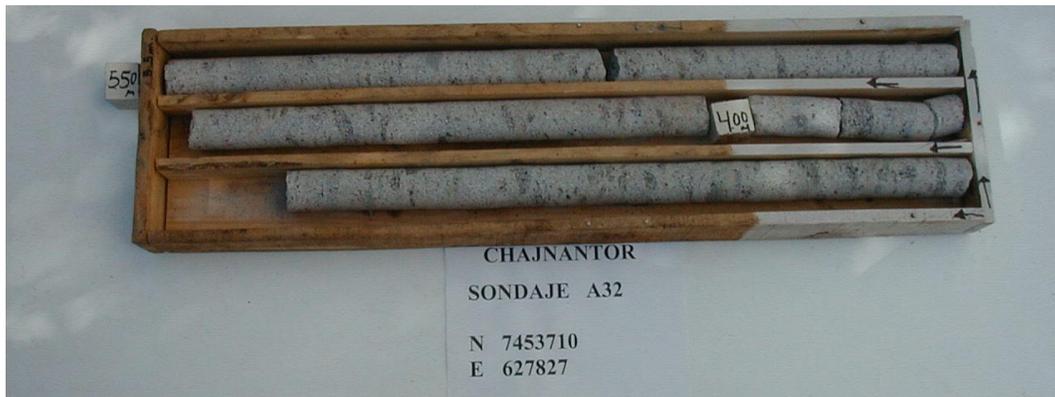
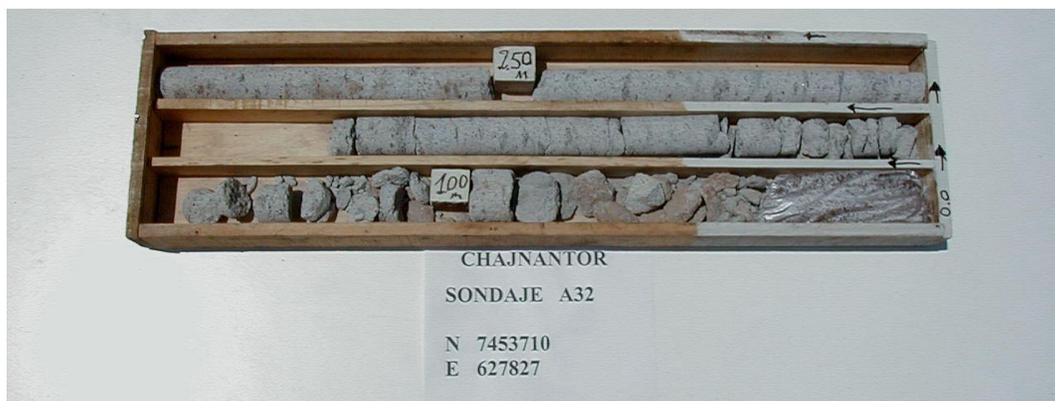
## BORING A32

DEPTH (m)	RECOVERY (%)	RQD (%)
0.0 – 1.0	25.3	0
1.0 – 2.5	96.6	84.6
2.5 – 4.0	100	100
4.0 – 5.5	100	100

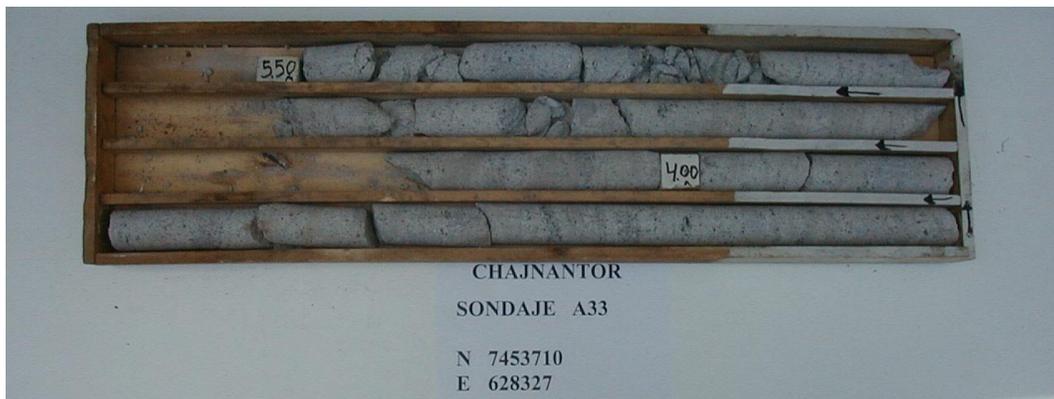
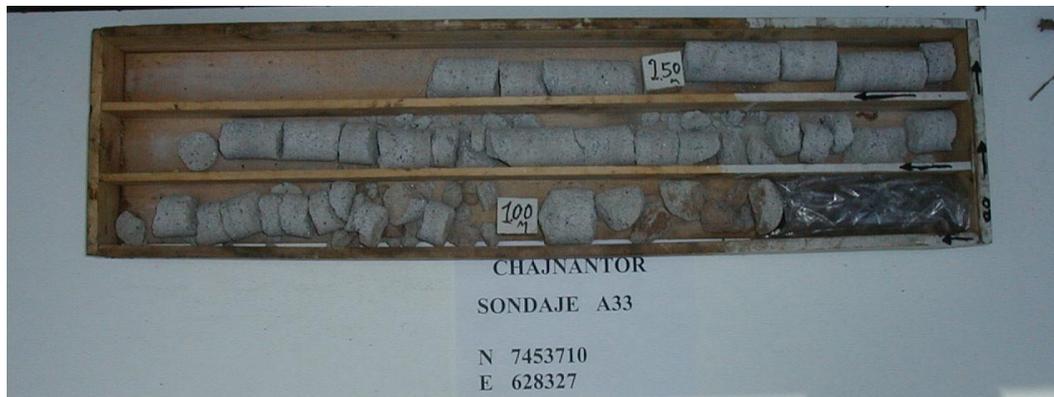
## BORING A33

DEPTH (m)	RECOVERY (%)	RQD (%)
0.0 – 1.0	16	0
1.0 – 2.5	100	76
2.5 – 4.0	100	92
4.0 – 5.5	100	63.7

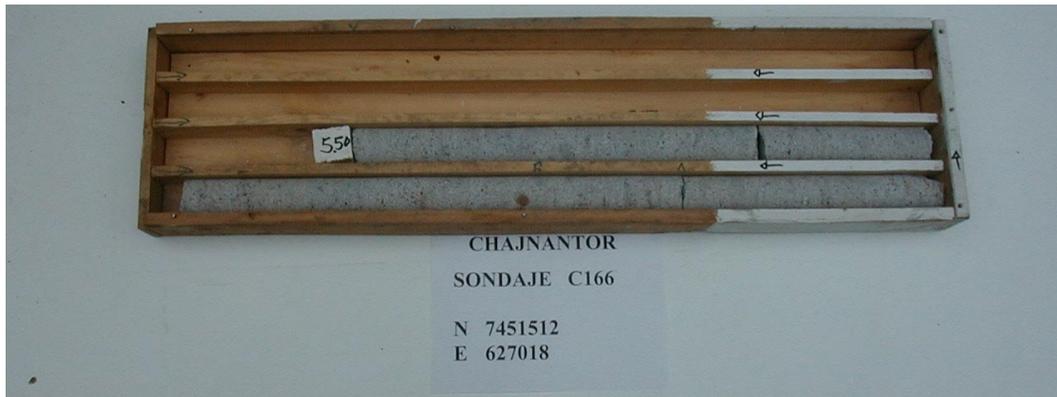
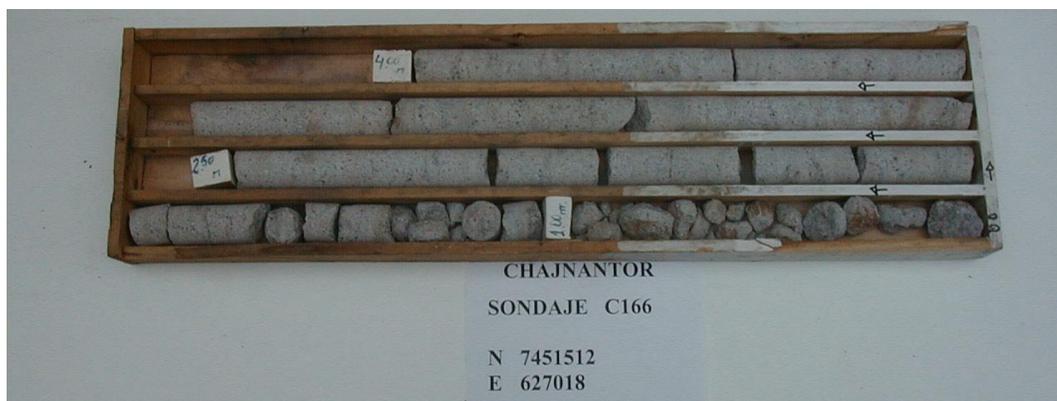
## BORING C166

DEPTH (m)	RECOVERY (%)	RQD (%)
0.0 – 1.0	30	0
1.0 – 2.5	85.3	85.3
2.5 – 4.0	100	100
4.0 – 5.5	100	100

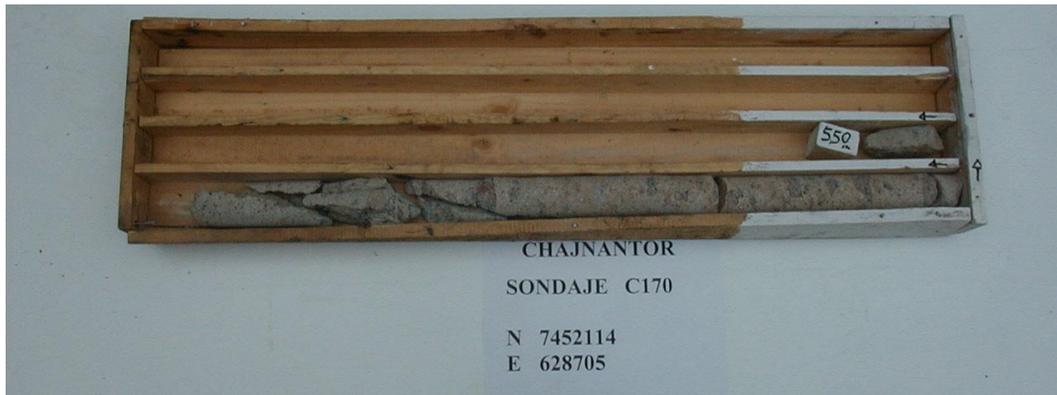
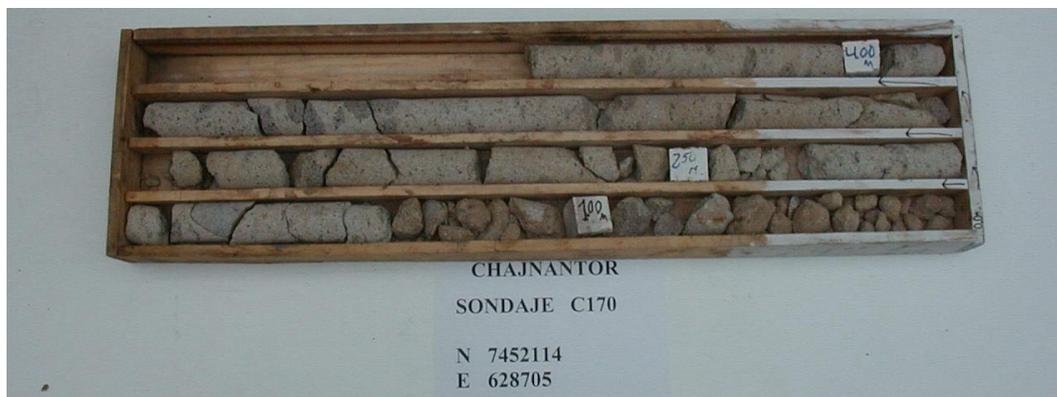
## BORING C170

DEPTH (m)	RECOVERY (%)	RQD (%)
0.0 – 1.0	28	0
1.0 – 2.5	49.3	31.6
2.5 – 4.0	100	74.6
4.0 – 5.5	85.3	71

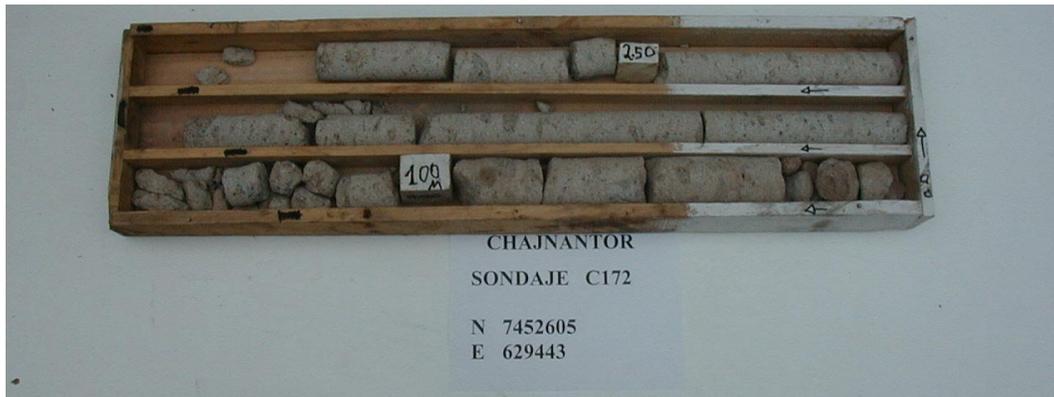
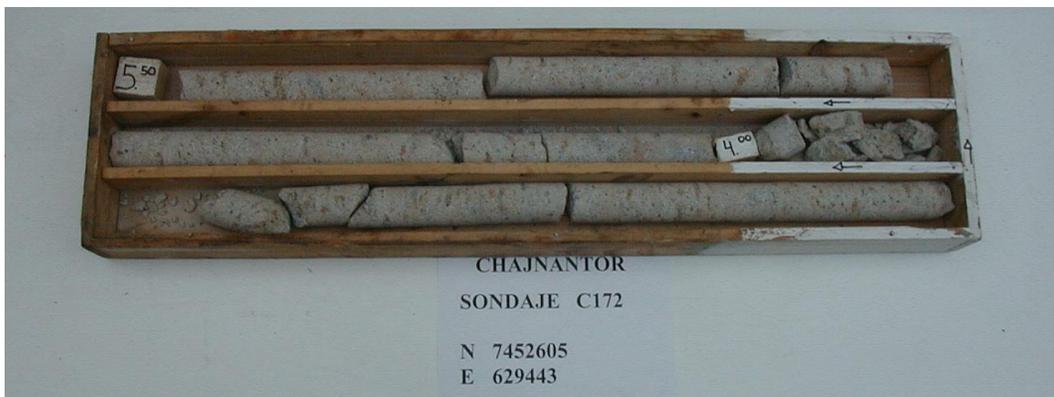
## BORING C172

DEPTH (m)	RECOVERY (%)	RQD (%)
0.0 – 1.0	36	25.3
1.0 – 2.5	100	79.3
2.5 – 4.0	98.6	70
4.0 – 5.5	100	94.6

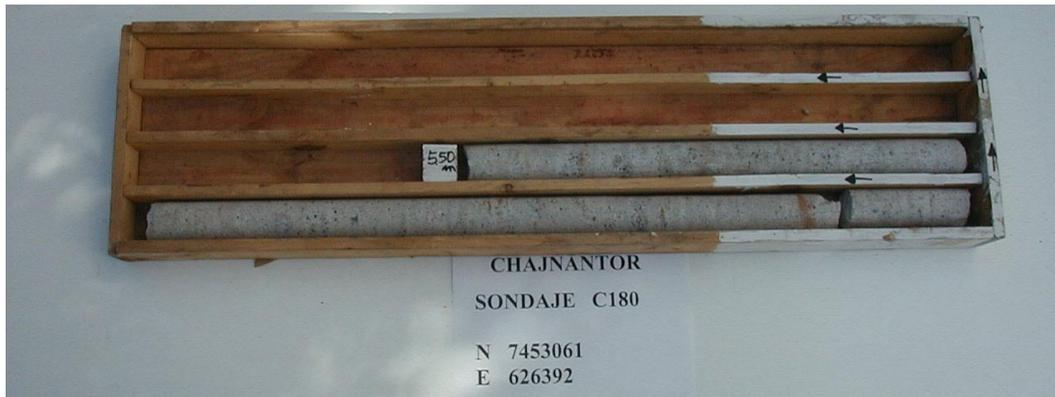
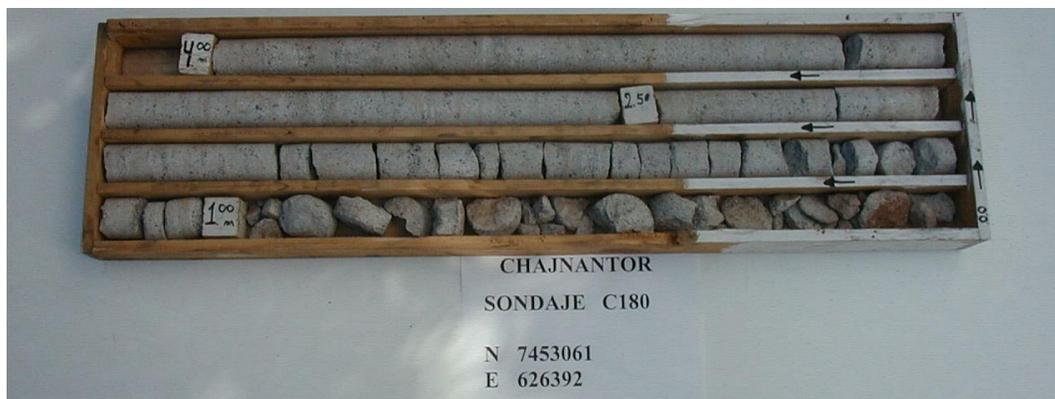
## BORING C180

DEPTH (m)	RECOVERY (%)	RQD (%)
0.0 – 1.0	53.3	0
1.0 – 2.5	100	100
2.5 – 4.0	100	100
4.0 – 5.5	100	100

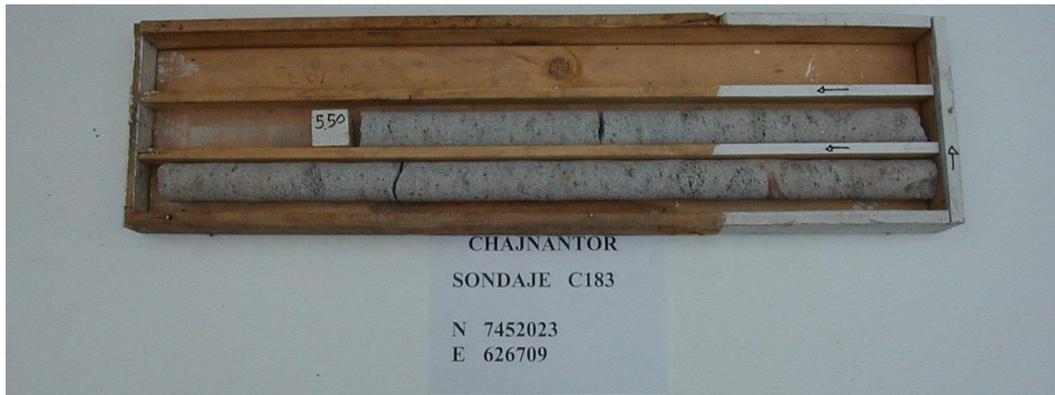
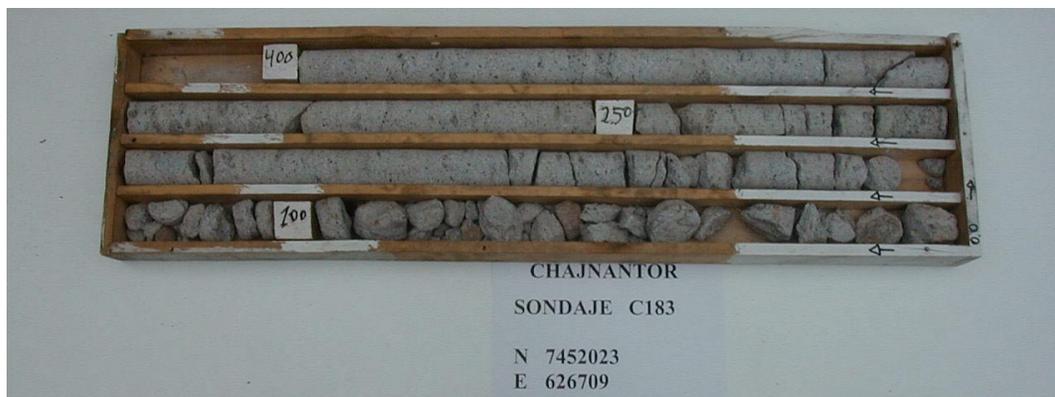
## BORING C183

DEPTH (m)	RECOVERY (%)	RQD (%)
0.0 – 1.0	46.6	0
1.0 – 2.5	100	100
2.5 – 4.0	100	100
4.0 – 5.5	100	100

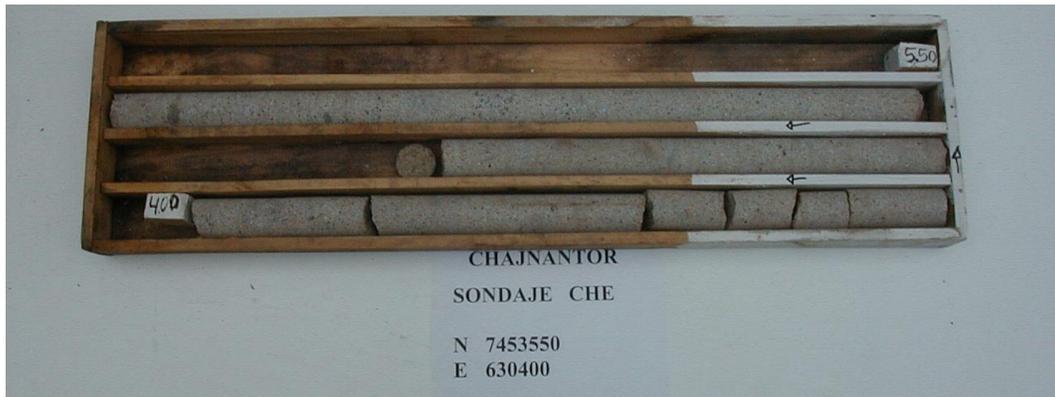
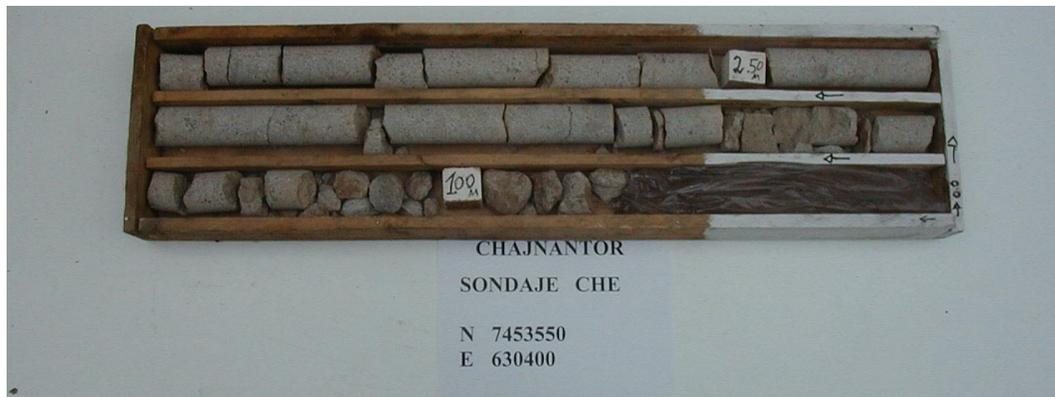
## BORING CHE

DEPTH (m)	RECOVERY (%)	RQD (%)
0.0 – 1.0	10	0
1.0 – 2.5	93.3	46
2.5 – 4.0	100	66
4.0 – 5.5	100	100

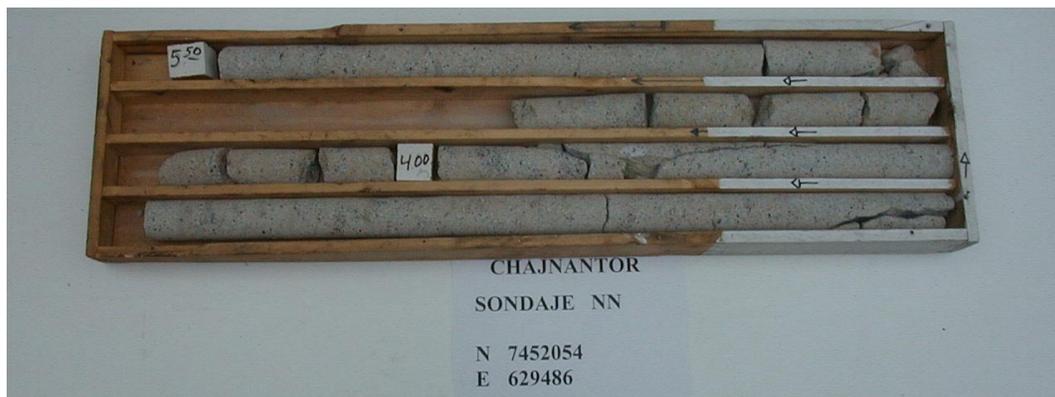
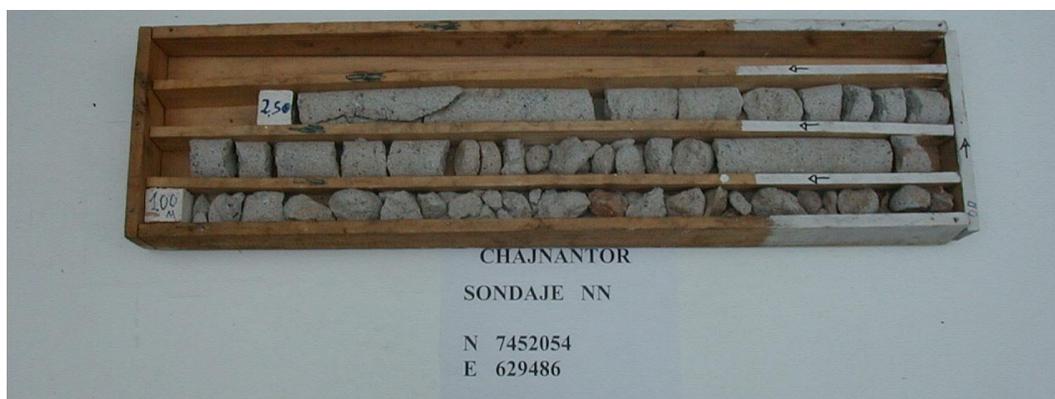
## BORING NN

DEPTH (m)	RECOVERY (%)	RQD (%)
0.0 – 1.0	60	0
1.0 – 2.5	100	100
2.5 – 4.0	100	100
4.0 – 5.5	100	100

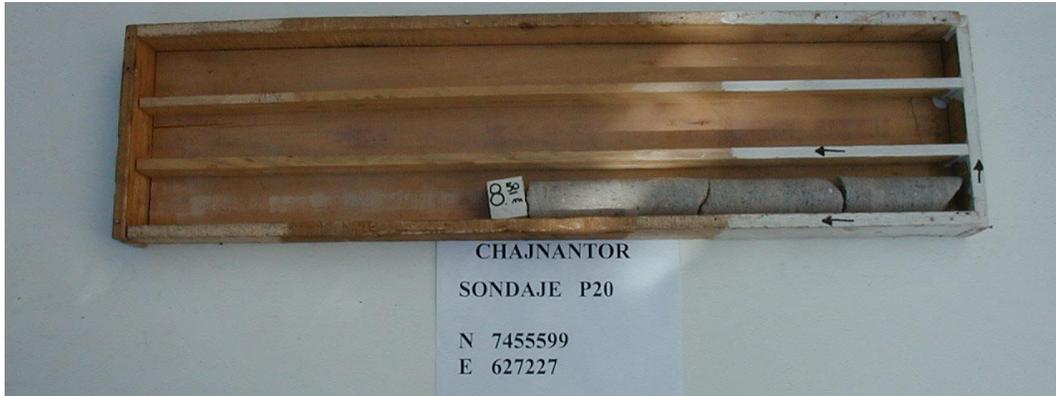
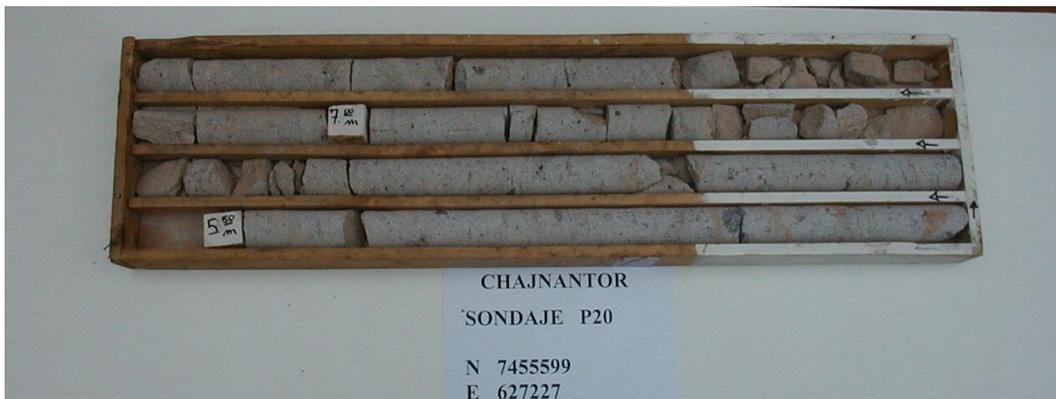
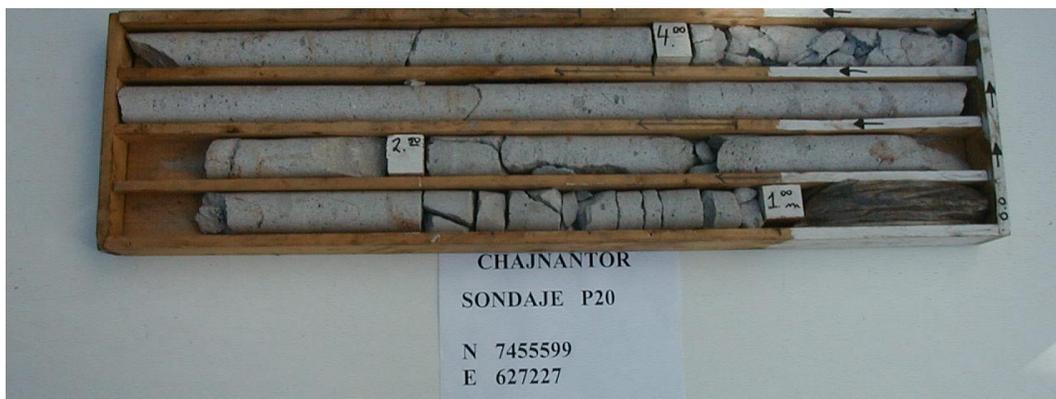
## BORING P20

<b>DEPTH (m)</b>	<b>RECOVERY (%)</b>	<b>RQD (%)</b>
0.0 – 1.0	(Sandy Soil)	0
1.0 – 2.5	82	69
2.5 – 4.0	100	94.3
4.0 – 5.5	94	94
5.5 – 7.0	100	58.3
7.0 – 8.5	100	81

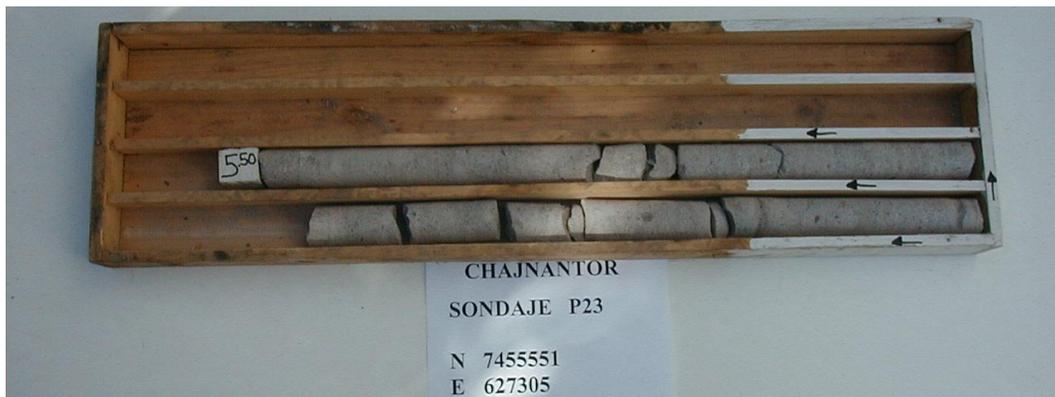
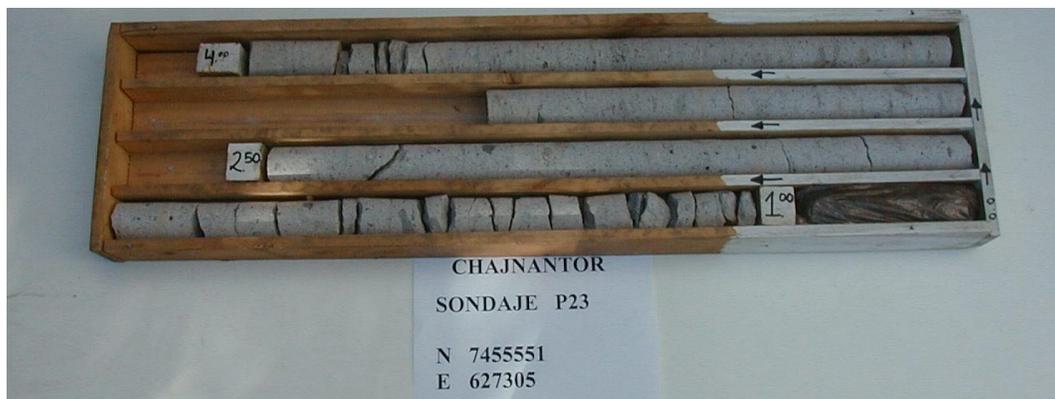
## BORING P23

DEPTH (m)	RECOVERY (%)	RQD (%)
0.0 – 1.0	(Sandy Soil)	0
1.0 – 2.5	100	100
2.5 – 4.0	94.6	94.6
4.0 – 5.5	100	100

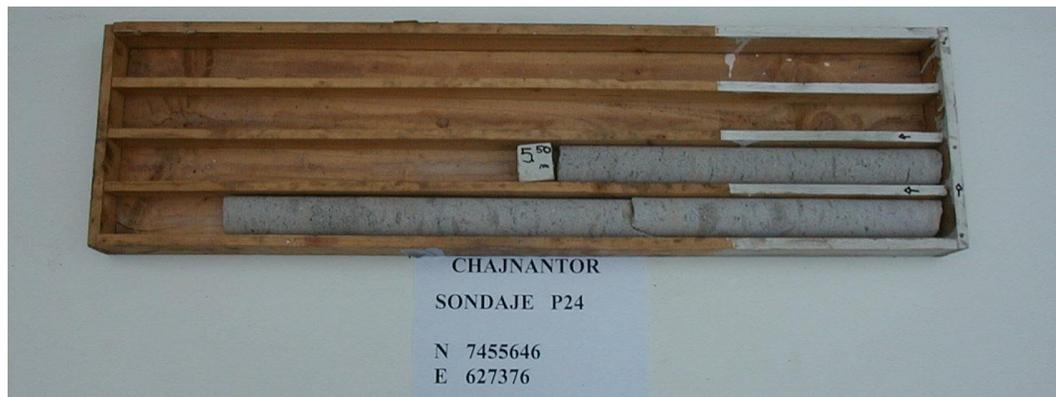
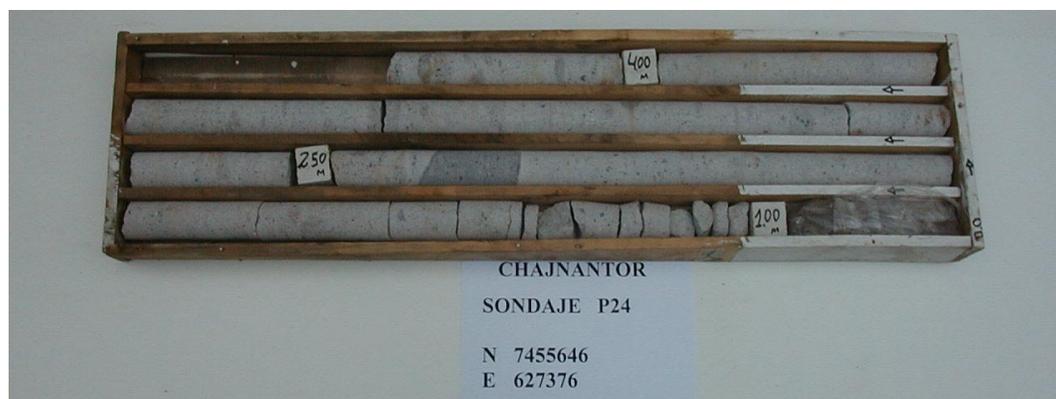
## BORING P24

DEPTH (m)	RECOVERY (%)	RQD (%)
0.0 – 1.0	(Sandy Soil)	0
1.0 – 2.5	100	100
2.5 – 4.0	100	100
4.0 – 5.5	100	100

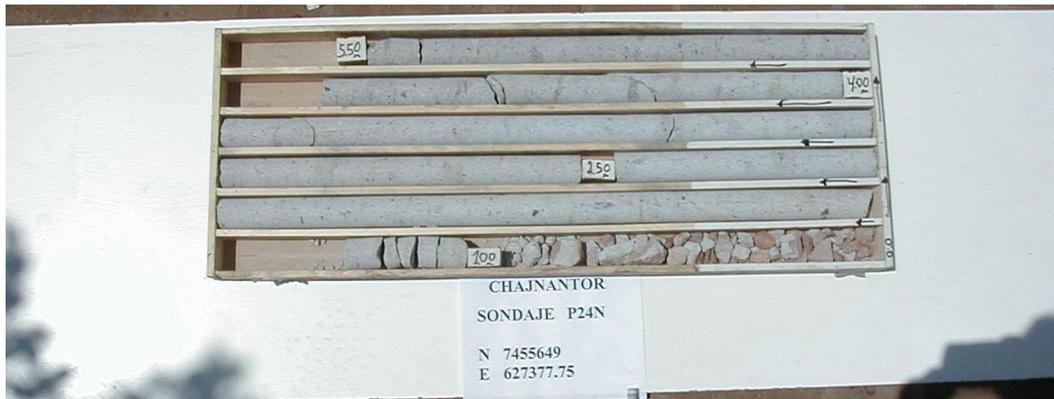
## BORING P24N

DEPTH (m)	RECOVERY (%)	RQD (%)
0.0 – 1.0	40	0
1.0 – 2.5	100	100
2.5 – 4.0	100	100

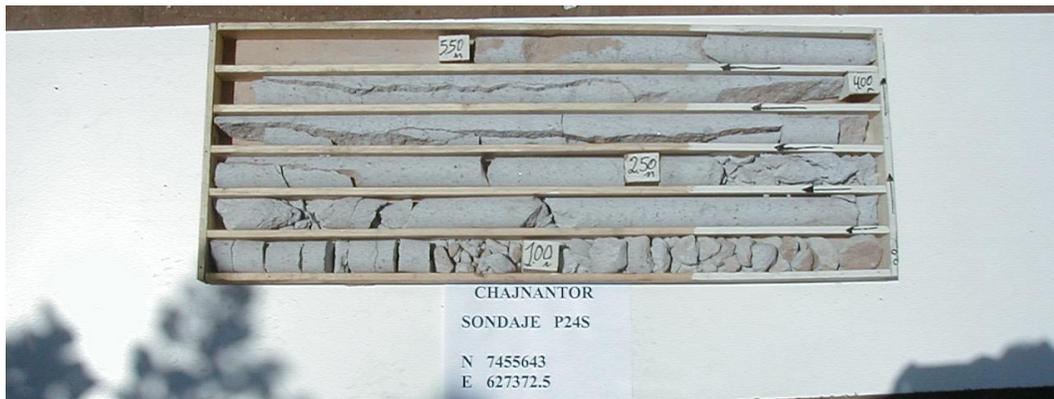
## BORING P24S

DEPTH (m)	RECOVERY (%)	RQD (%)
0.0 – 1.0	40	0
1.0 – 2.5	100	37
2.5 – 4.0	100	100
4.0 – 5.5	100	100

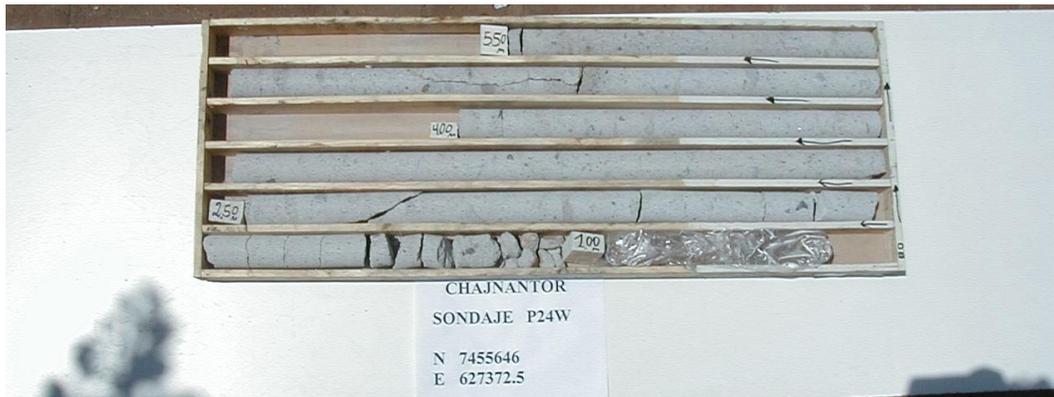
## BORING P24W

DEPTH (m)	RECOVERY (%)	RQD (%)
0.0 – 1.0	(Sandy Soil)	0
1.0 – 2.5	97.3	78
2.5 – 4.0	100	100
4.0 – 5.5	100	100

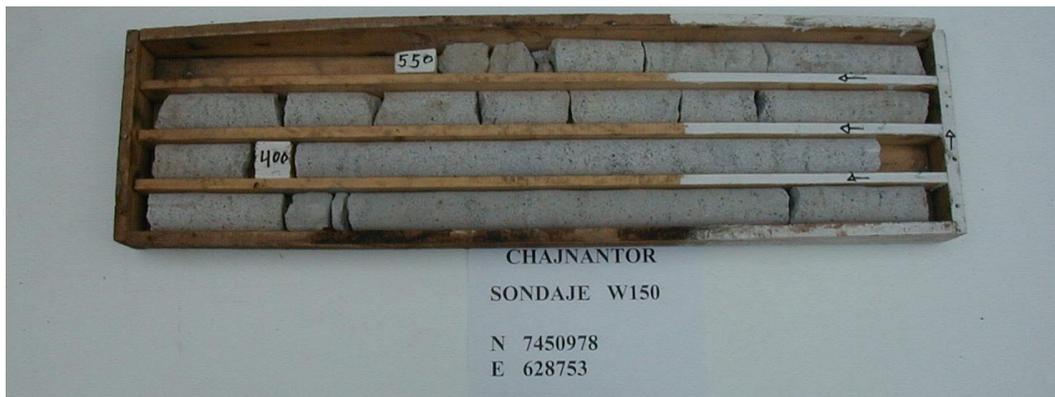
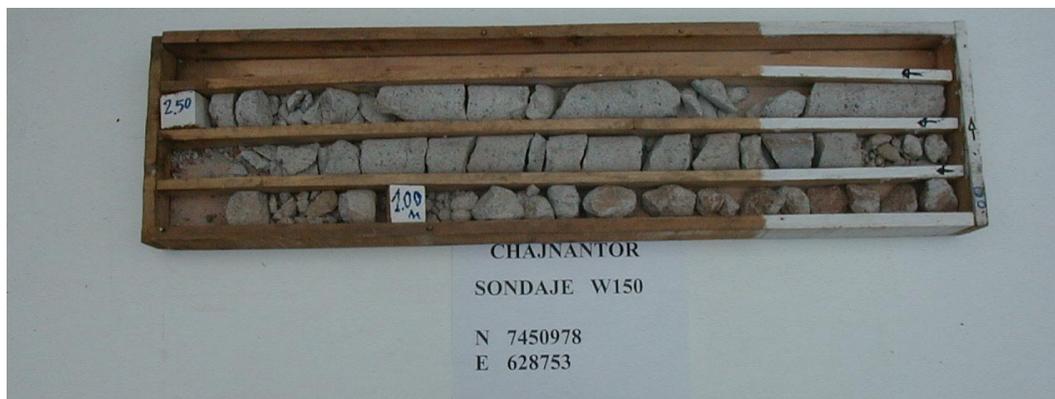
## BORING W150

DEPTH (m)	RECOVERY (%)	RQD (%)
0.0 – 1.0	43.3	0
1.0 – 2.5	100	73.3
2.5 – 4.0	100	100
4.0 – 5.5	100	100
