Demonstration of the mechanism driving the GBT track movement

David H. Parker

July 26, 2001

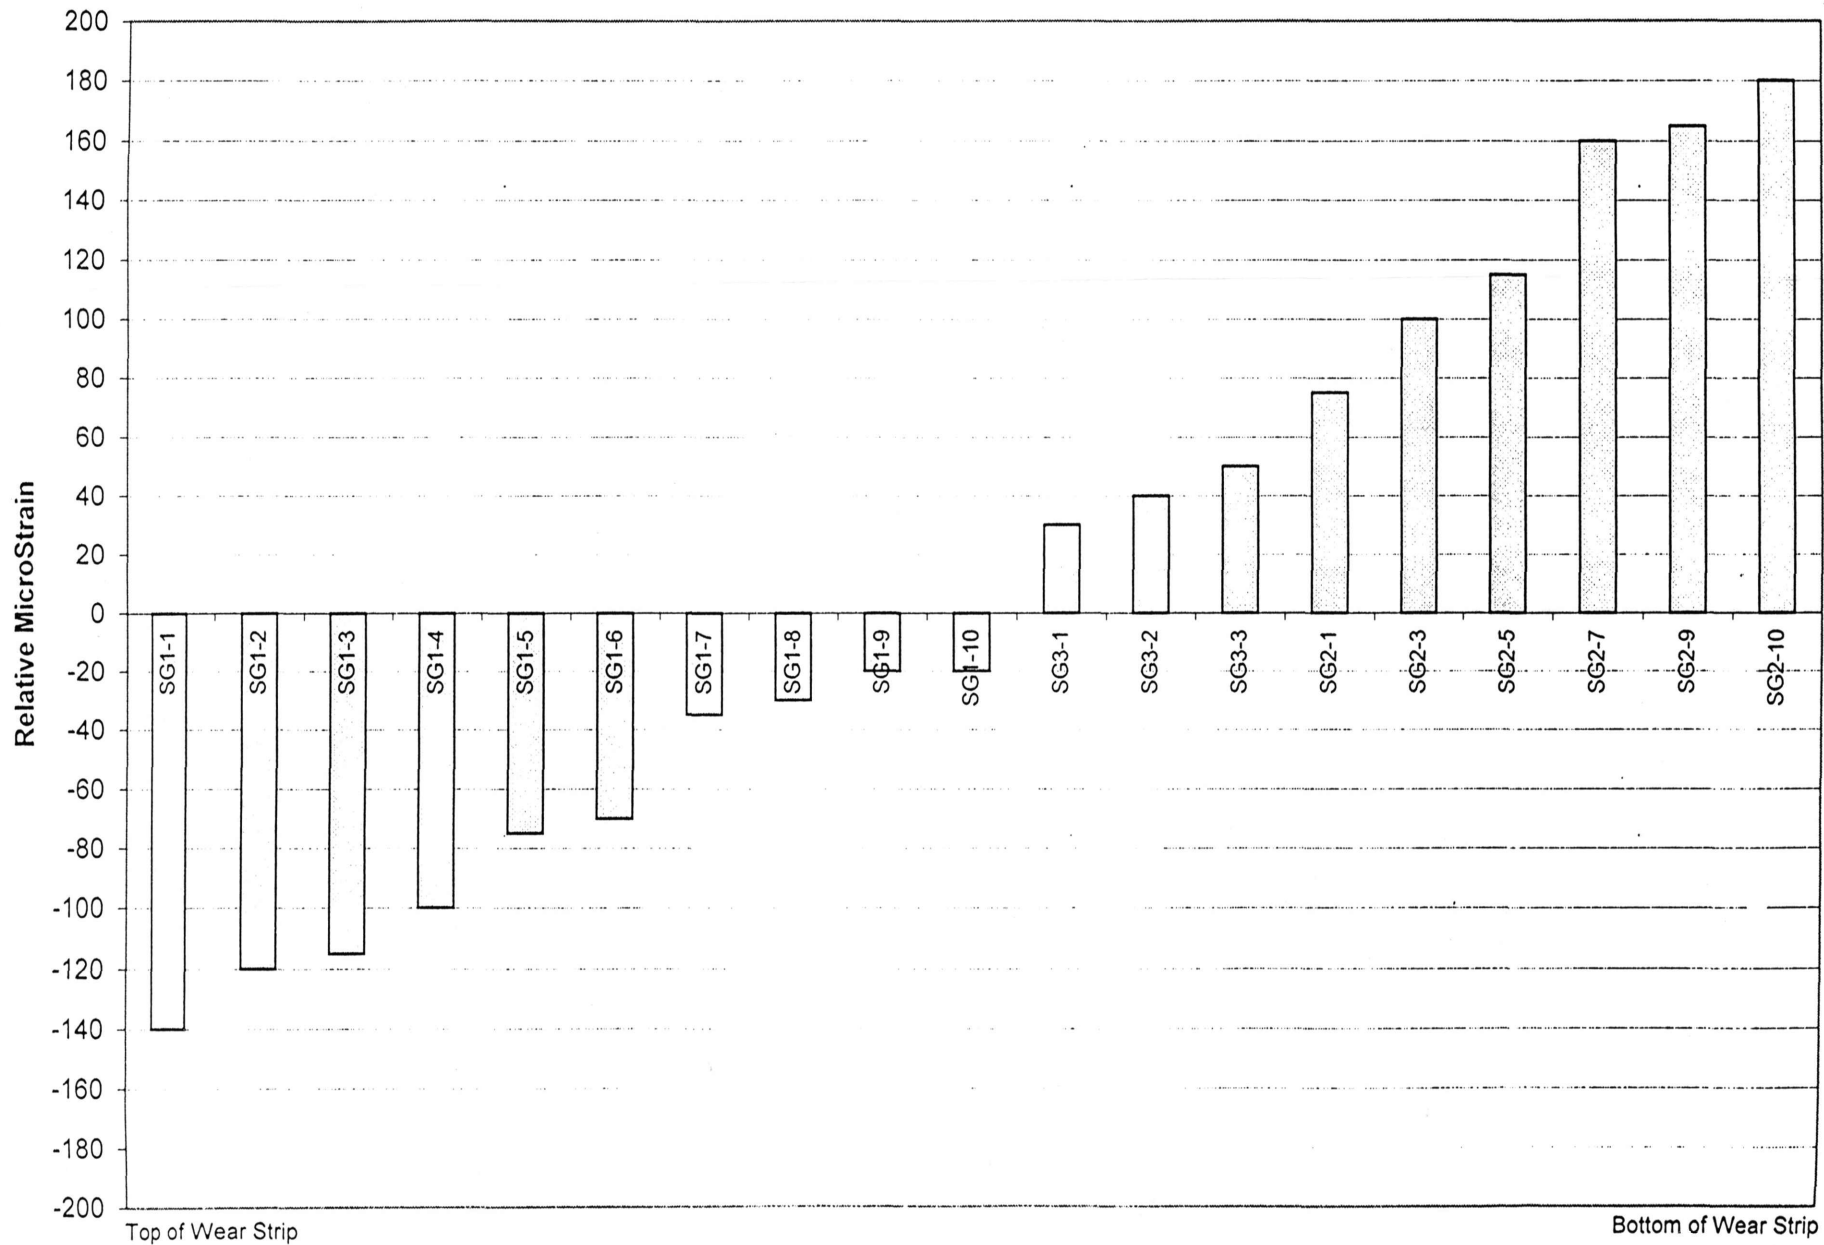
Wheel On MicroStrain - Wheel Off MicroStrain vs Strain Gauge Number

Much to our surprise, we discovered that, under the wheel the strain was in compression at the top of the wear strip, and in *tension* at the bottom of the wear strip. The attached plot, taken from report A0234, looks like the strain pattern for a bending beam. Everyone was expecting the wear strip and base plate to act together as a laminated beam—which should have produced strain in compression down to about the middle of the assembly, i.e., about 5-6 inches. Subsequent measurements on the base plate confirmed that it too was in compression at the top.

So, given that the strain on the bottom of the wear strip was 180 degrees out of phase with the top of the base plate, a mechanism for relative movement at the interface was clear. This is demonstrated by a simple experiment.

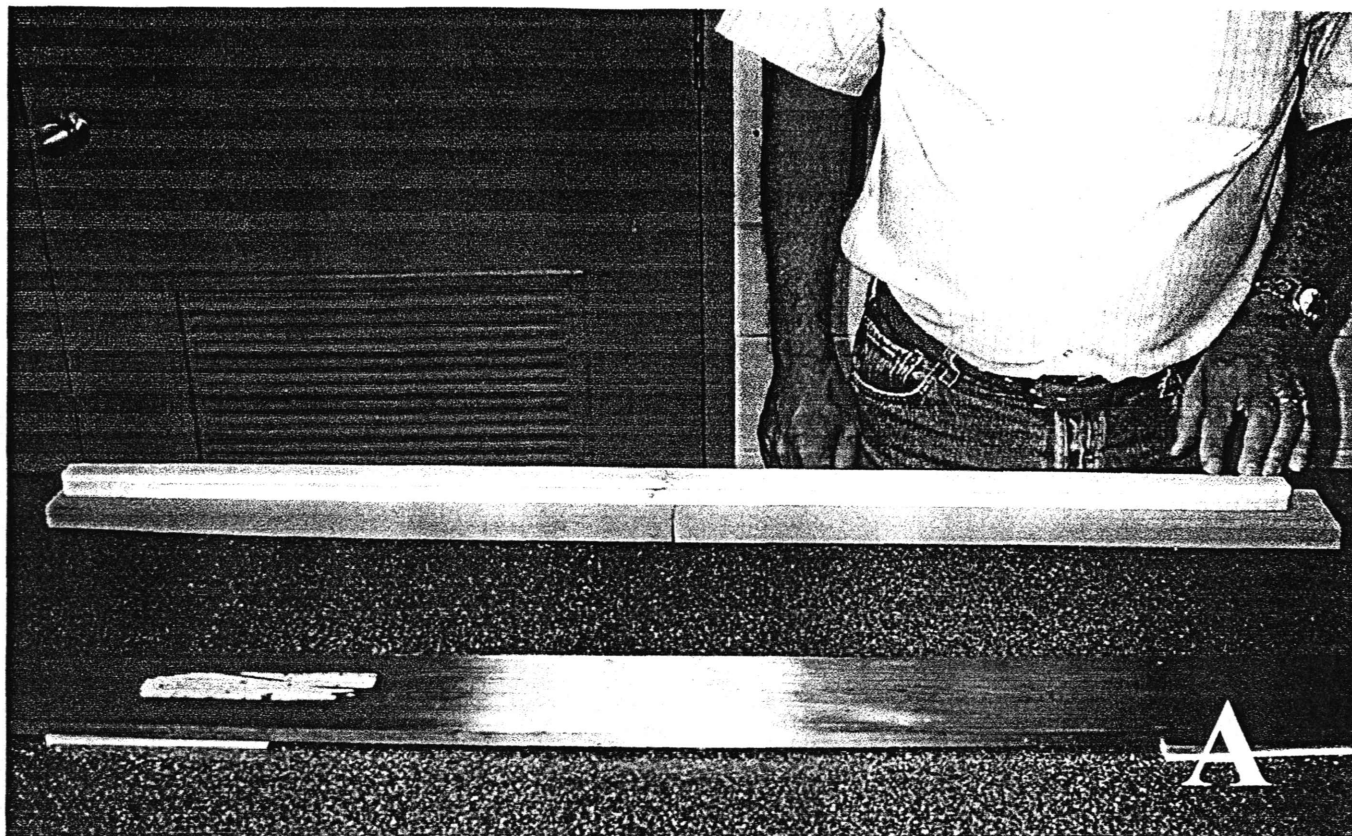
Figure A shows two strips of wood. The upper strip is about 1/4 inch thick and the lower strip is about 7/16 inch thick. Figure B shows a clamp holding the right end of the assembly. Note that the assembly is free to slide, except at the clamp, and thus the beams are delaminated and act independently. Figure C illustrates the assembly bending under a load. Under this bending condition, Figure D clearly shows that, at the interface, the bottom of the upper beam is longer than the top of the lower beam.

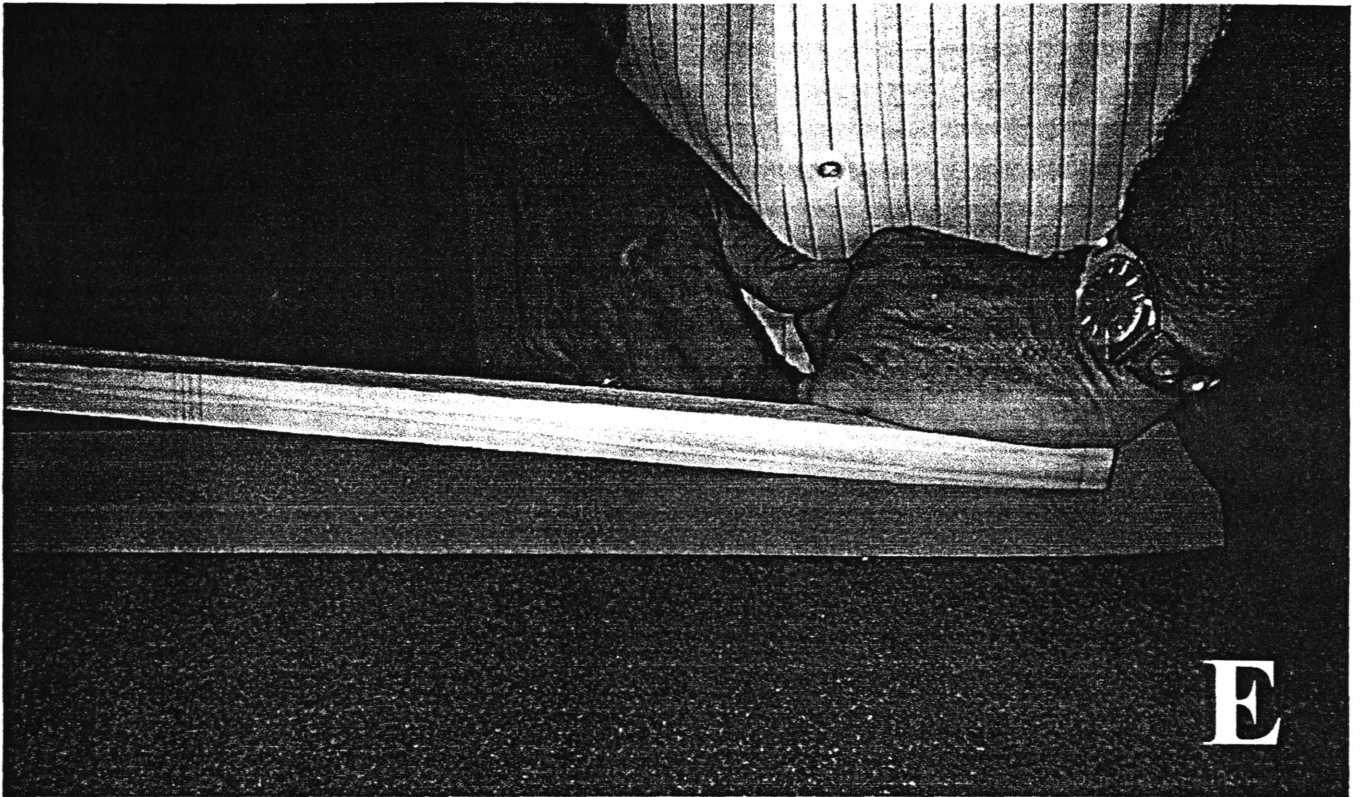
Figure E shows the two strips resting on two keyboard wrist pads. By applying pressure, starting at the right side and stepping across as shown in figures F-I, a load migrates across the beam. A wheel can be thought of as the same process where the incremental steps become smaller. Figure J shows the characteristic motion in the direction of travel.
