RADIOASTRON COMPATIBILITY TESTS AT GREEN BANK, MAY 1999

Anthony Minter , Dan Pedtke and Annamarie Wester

*1999 November 9***INTRODUCTION**

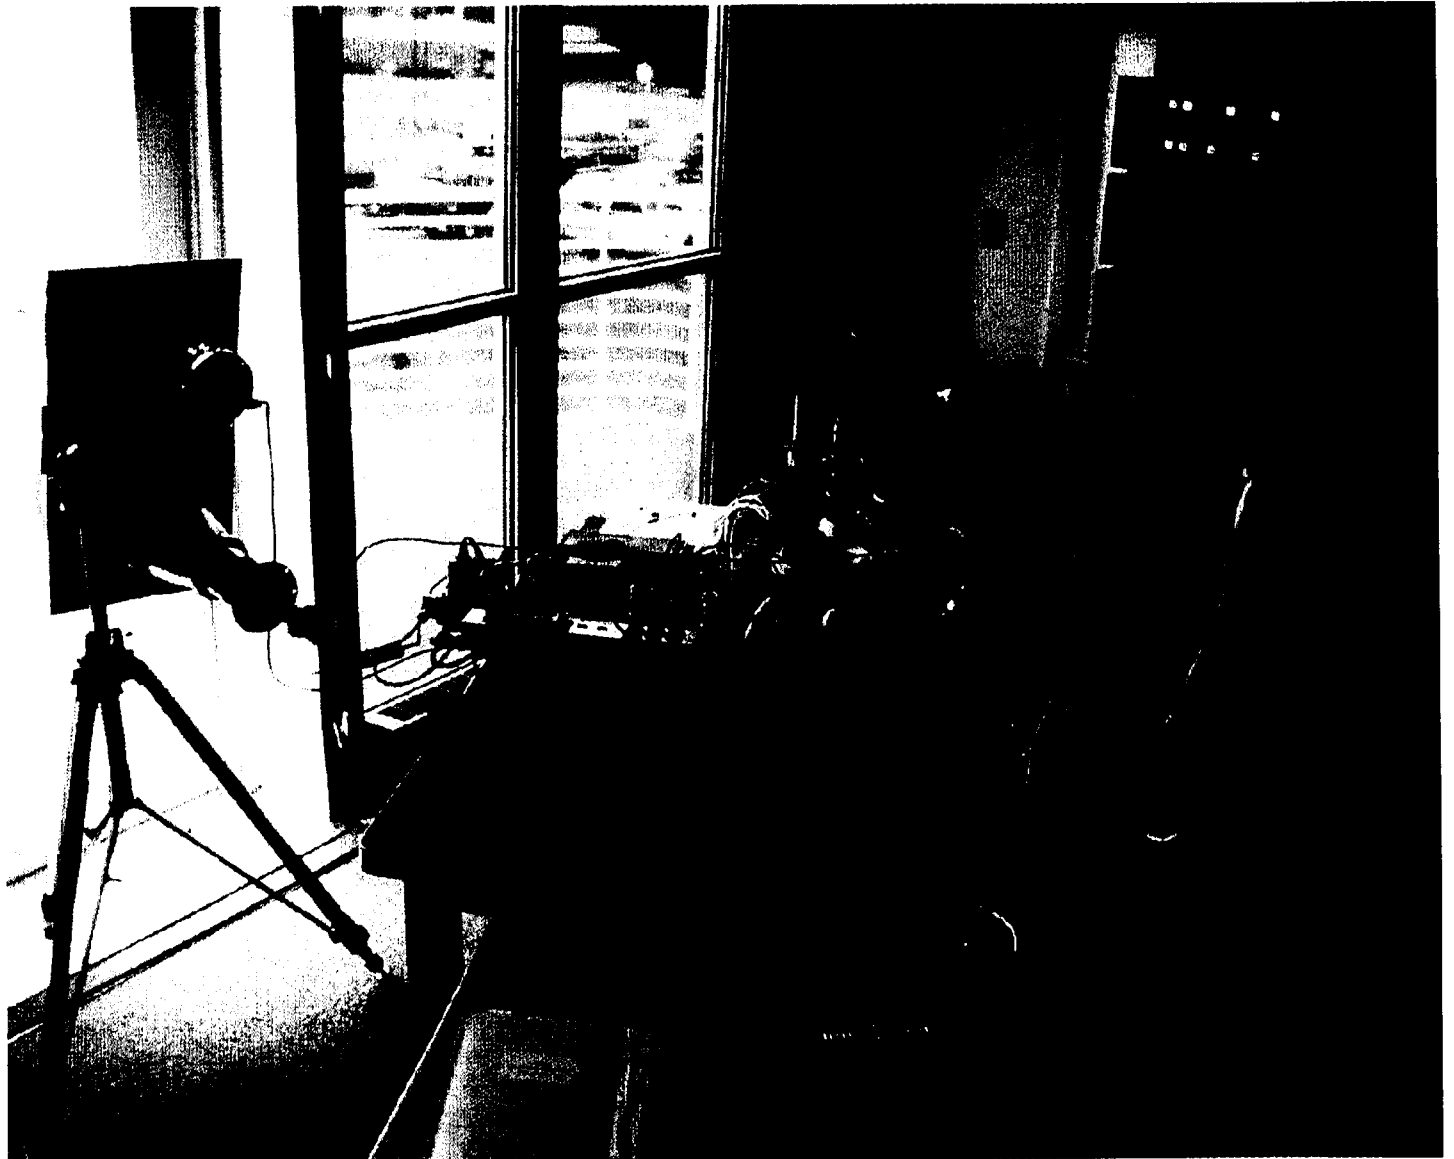
Figure 11: Test setup from inside the GBT operations room.

The Russian test set was moved to the Green Bank Telescope (GBT) control room during the afternoon of May 24, 1999 in preparation for the radiative link tests that could begin on May 25. The setup is shown in Figures 11 and 12 with a block diagram of the setup shown in Figure 13.

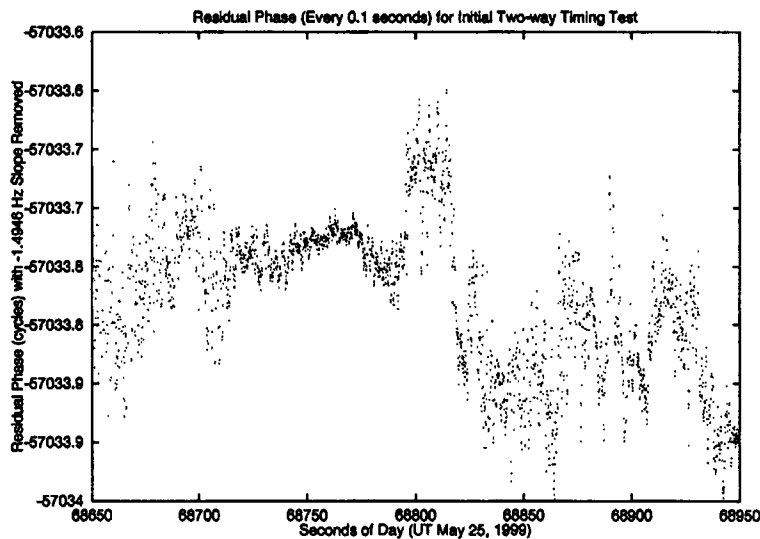
Figure 14: Phase residuals from the initial two-way timing test between the earth station and the Russian RadioAstron test set. A slope of -1.4946 Hz has been removed from this plot in order to show the fluctuations in the measured phase residuals.

A 10 minute round-trip lock test of the two-way timing phase stability was performed (see Figures 14-15). The first five minutes of this test were used to adjust/tune the earth station

The two-way timing link during this 10 minute round-trip lock test proved to be relatively noisy with an RMS noise level about an order of magnitude larger than what is observed for the two-way timing link to the Japanese space VLBI satellite, HALCA, which is in orbit (see Figures 15 and 16).

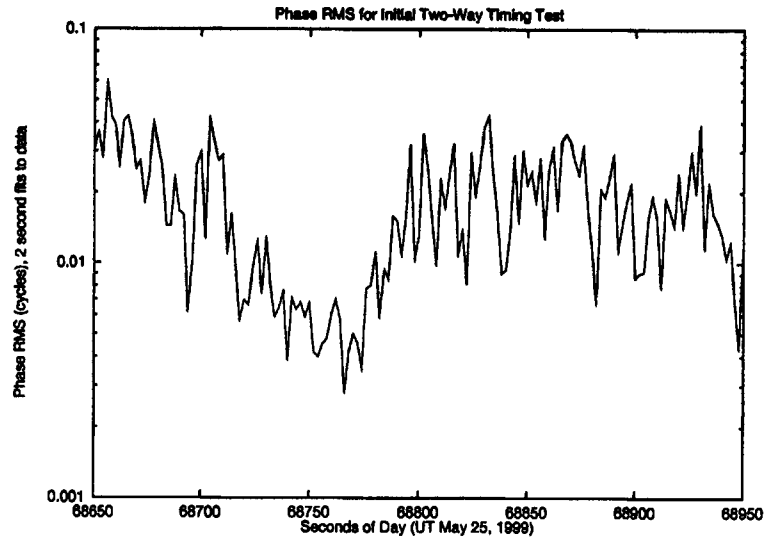
Figure 15: RMS of the measured timing residuals from the initial two-way timing test between the earth station and the Russian RadioAstron test set. The RMS was determined using a linear fit to two seconds of phase data.

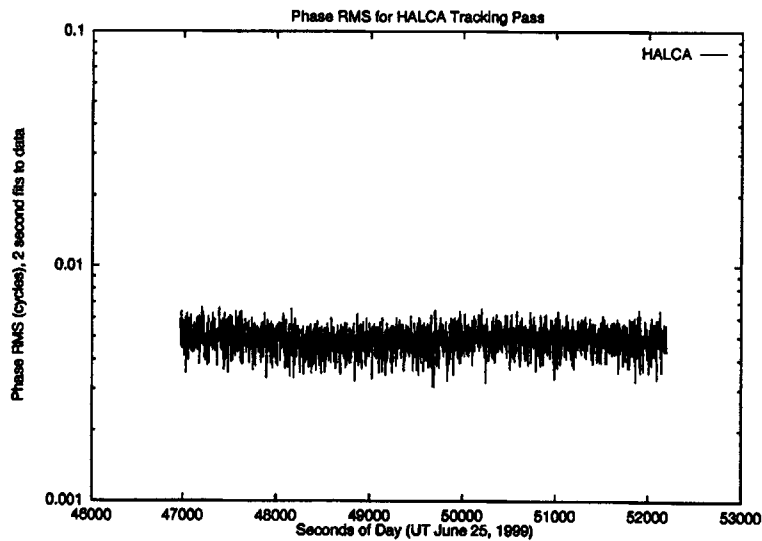
Figure 16: A typical RMS of the measured timing residuals from the two-way timing link between the earth station and HALCA. The RMS is determined in the same manner as in Figure 16.

The VIRK produced residual timing data that were similar to but generally noisier than what is observed for the Japanese HALCA satellite (see Figures 16 and 18). We can compute the expected coherence Γ of radio astronomical observations from the RMS timing noise τ_{RMS} (in seconds) in the timing residuals. This is calculated using the relationship

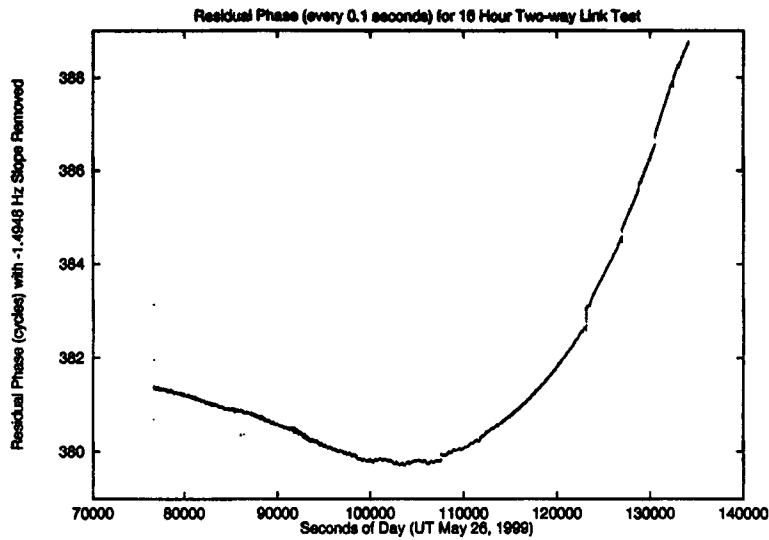
Figure 17: Phase residuals from the 16 hour long two-way timing test between the earth station and the Russian RadioAstron test set. A slope of -1.4948 Hz has been removed from this plot in order to show the fluctuations in the measured phase residuals. Note the many sudden jumps of the phase with amplitudes of 0.0625 to 0.25 cycles (7.4 to 29.5 picoseconds). The curvature of the phase residuals in this plot results entirely from the pseudo-orbit file.

An overnight phase stability test for the 8 GHz band two-way timing link was started around 21:30 UTC, May 26, 1999. This test ran for approximately 16 hours. Plots of the resulting residual phases and RMS noise are shown in Figures 17 and 18. The noise level for this test was generally similar to what is observed for HALCA. More detailed results from this test are presented in a latter section of this document.

with an orbit prediction file that would produce a residual “Doppler” frequency of about -1.5 Hz. The exact times when this test was performed are 21h15m16s May 26, 1999 until 13h15m18s May 27, 1999. The measured residual phases, residual “Doppler” frequency and the RMS noise level determined using a linear fit to the phases are shown in Figures 17 and 18.

In Figure 17 it can be seen that there are several small glitches in the residual phase measurements. These glitches are of unknown origin and are jumps in phase of order 0.1 cycles – 11.8 picoseconds in the residual timing measurements. Tests of a similar length of time were performed using the NRAO satellite simulator in which no glitches were seen. This suggests that the source of the glitches is within the VIRK modules or the Russian test set. The measured phase residuals were run through the earth station program *doppler*. This program creates a “Doppler” file. During normal on-orbit operations, such a file would

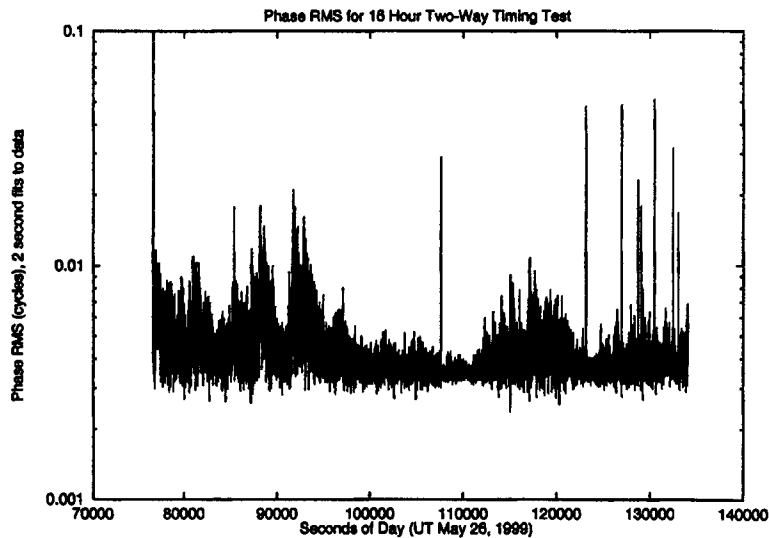
Figure 18: RMS of the timing residuals measurements from the 16 hour long two-way timing test between the earth station and the Russian RadioAstron test set. The RMS was determined using a linear fit to two seconds of phase data.

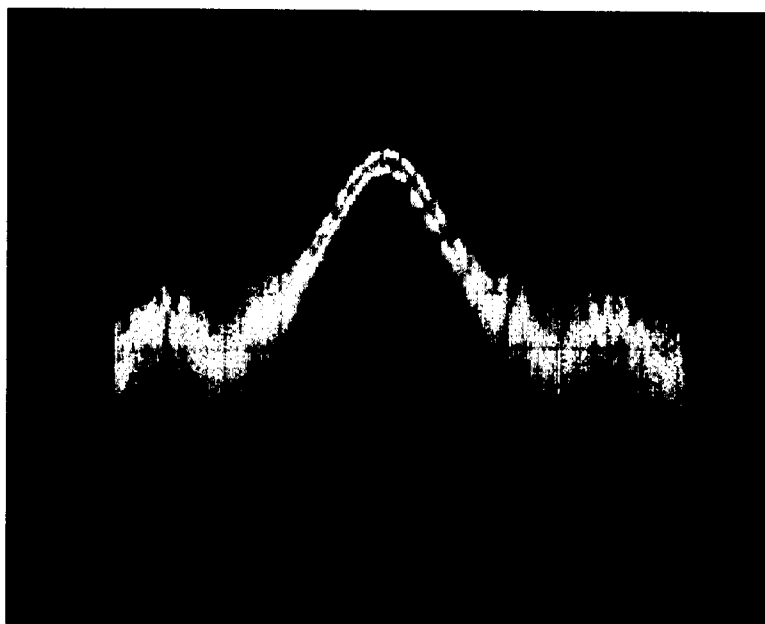
Figure 26: The VIRK signal with no modulation as measured at the earth station. The center frequency is 15.063 GHz. The vertical axis has 10 dB per division and the horizontal axis has 20 MHz per division. Note the 500 Hz 4 dB amplitude modulation – the bi-modal appearance of the spectrum.

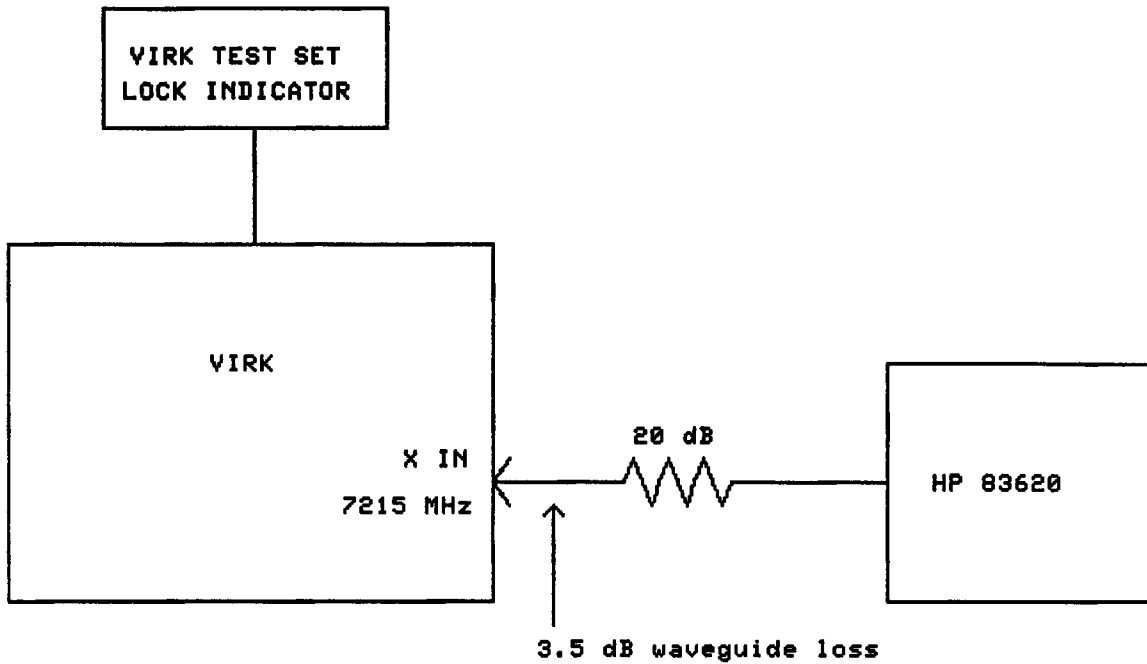
Figure 30: Block diagram of the equipment setup for the lock range tests.

On Friday, May 28, 1999 we decided to test the lock range of the VIRK 8 GHz band system. In Figure 30 we show a block diagram of the setup for these tests. An HP 83620 was used to provide a source signal input directly into the 8 GHz band uplink receiver of the VIRK. The VIRK test set lock indicator was used to determine if the VIRK was locked to the source signal. Both the input frequency and the power level were varied to study the lock and hold range of the VIRK module.

These tests showed that the lock range was limited mainly by the search sweep range of the PLL, as the frequency limits were not power level sensitive. The input capture range was from 7215.2670 to 7215.2320 MHz (+12 to -23 kHz), and the hold range was 7215.26724 to 7215.232240 MHz (+26.5 to -23 kHz). The hold range widened by about 1200 Hz when the input power was increased from -70 dBm to -50 dBm. Note that the hold range measurements were very sensitive to the rate of change of the received signal's frequency near the limits of the hold range – within ~ 500 Hz of the edges of the hold range. Here we had to move the signal source in 1 Hz steps, at a maximum rate of about 1 step per second, to hold lock at the extremes. Within the center of the hold range, roughly 7215.2665 to 7215.2325 MHz, the rate of change of the frequency of the signal did not matter. The VIRK would lock to any signal ≥ -100.5 dBm (8.9×10^{-14} Watts). The VIRK would not lock to a signal ≤ -101.5 dBm (7.1×10^{-14} Watts). Note that the power level for the inputs could only be changed in increments of 1 dBm for this test. If the VIRK was locked to a signal it would lose lock as soon as the signal dropped below -100.5 dBm.
