VLA-VLBA Interference Protection Memo #37

VLBA-PT Station Building Shielding Test Report

Dan Mertely, Charlie Barham
20090602

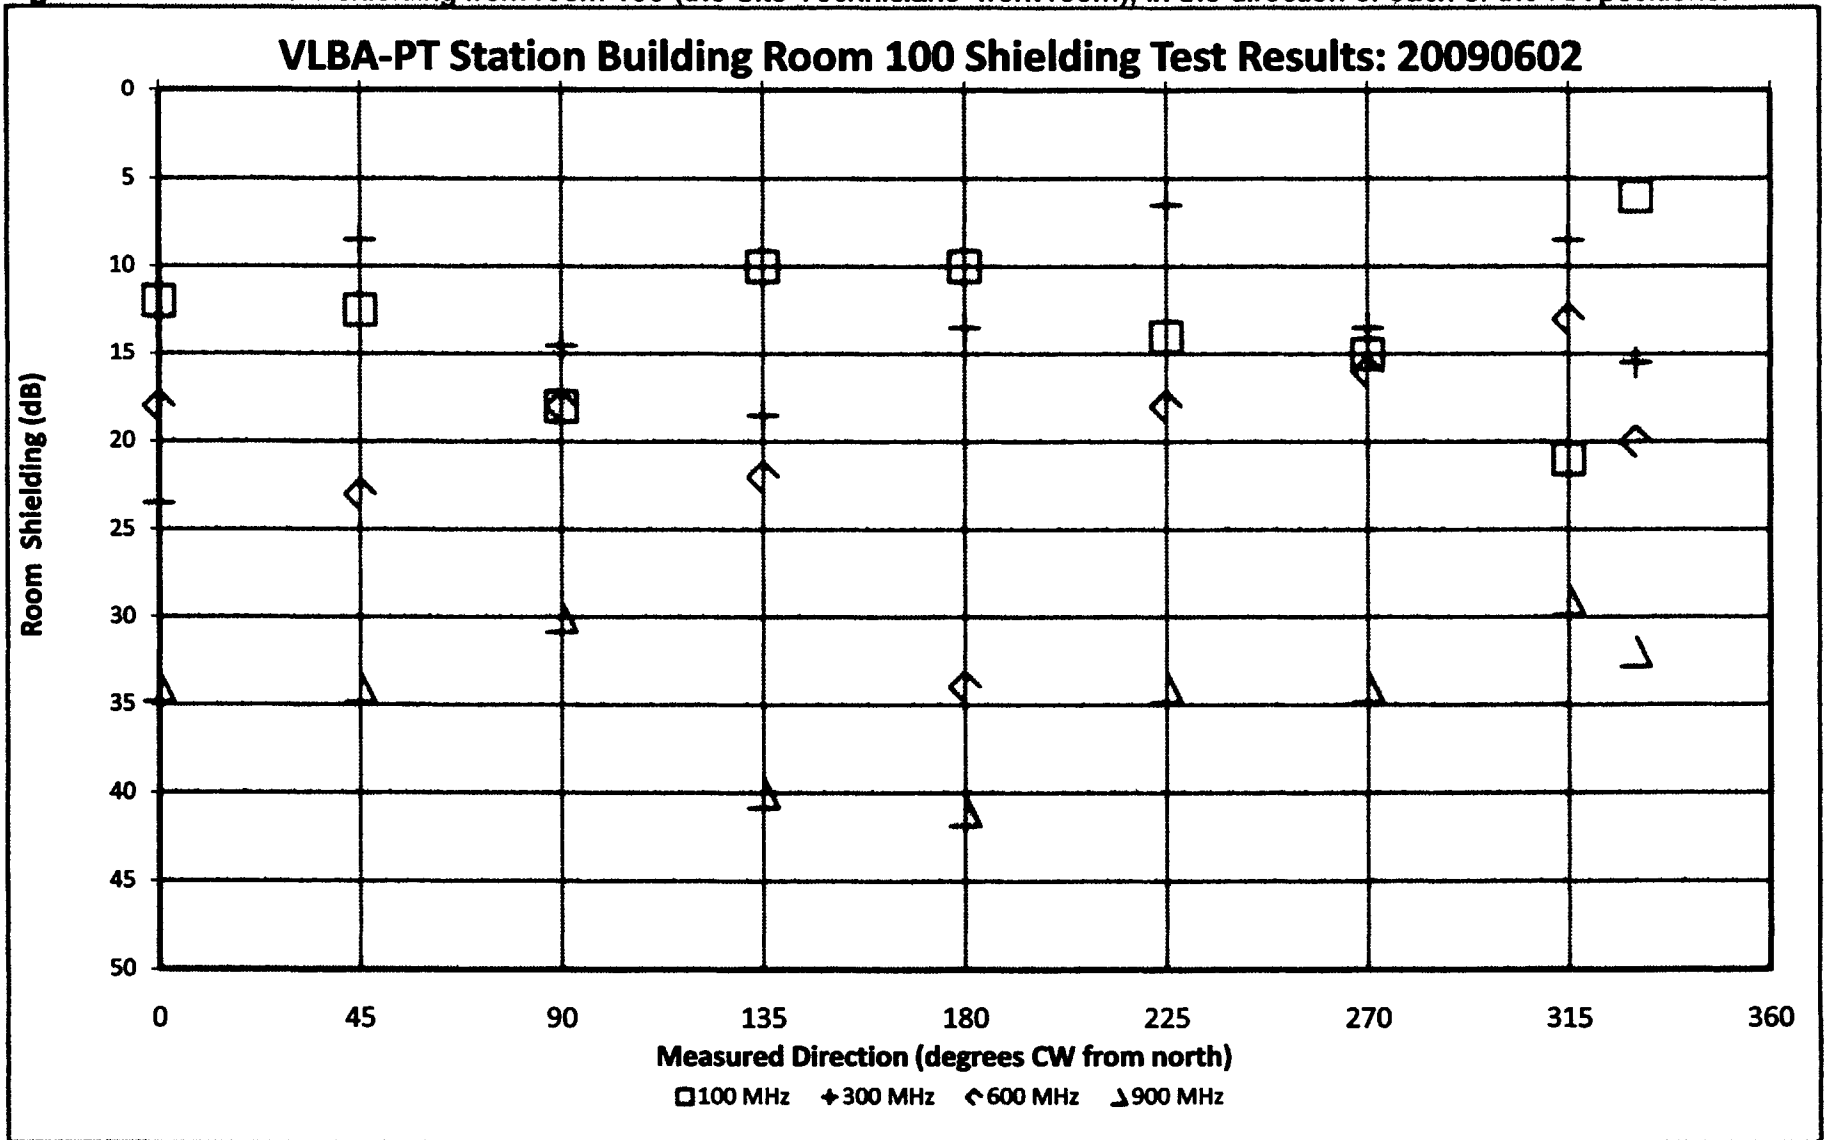
Figure 2: The VLBA-PT shielding from room 100 (the Site Technicians' work room), in the direction of each of the RX positions.

The VLBA-PT station building shielding from room 100 (the Site Technicians' work room), in the direction of the VLBA antenna, varied from around 10 dB at 100 MHz to around 37 dB at 900 MHz. The room 103 shielding (the future DBE room) varied from around 20 dB at 100 MHz to around 40 dB at 900 MHz. The room 104 shielding (the LO/IF/MASER room) varied from around 18 dB at 100 MHz to around 30 dB at 900 MHz

The VLBA-PT station building shielding from room 100 (the Site Technicians' work room), in the direction of each of the RX positions is presented in **Figure 2**. The 1987 results are displayed in **Figure 3**.

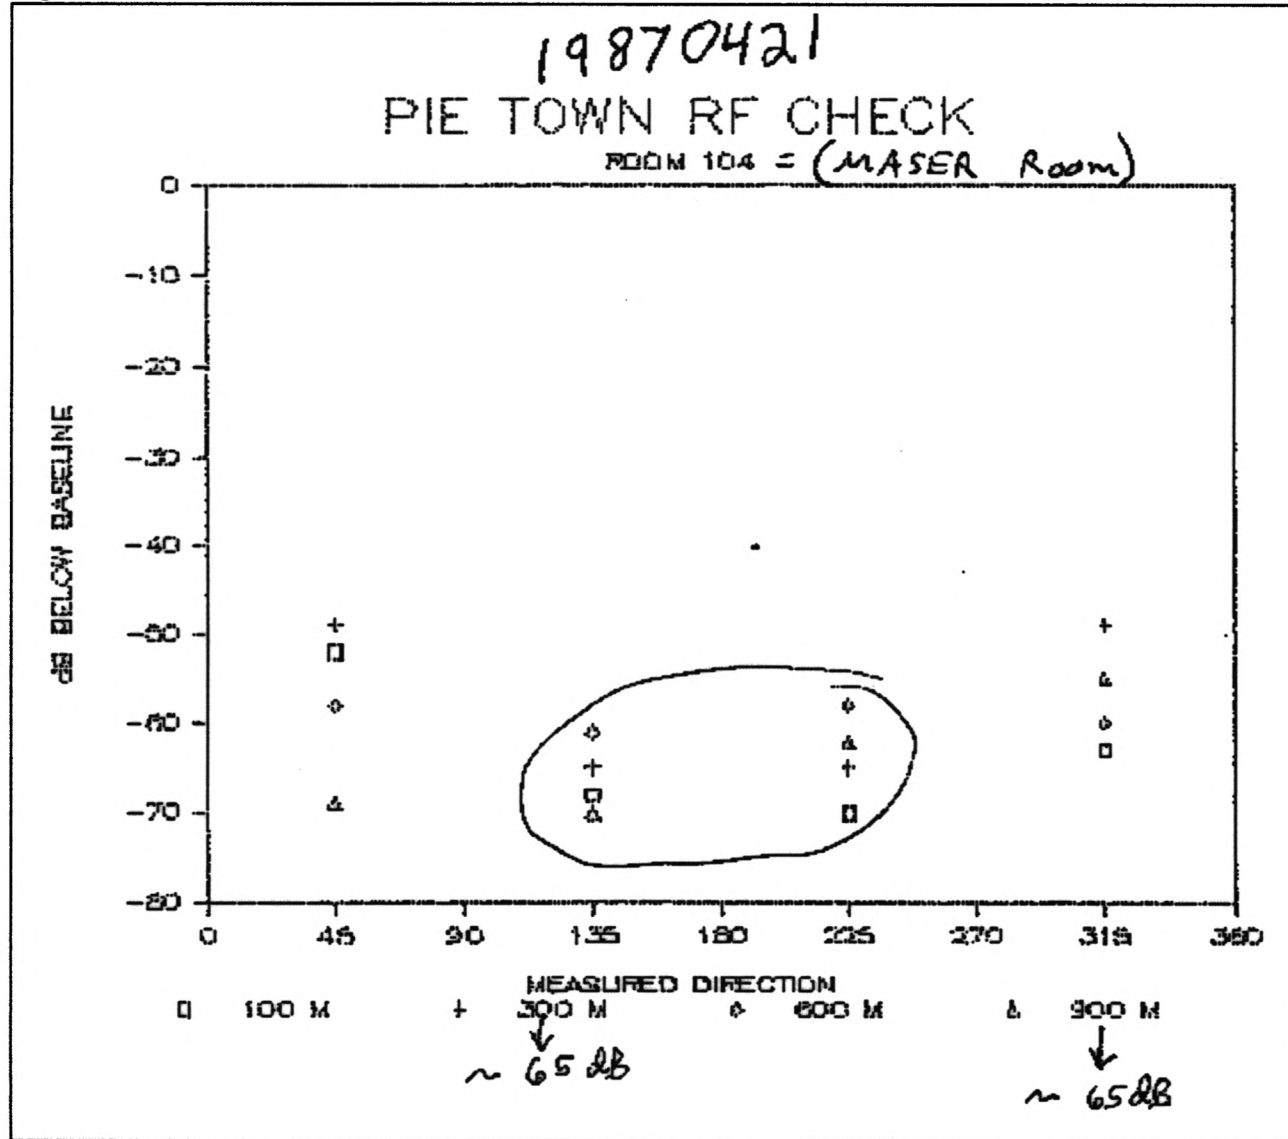
Figure 7: The 1987 Room 104 results.

The VLBA-PT station building shielding from room 104 (the LO/IF/MASER room), in the direction of each of the RX positions is presented in **Figure 6**. The 1987 results are displayed in **Figure 7**.
