National Radio Astronomy Observatory VLBA Antenna Memo Series – No. 104

TRIP REPORT – FORT DAVIS, FEBRUARY 14-17, 2023
ANTENNA INSPECTION AND GEARBOX INSPECTION

A group from the VLA traveled to the Fort Davis, TX VLBA station (FD) to perform an overall antenna inspection to include tear down of an azimuth and an elevation gear box and site inspection. Some observations were made for planning of future work activities.

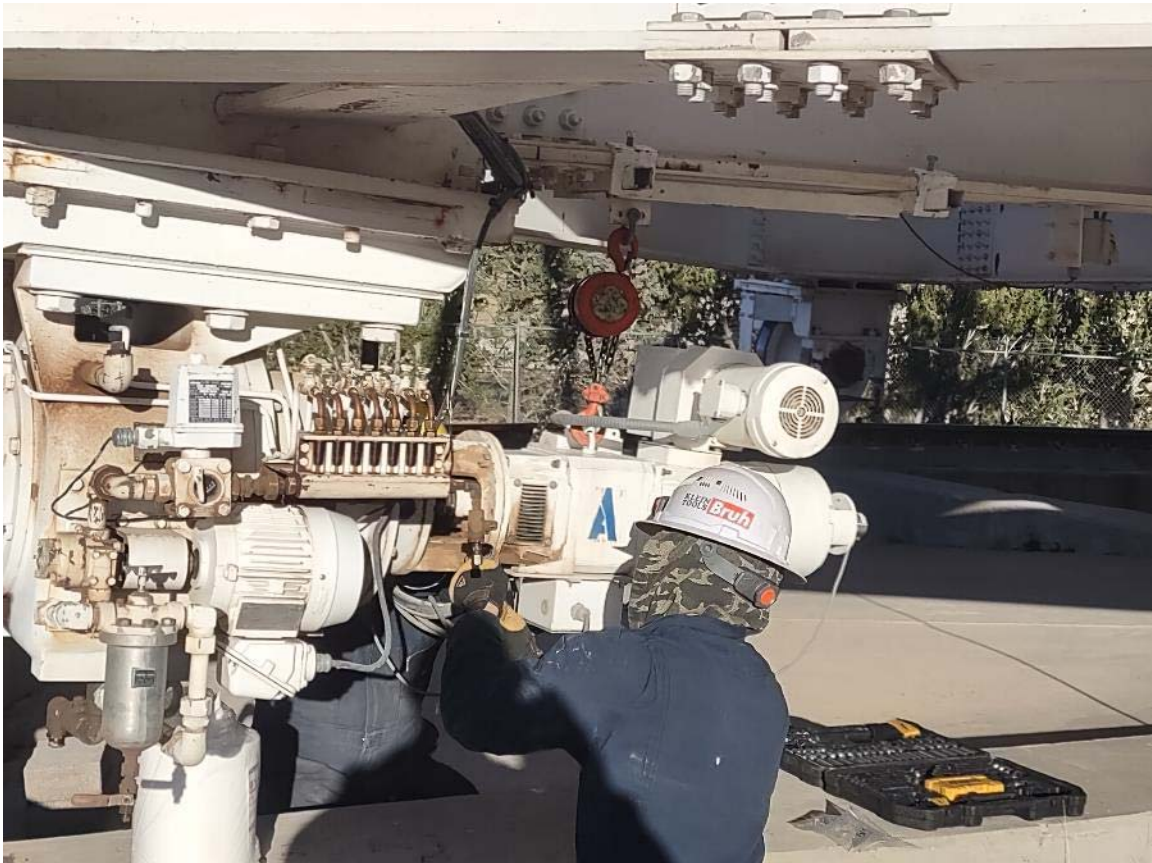
Met the site technicians and got acquainted. Got a tour of the control building. Mechanics rebuilt brake assembly on azimuth gear box #2. Gear box tear down commenced for the same #2 unit. Inspection of gear wear is the intent of tear down. This will provide information used by engineering for ordering replacement parts.

Figure 2: Pat and Carlos utilizing motor-brake assembly lifting device during removal

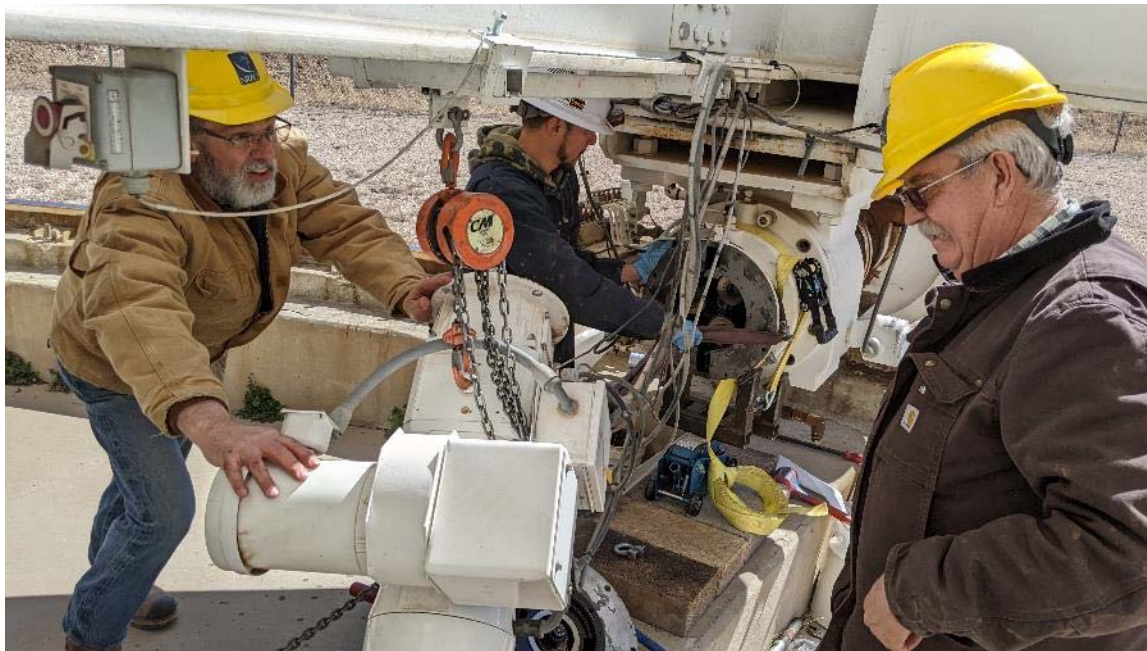
The mechanics had brought a small floor jack with a bracket attached for use in removing the second housing from the gear box assembly. Some on-site rigging was required to pull on the housing to get it to come loose. One end was attached to a pintle bearing housing bolt and the other was attached to the gear box housing. Better rigging could be utilized in the future for this task. See Figure 3.

Figure 3: Rigging around motor assembly to pull off second motor housing.

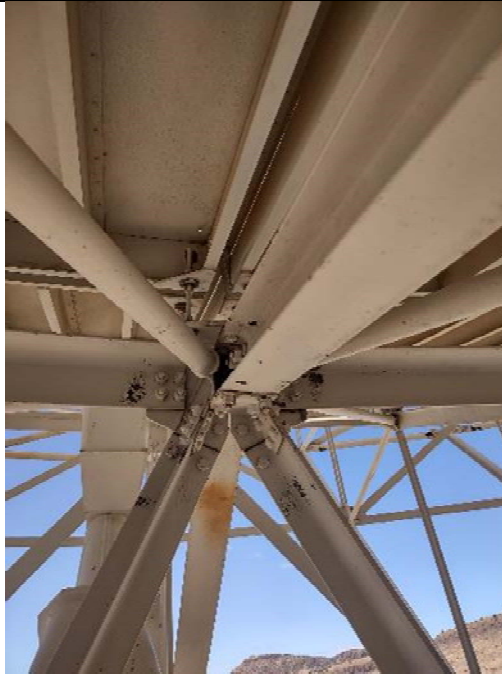
The dish backup structure was inspected for corrosion and cracks. Access was assessed to tiers 1, 2 & 3 to the dish panel rivets for use in planning Mauna Kea, HI future panel replacement work. See Figures 10 & 11.

Figure 10: Dish Backup Structure Inspection

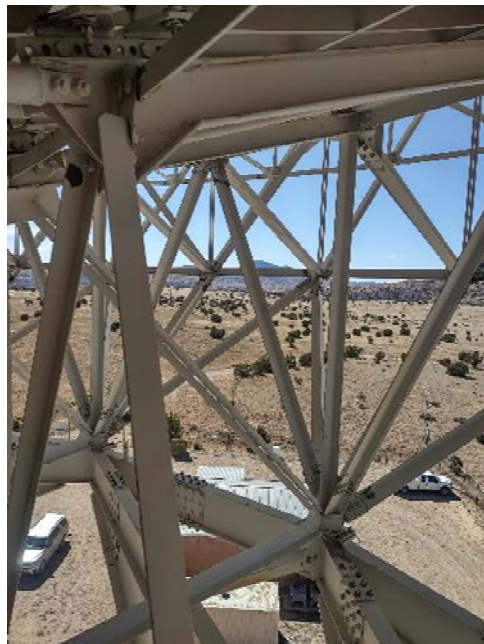
Figure 11: Dish Backup Structure Inspection
