VLBA Antenna Memo Series No.14

**Brewster Maintenance Visit, August 17 - 22, 1998 - Trip Report**

J. E. Thunborg  
September 10, 1998

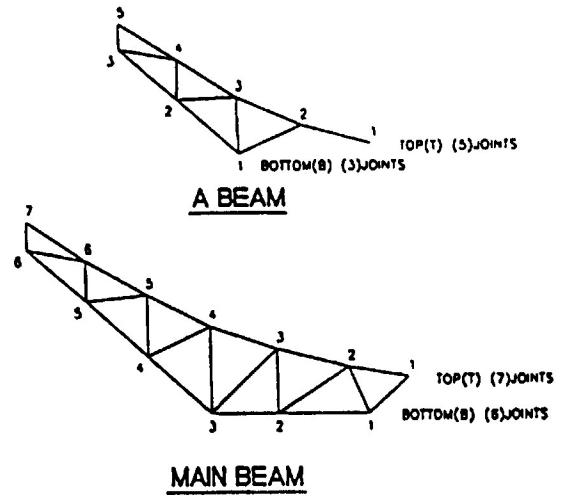
JOINT LISTING REQUIRING REPAIR  
(NOT INCLUSIVE)

*1/4 - 3/4"  
PAINT PEELS*

- ANGLE PEELING
- WF BEAM AROUND VERTEX TOUCHUP
- SMALL RUST SPOTS

NOTE: INSPECT CONE ASSY. INTERNALLY  
REPAIR/PAINT AS REQUIRED

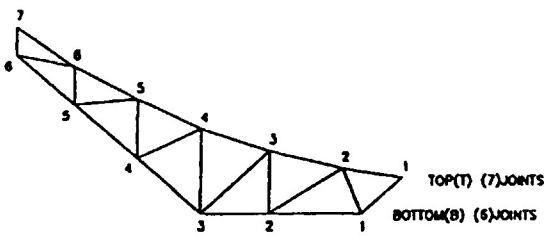
**MAIN BEAM**

**JOINT LISTING REQUIRING REPAIR  
(NOT INCLUSIVE)**

- \* ANGLE PEELING
- \*\* WF BEAM AROUND VERTEX TOUCHUP
- \*\*\* SMALL RUST SPOTS
