VLBA Antenna Memo Series No.22

**Hancock, New Hampshire- Maintenance Visit, June 22 - 28, 1999 - Trip Report**

J. E. Thunborg  
September 2, 1999

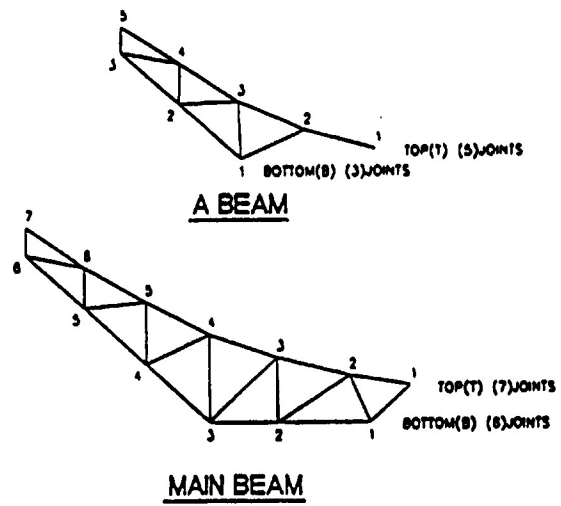
JOINT LISTING REQUIRING REPAIR  
(NOT INCLUSIVE)

*Pretty Good  
A few Missed spots*

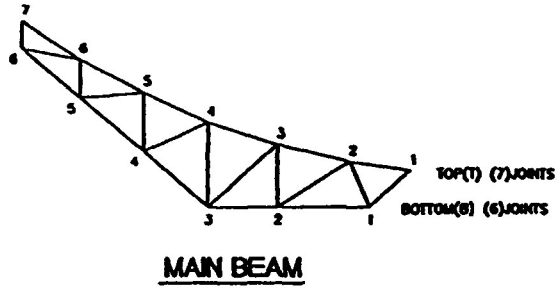
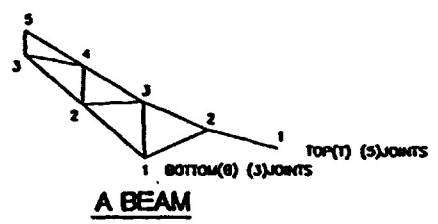
JOINT LISTING REQUIRING REPAIR (NOT INCLUSIVE)					
BEAM #	BOTTOM	TOP	BEAM #	BOTTOM	TOP
1			11		
1A			11A		
2			12		
2A			12A		
3			13		
3A			13A		
4			14		
4A			14A		
5			15		
5A			15A		
6			16		
6A			16A		
7			17		
7A			17A		
8			18		
8A			18A		
9			19		
9A			19A		
10			20		
10A			20A

- \* ANGLE PEELING
- \*\* WF BEAM AROUND VERTEX TOUCHUP
- \*\*\* SMALL RUST SPOTS
