VLBA Antenna Memo Series No. 75

**St Croix Maintenance Trip Report**  
**October 27 - November 14, 2008**

J. E. Thunborg  
December 18, 2008

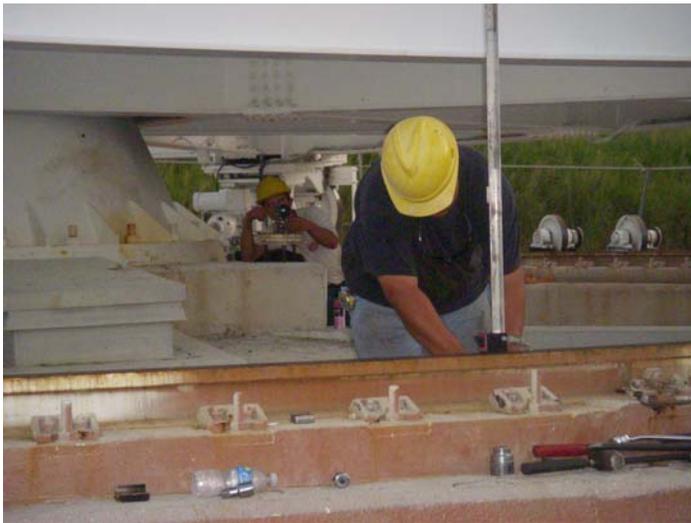
St Croix Az Rail Elevations  
First Order Tilt Removed

The azimuth rail was measured. As can be seen in the chart above, a low spot was developing at bolt number 119. This spot was repaired by installing shims between the rail and the splice plate. These shims should be monitored on subsequent maintenance visits to ensure that they do not initiate corrosion under the rail. A 0.080\"/>

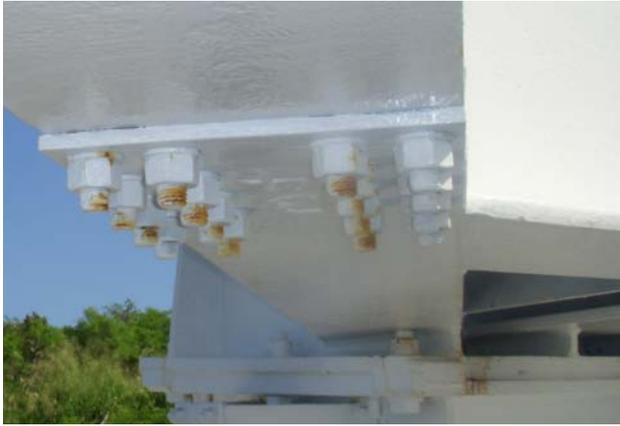
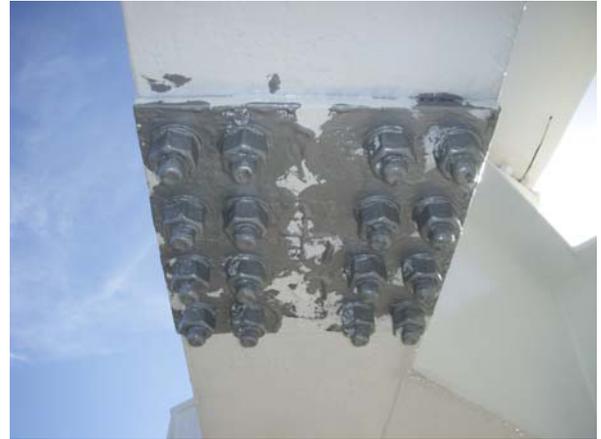
Some of the rust stained bolt heads and nuts were also painted by brush to inhibit further corrosion. Additional stripe painting of bolt heads and nuts should be performed in the near future to deter further corrosion.
