NATIONAL RADIO ASTRONOMY OBSERVATORY
Socorro, New Mexico

VLBA Antenna Memo Series No.90

2015 - St Croix Corrosion Report

J. E. Thunborg
August 12, 2015

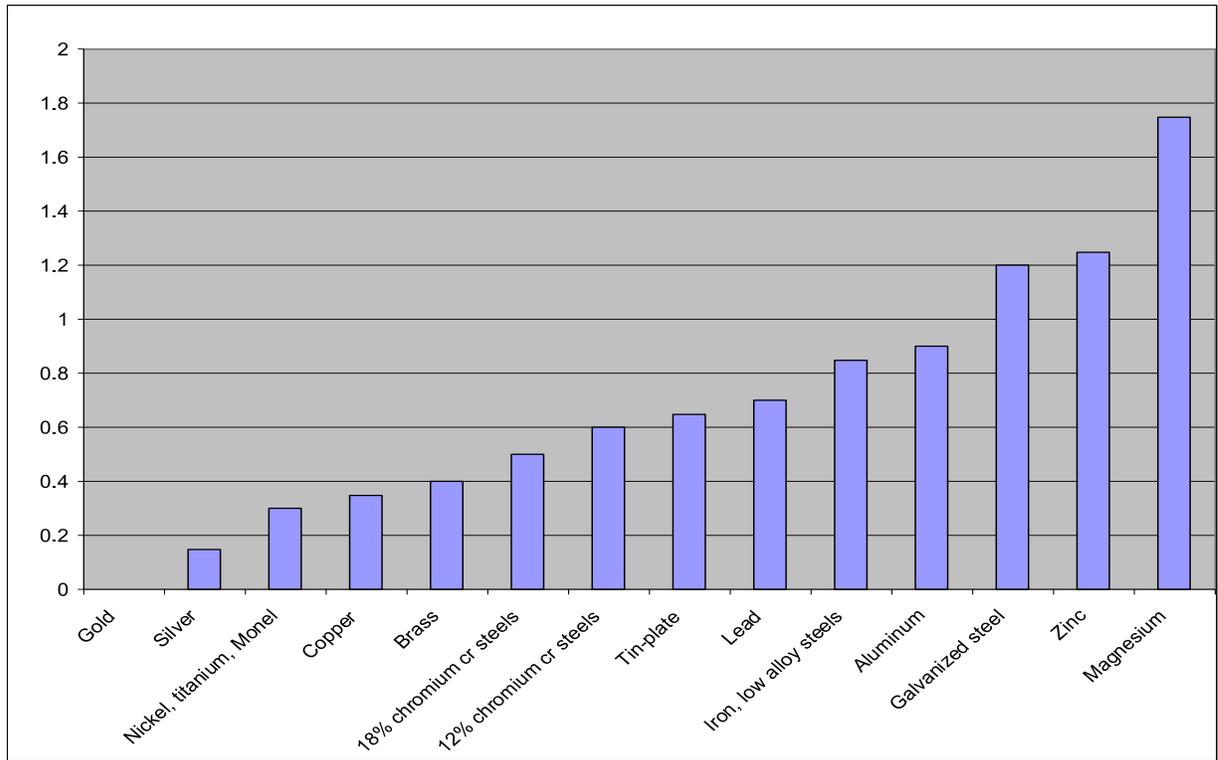
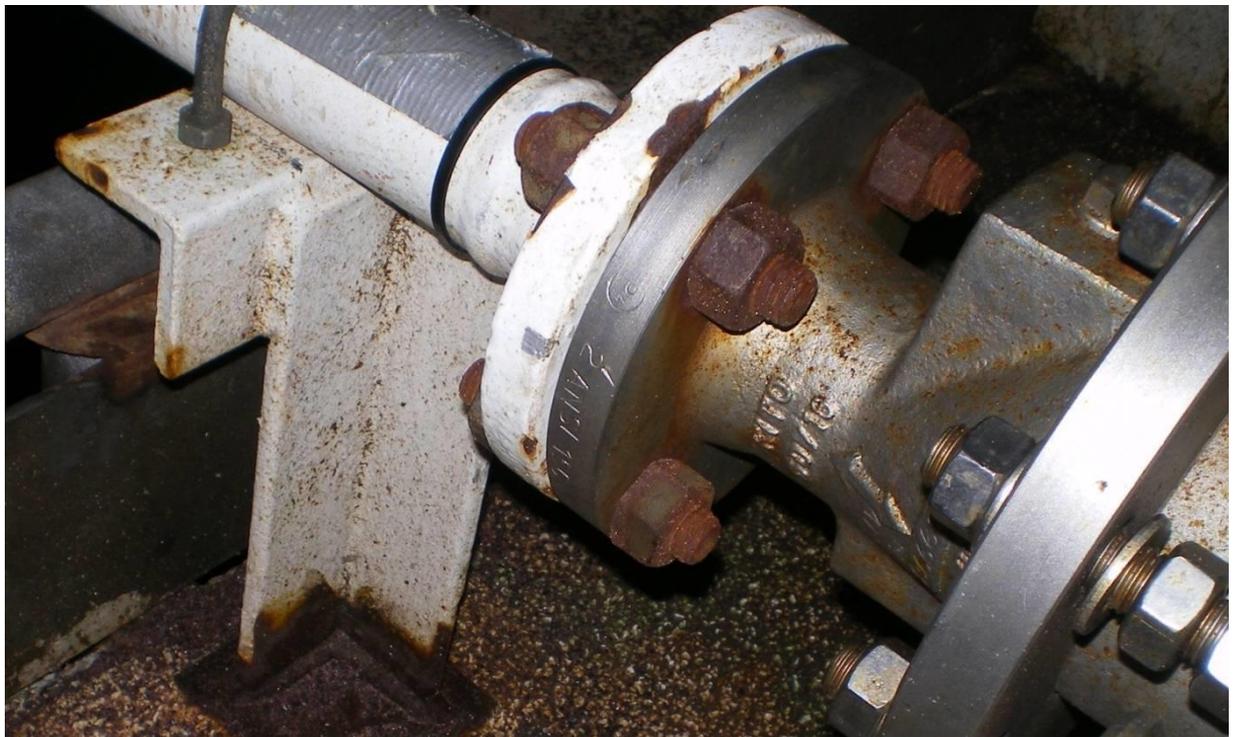
Now that we have established a context, let us look at the photograph (Figure 1). This is just one of a million pictures I could show you where design and construction of an assembly are creating unnecessary corrosion problems – and making remedial treatment extremely difficult. The photo shows a section of pipework constructed from a combination of low and high alloy steels, with a central section where a low-alloy steel flange is connected to a high-alloy flange using low-alloy bolts and nuts – all supported by pieces of welded angle iron. It may surprise you to learn that this structure is less than two years old.

Figure 1: corroding low-alloy bolts in contact with high-alloy components

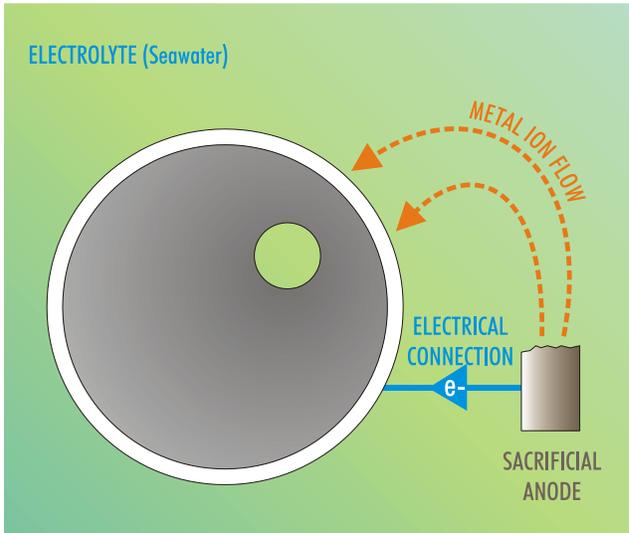
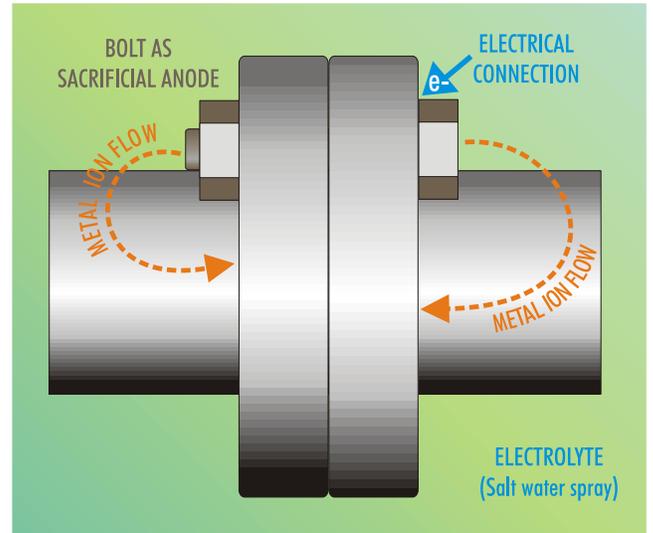
As you can see in Figure 2, small, low-alloy bolts play the same role in a bolted system as do the sacrificial anodes in a CP system.

Figure 2: comparison between bolt as a sacrificial anode and CP system

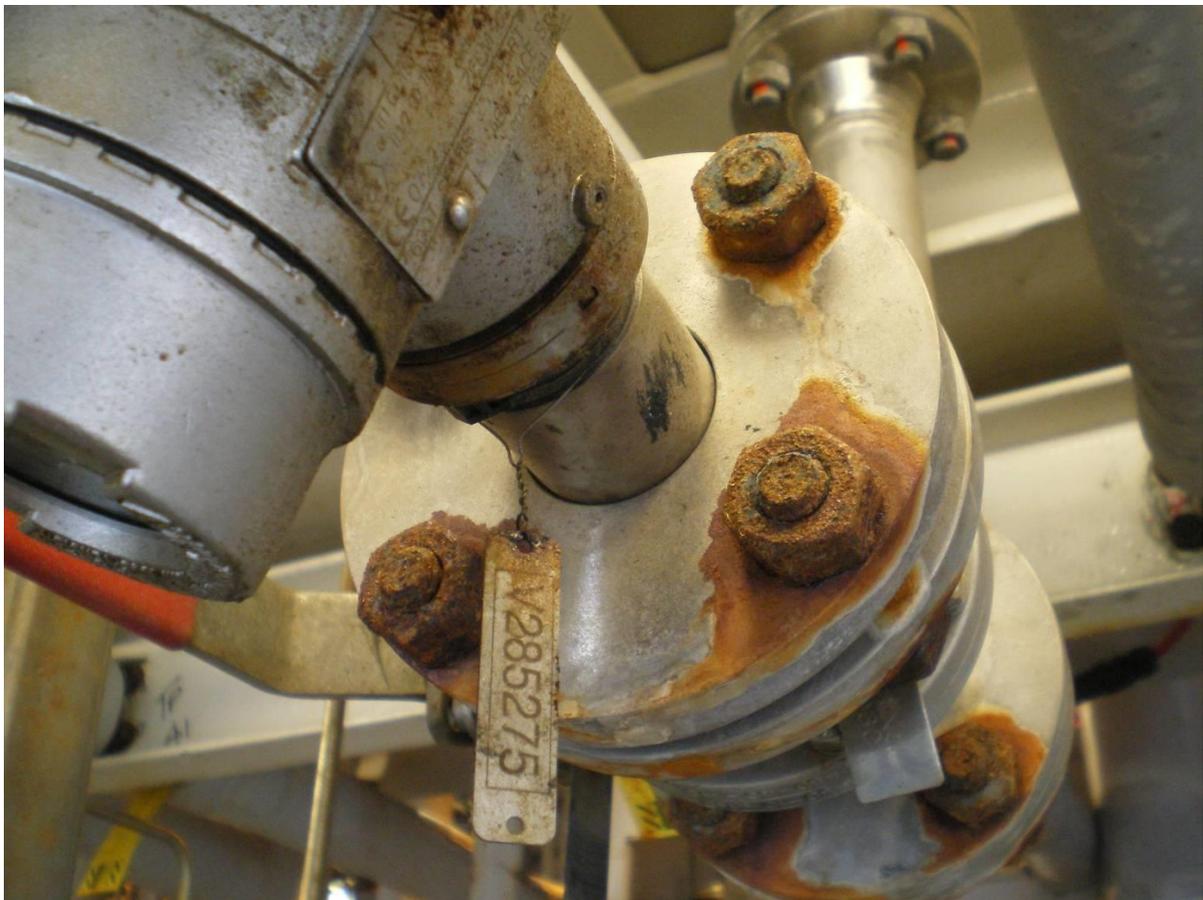
We have already seen that coating damage can lead to corrosion on the flange surfaces. In nuts and bolts too, assembly can cause damage and penetration of the coating leading to corrosion. Figure 3 shows a nut after only 18 months in the splash zone, its ptfе and zinc plating failing within 6 weeks of exposure.

Figure 3: salt spray affected low-alloy bolts in high-alloy substrate

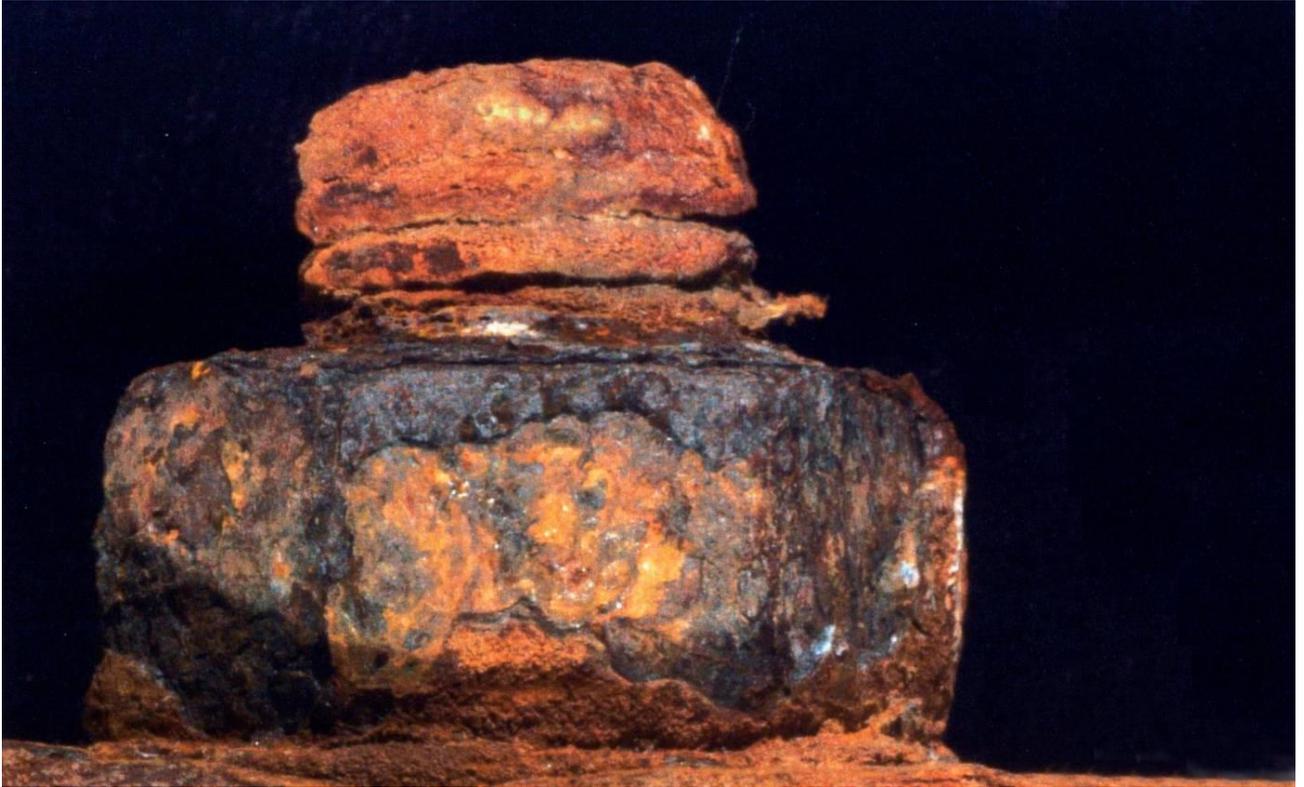
However, 1000 hours is only 6 weeks. In the real world, the fasteners in Figure 4 have been exposed to constant salt-spray conditions for eighteen months.

Figure 4: failed PTFE/nickel plated low-alloy nut and bolt after 18 months in splash zone

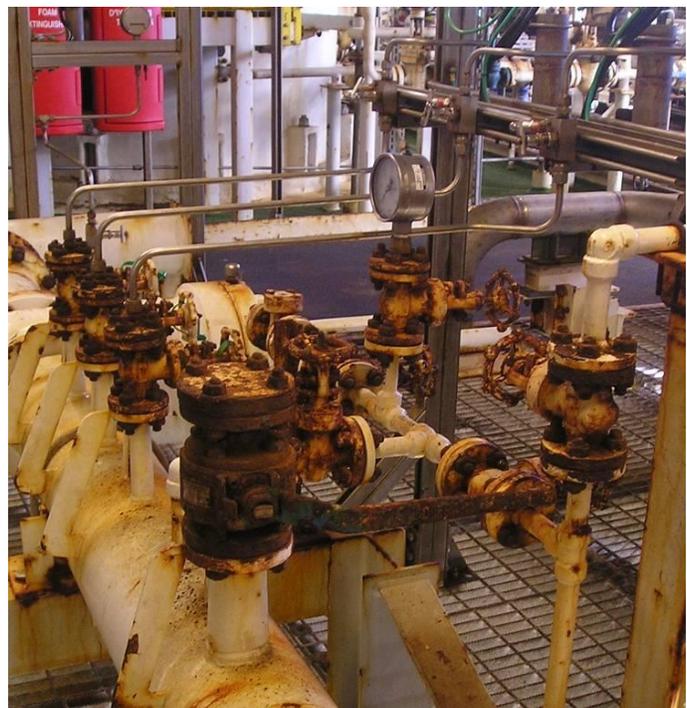
CIST has been successfully applied since 2003 in the North Sea for the protection of prematurely rusting bolts (Figure 8). Severe corrosion was experienced in systems that had been expected to last many years using ptfе-coated, zinc-plated low-alloy bolts. Anecdotally, the failures were ascribed to attrition of the zinc plating during the ptfе coating process and subsequent damage to the outer coating during assembly exposing the vulnerable bolt substrate.

Figure 8: rusting flanges on a North Sea platform

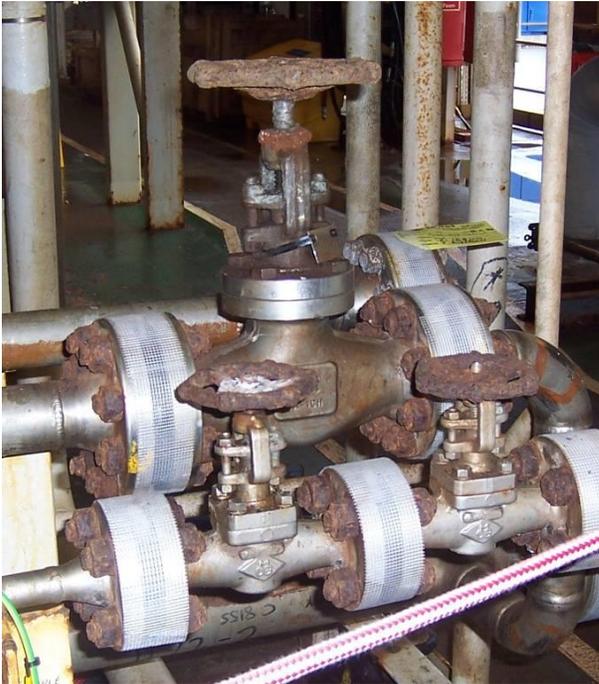
Figure 9: typical substrate prior to application

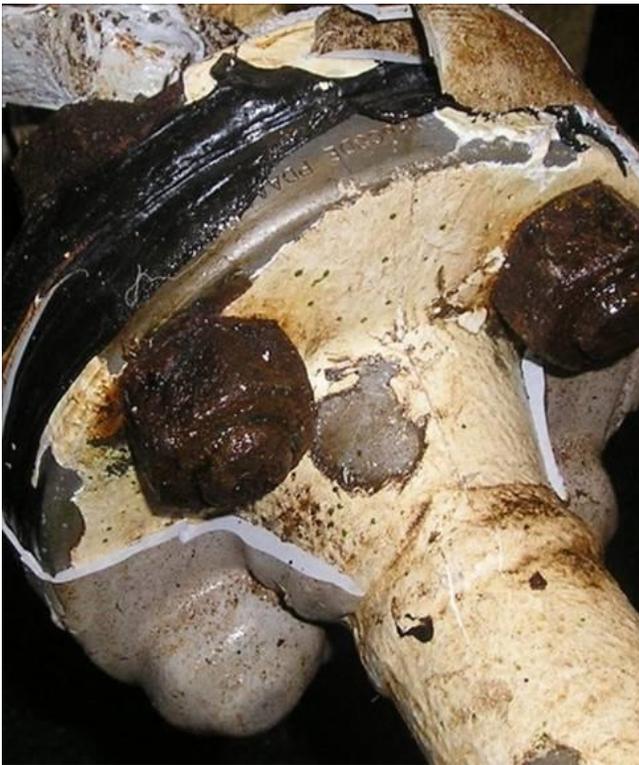
Figure 11: after 2 years oil-soaked substrate shows no further corrosion 7 years with CIST

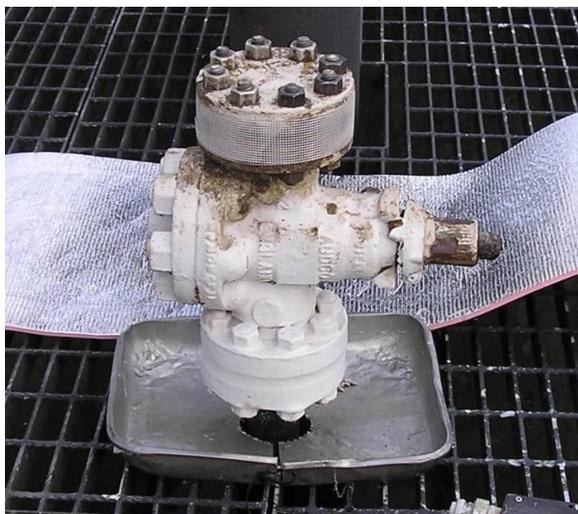
Fig 13: Bacton test prior to application 2005 substrate

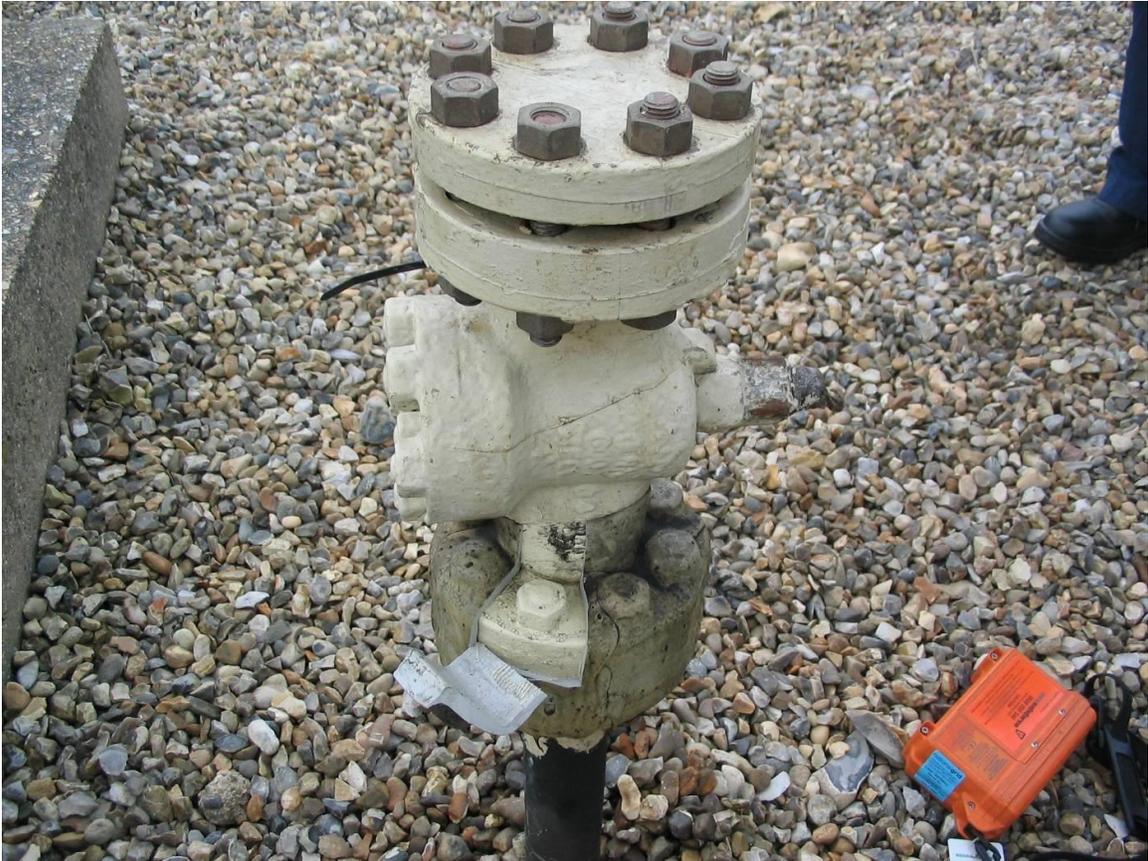
Figure 15: Bacton test substrate after removal in 2009

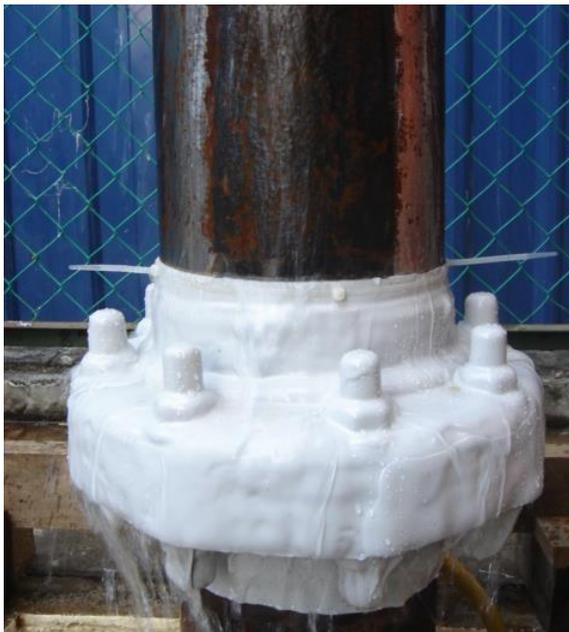
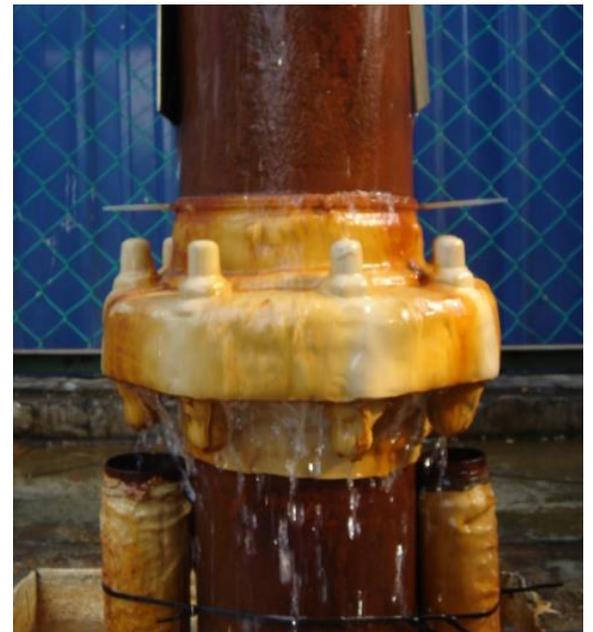
The susceptibility of low-alloy steel assemblies to the corrosion effects of salt water is well documented. In this test, shown in Figures 16 and 17, a low-alloy pipe and flange is subject to a constant flow from a 20% saline mixture for 5 days a week for periods up to six months at 30°C.

Figures 16 & 17: Pipe at beginning of salt water deluge testing and after 2 months

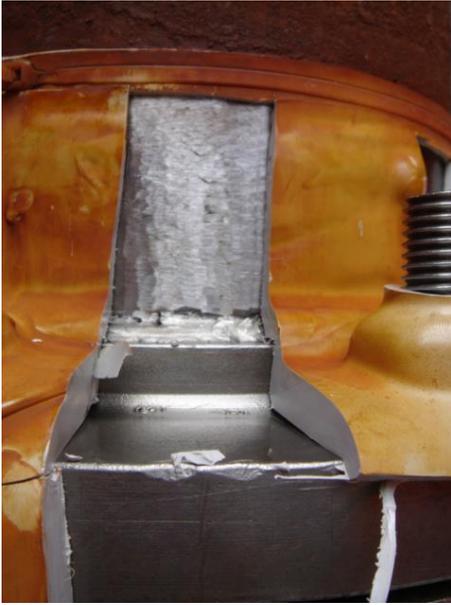
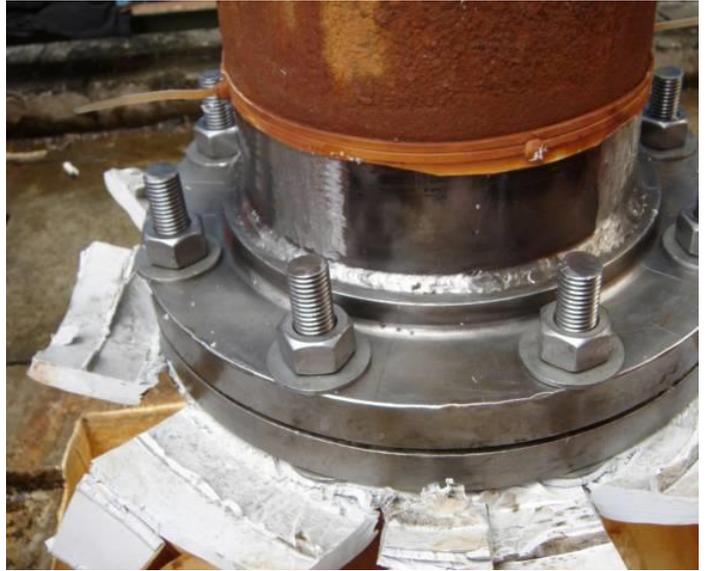
The flange is protected with CIST but the pipe remains unprotected. After 6 months the constant cycle of salt water and drying has corroded the unprotected pipe but within the CIST, as shown in Figures 18 and 19, the substrate remains completely untouched.

Figures 18 & 19: bare steel substrate show no sign of corrosion after 6 months
