National Radio Astronomy Observatory
VLBA Antenna Memo Series – No. 95
TRIP REPORT – HANCOCK, NH MAY 14-23, 2022
DUAL ELEVATION BEARING CHANGE

Trip Report – Hancock, NH VLBA Station
Dual Elevation Bearing Change and Failure Analysis

May 14-23, 2022

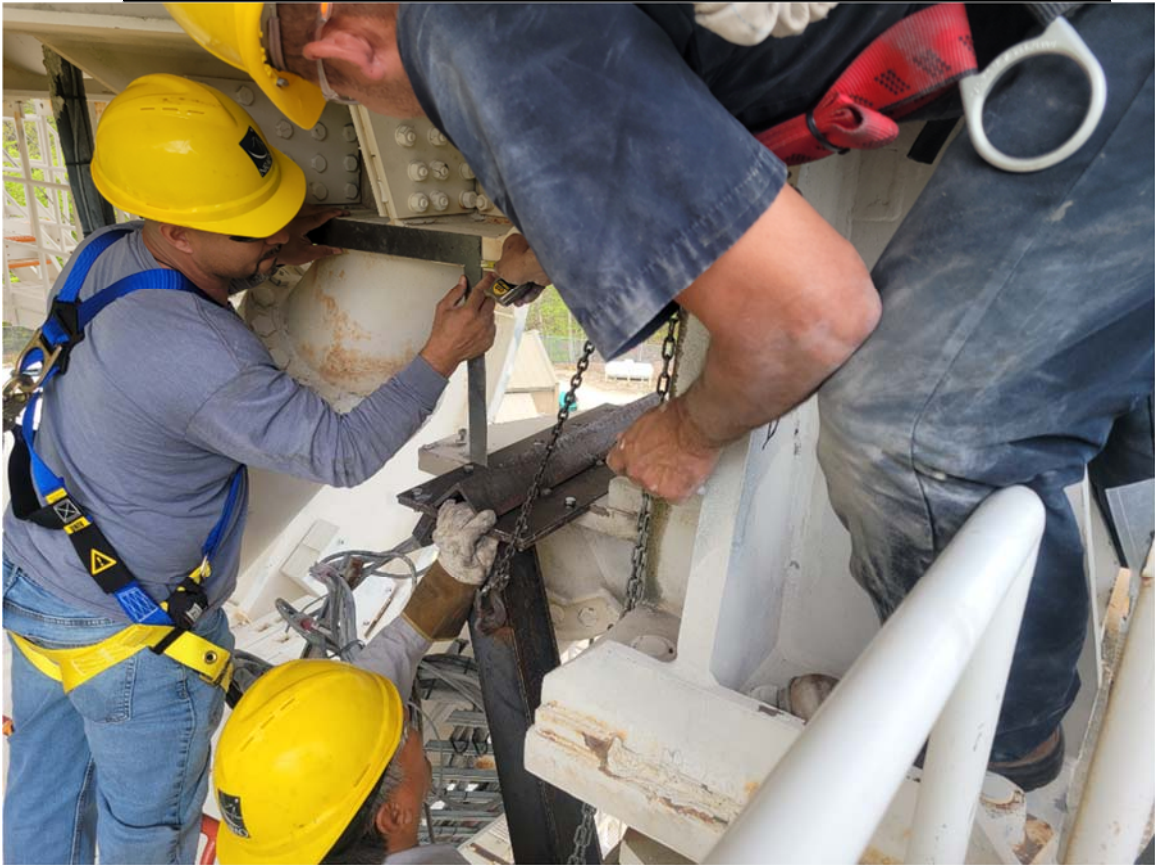
Figure 2: Scottin, Jason, and Patrick using the newly built template for marking the platform for drilling. Note that it is impossible to use it upside down.

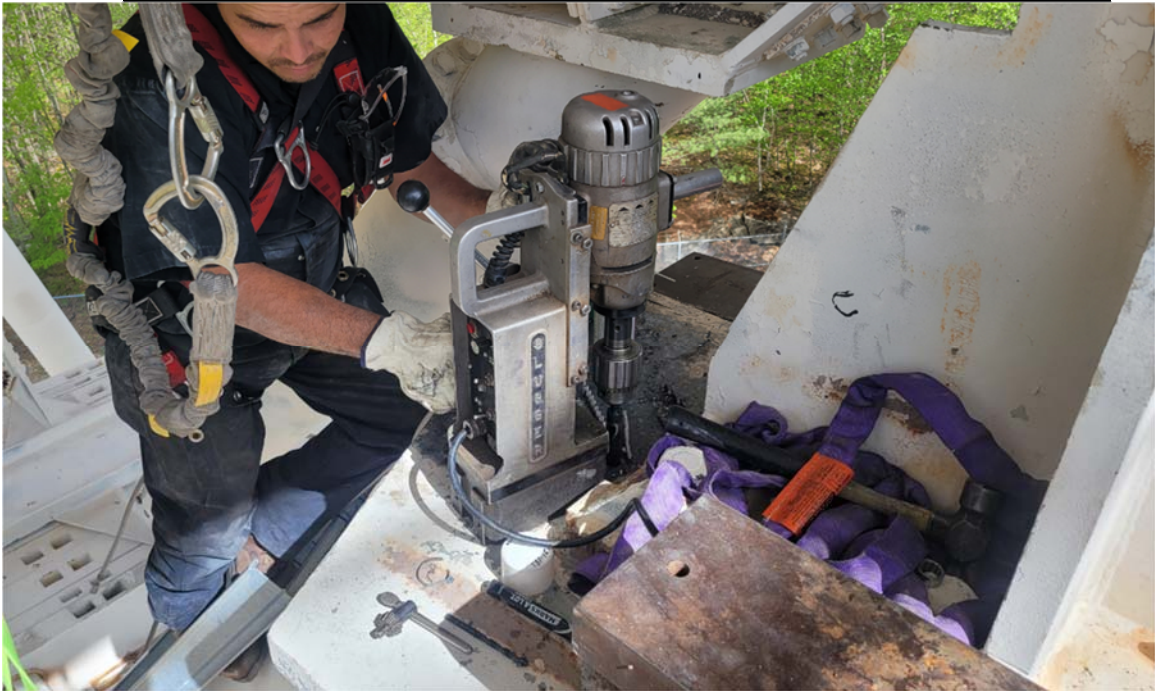
Figure 3: The encoder platform being drilled in preparation for installing the jack support beam.

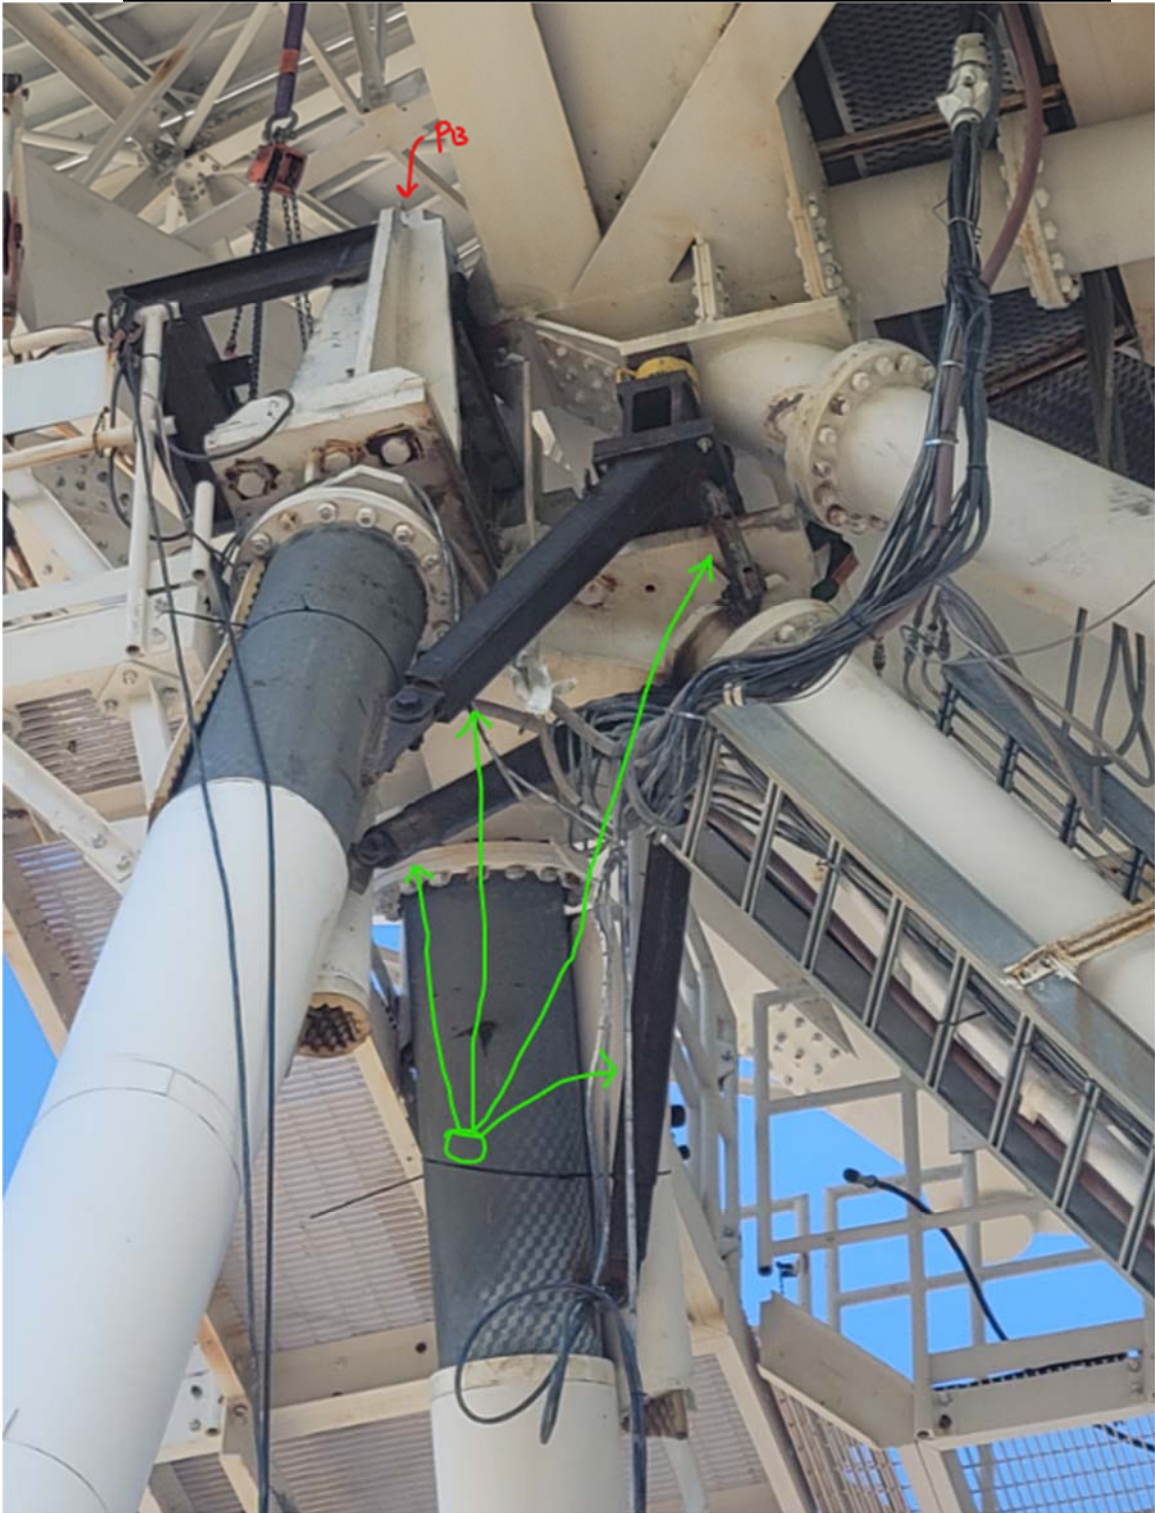
Figure 4: An annotated picture highlighting the pillow block, structural supports, jacks, and bearing puller fully installed.

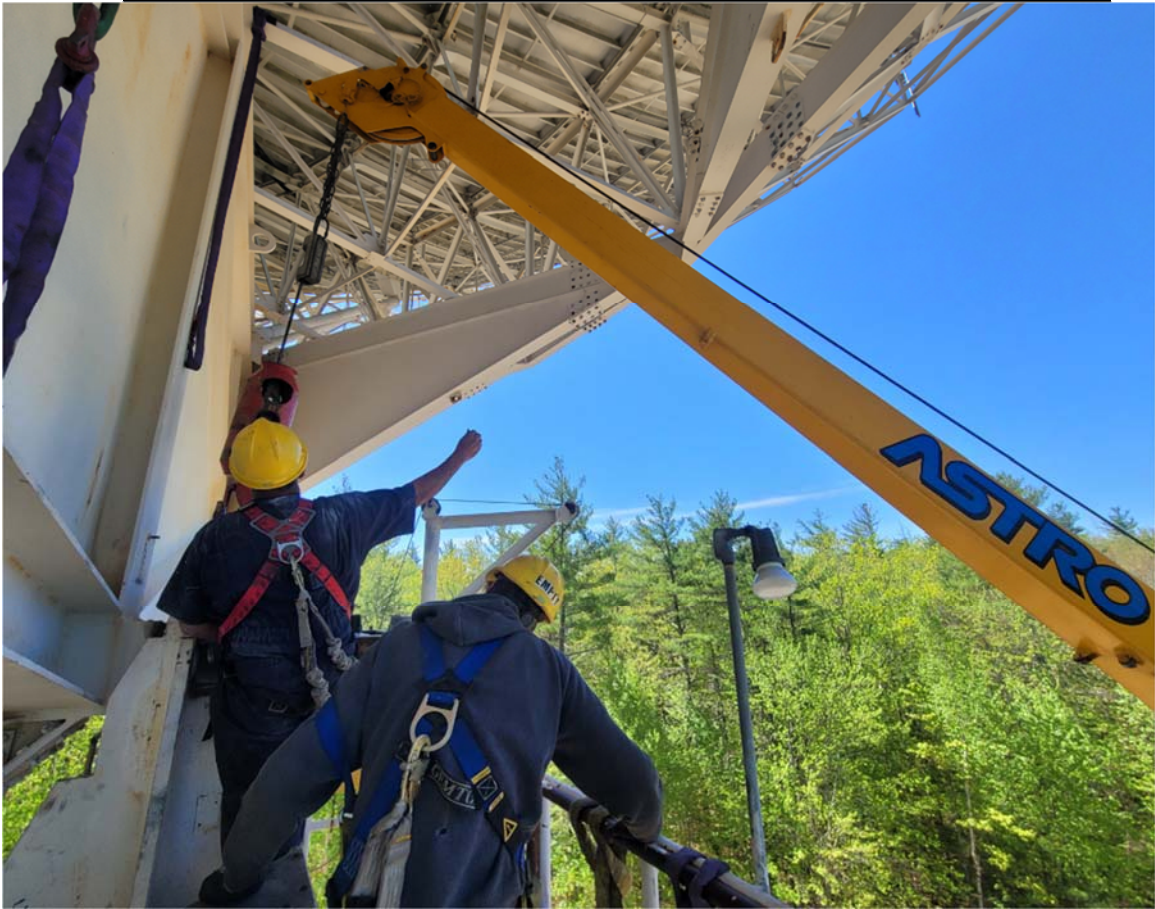
The dish was jacked up, pillow block unbolted, and removed from the antenna. The bearing was pulled from the block, it pressed out with relative ease. The bearing races were intact although one of the rollers had rotated sideways relative to the others. This block had spacers installed in front of and behind the bearing. The new bearing was pressed into place to rest against the rear spacer and the pillow block reinstalled on the platform. The reduction in clearance (RIC) was started late in the afternoon but was paused to finish the next morning.

Figure 7: Mechanics work with the crane operator to hoist the pillow block up and out of the antenna.

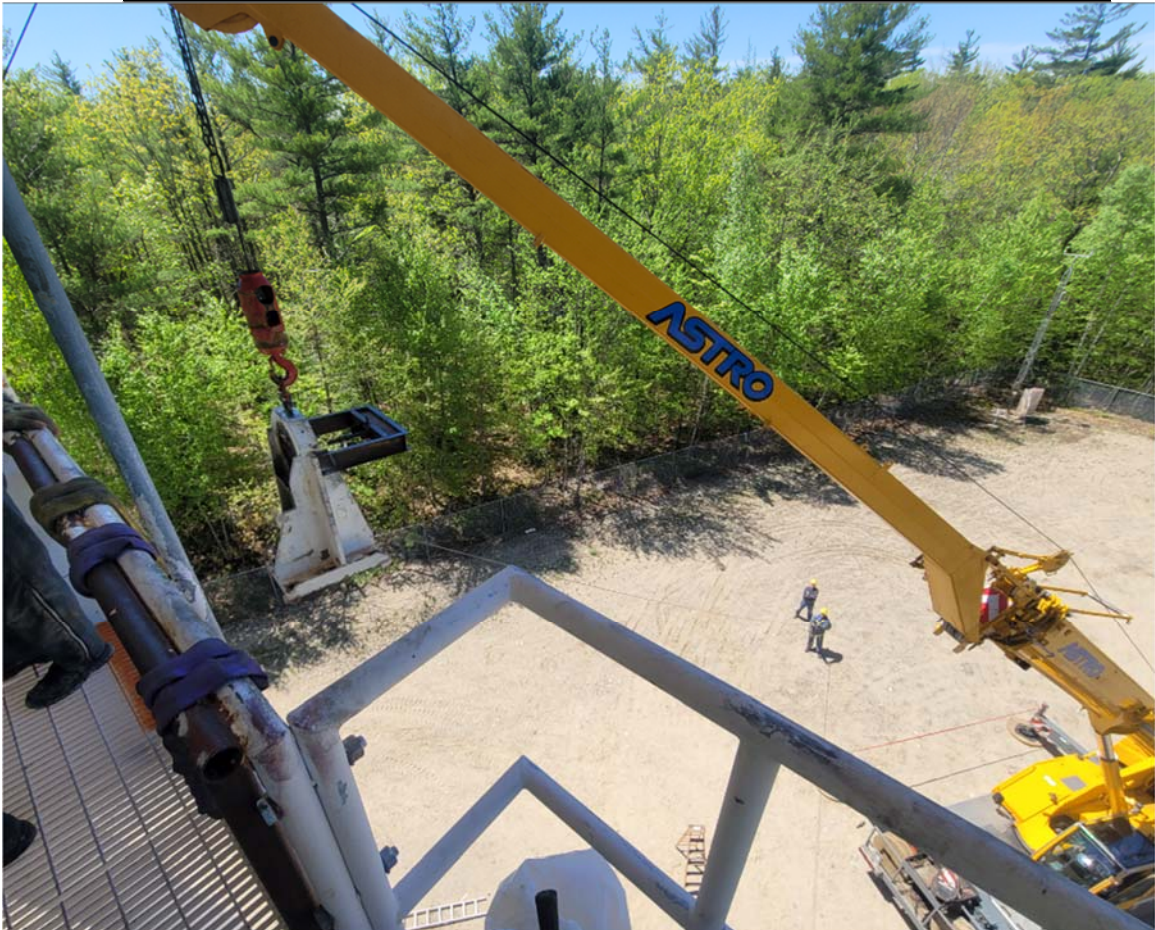
Figure 8: The pillow block being lowered from the platform. The crane operator showed 2700 lbs on the hook when the block was fully freed from the antenna.

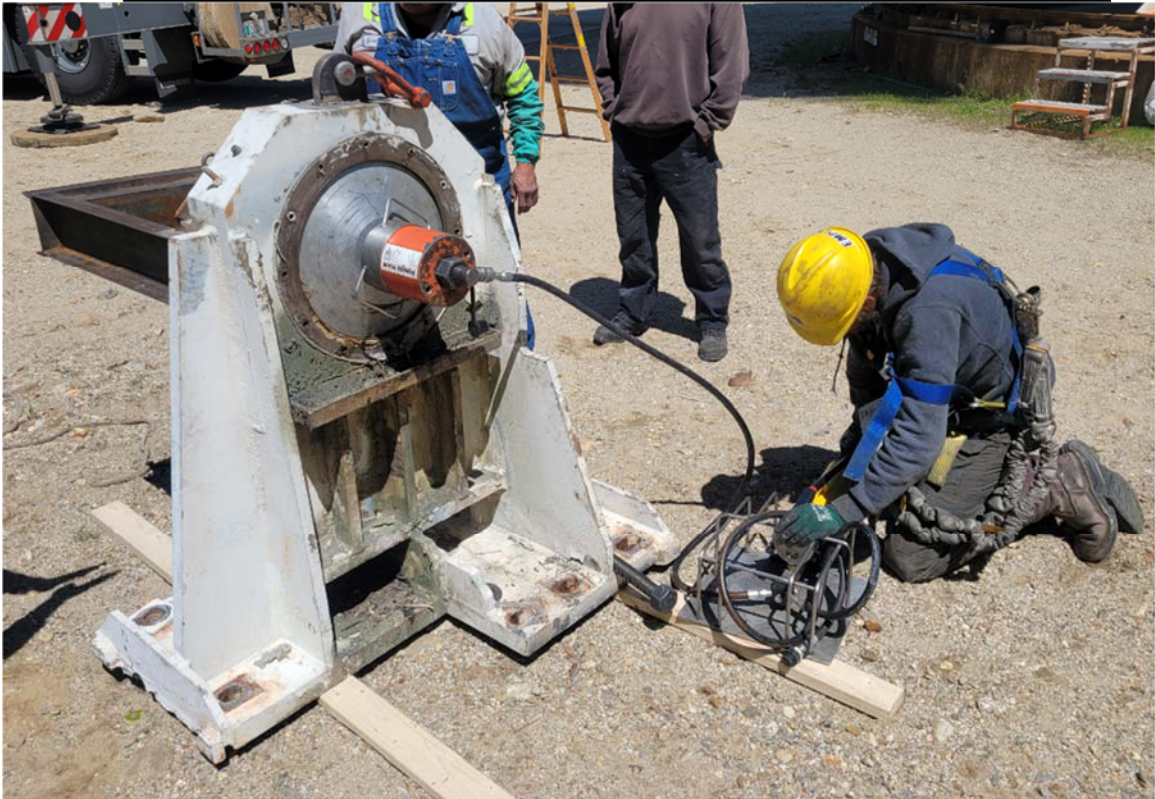
Figure 9: The bearing being pressed out of the block. The jack and pressure plate are used on the other side when pressing the new bearing into the block.

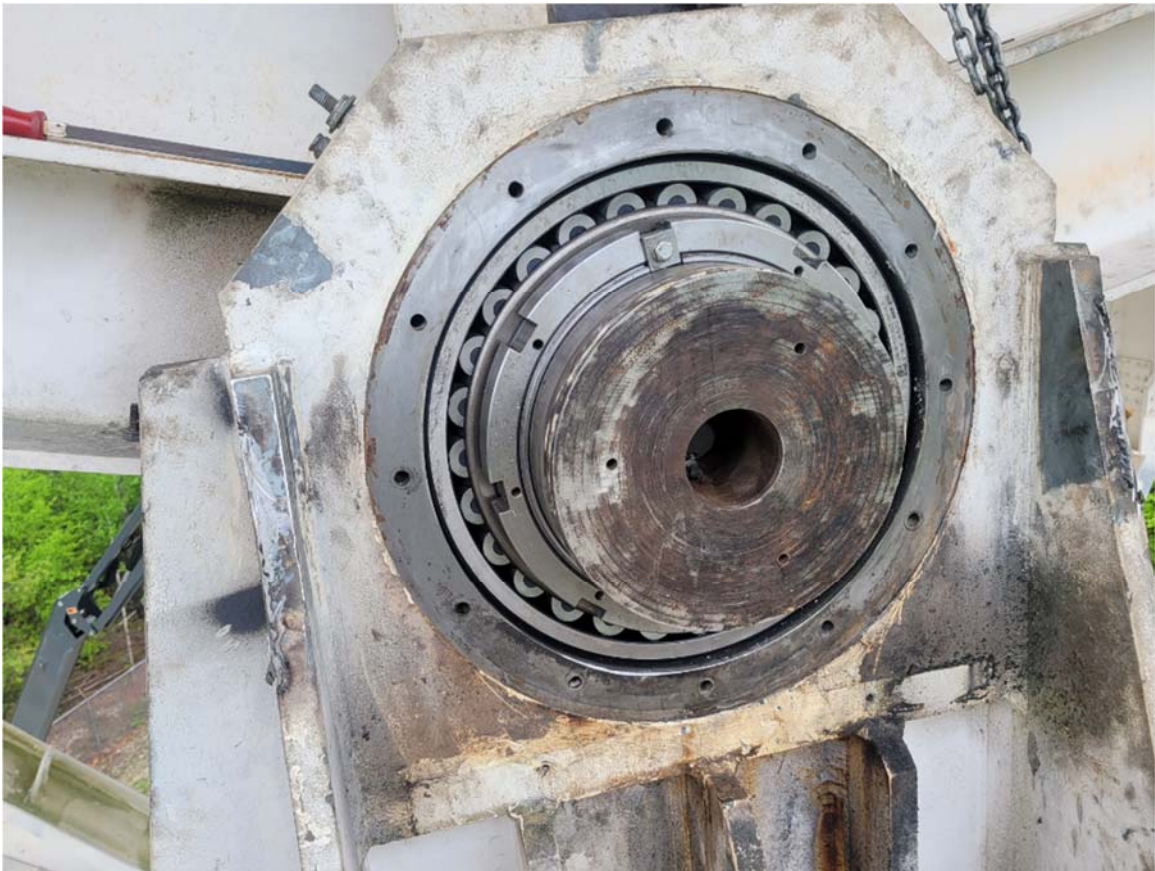
Figure 12: A newly installed bearing on the synchro side (before it had been greased.)

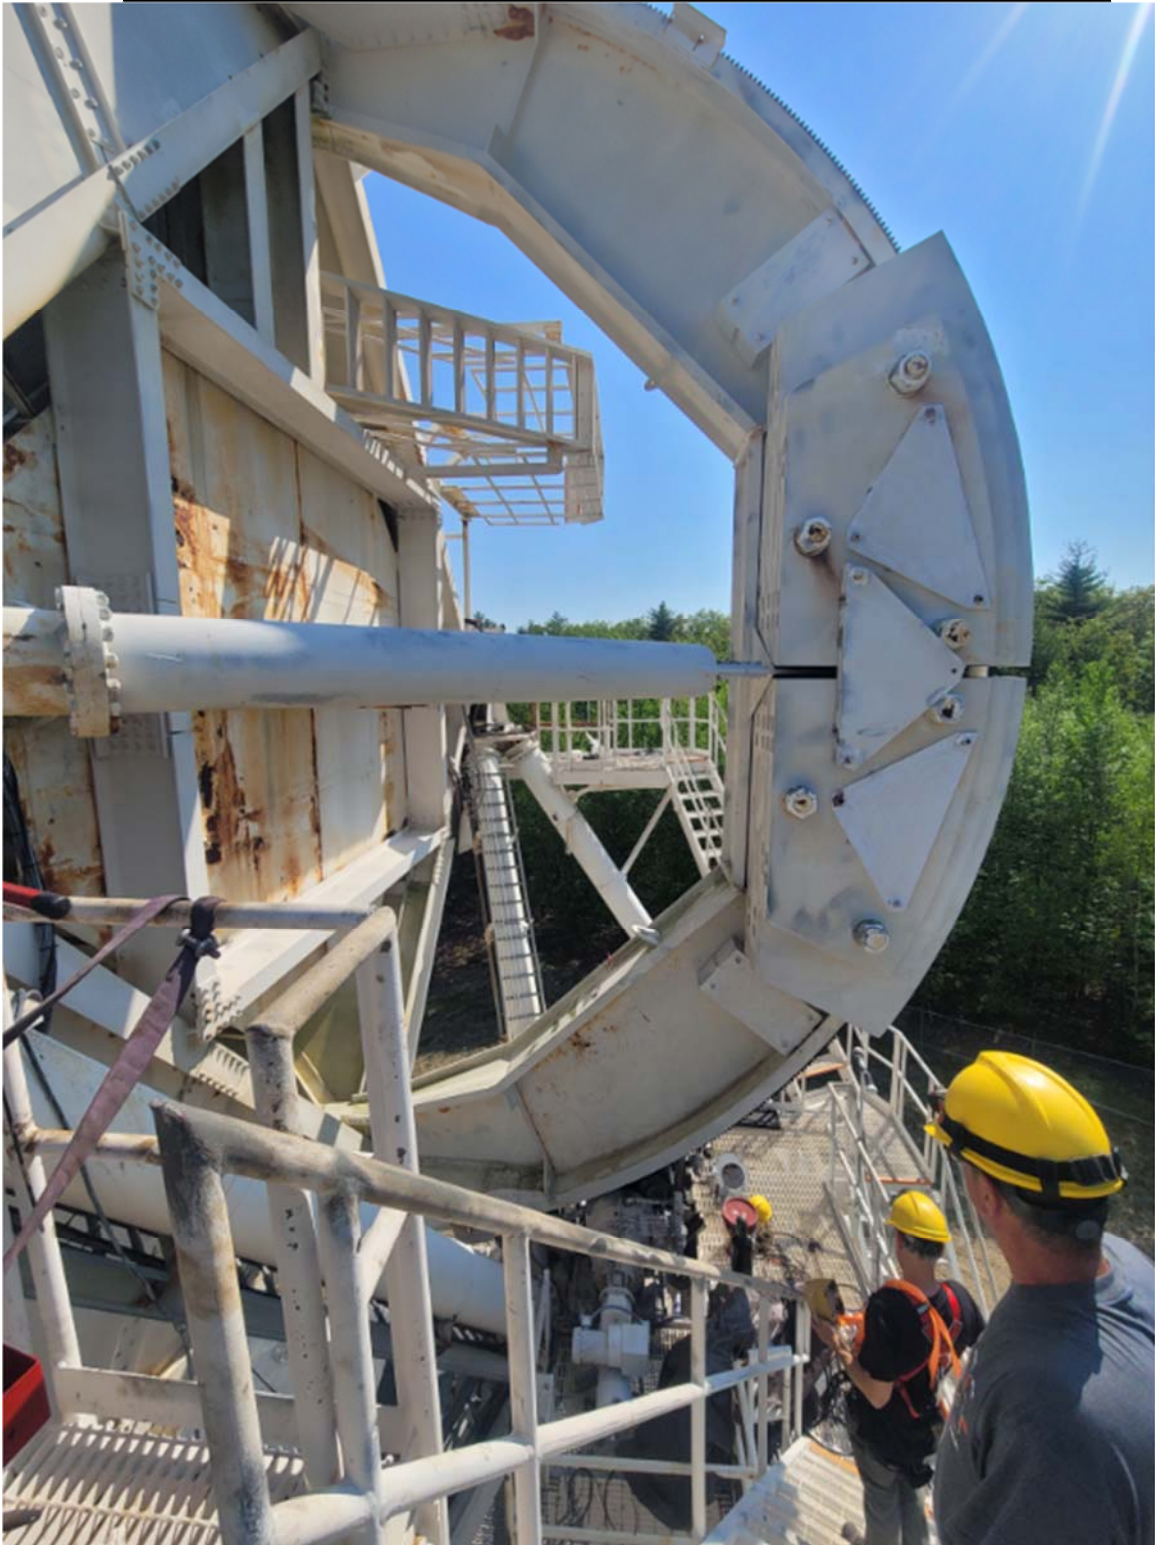
Figure 13: The dish was rocked back and forth repeatedly to ensure it was not making unusual sounds or movements.
