**NATIONAL RADIO ASTRONOMY OBSERVATORY**

VLBA Antenna Memo Series No.37

**Owens Valley Gearbox Repair**

J. E. Thunborg  
April 26, 2002

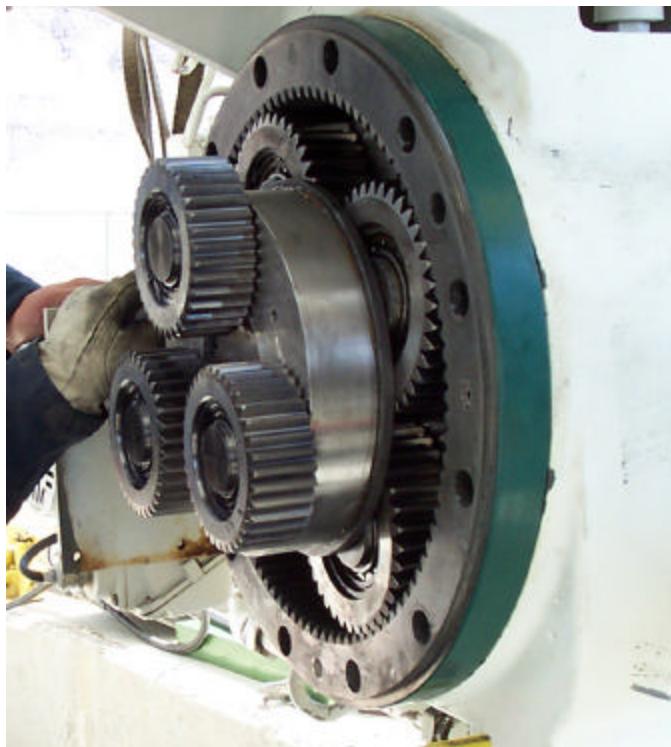
On April 4, 2002, The Owens Valley VLBA Antenna was removed from service because of frequent “azimuth current motor sums greater than 30 amps” errors. The motor current plots recorded during observations showed periodic current fluctuations of 5 - 10 amps amplitude and 2 hour period. After a complete check of the drive electronics, the site techs (Jim Brown and Bill Robins) used a ½ inch drill motor to power the antenna in Azimuth. They found that the antenna had tight spots where the drill motor did not have sufficient power to turn the antenna.
