National Radio Astronomy Observatory
Socorro, NM

VLBA Antenna Memo Series #40

St Croix Maintenance Visit
April 8th through 25th, 2002

Jim Ruff
6/24/02

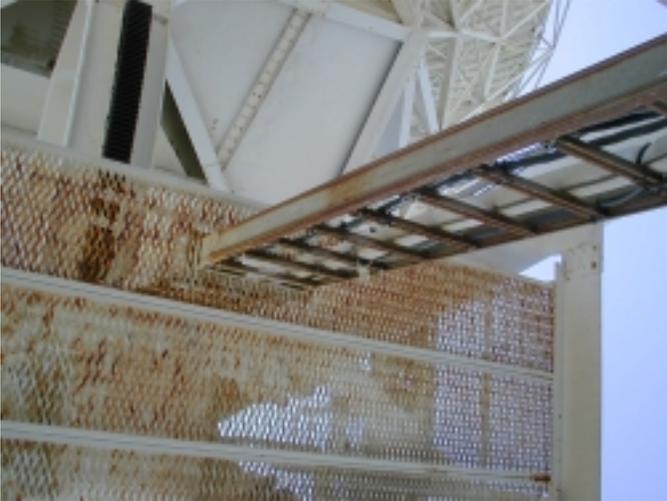
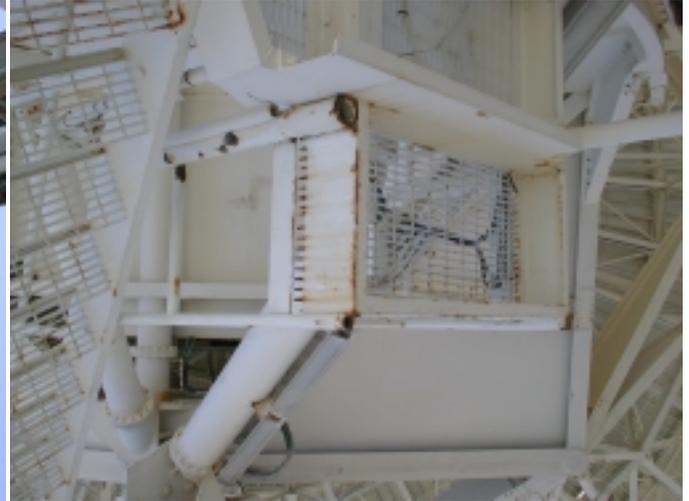
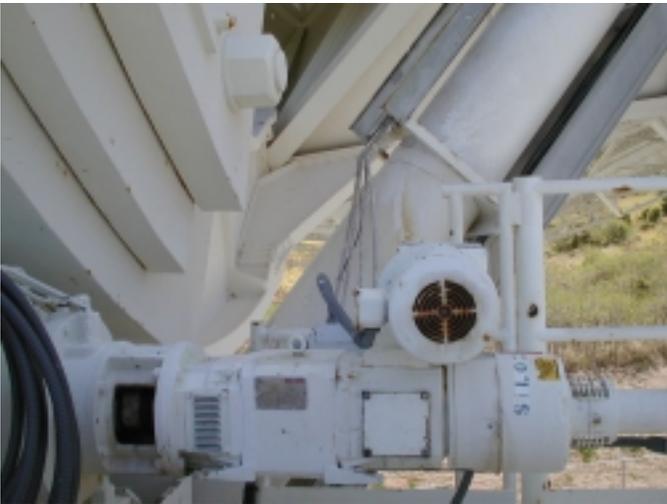
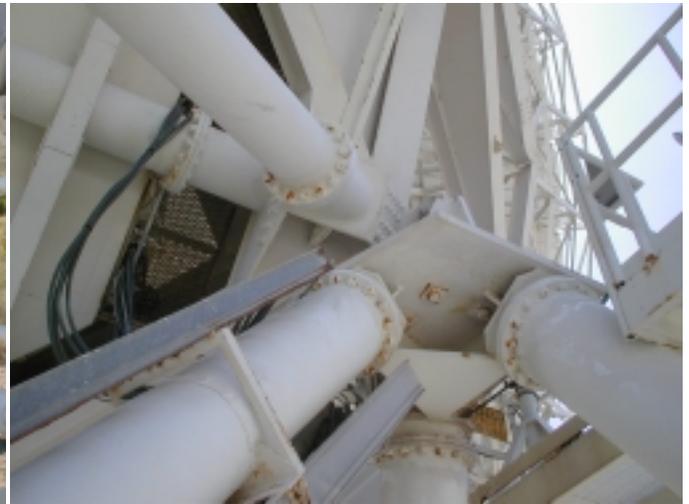
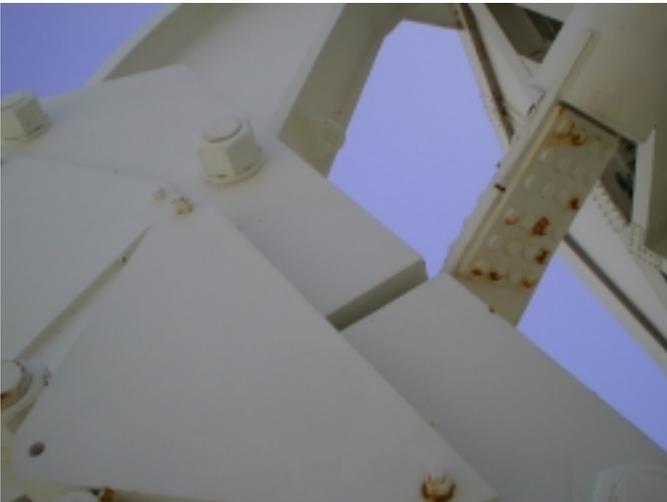
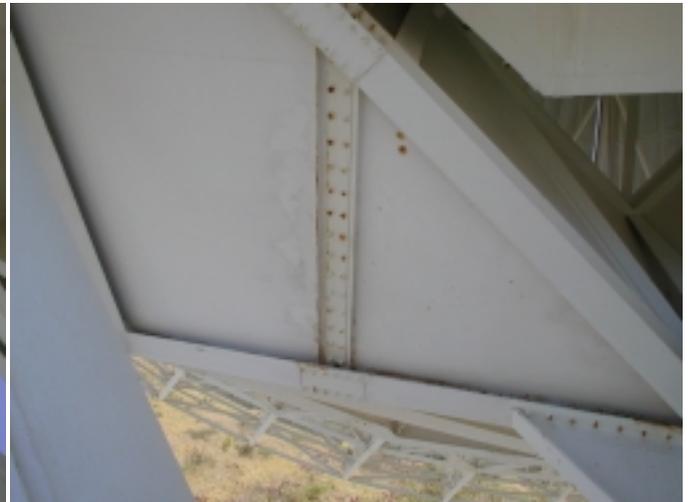
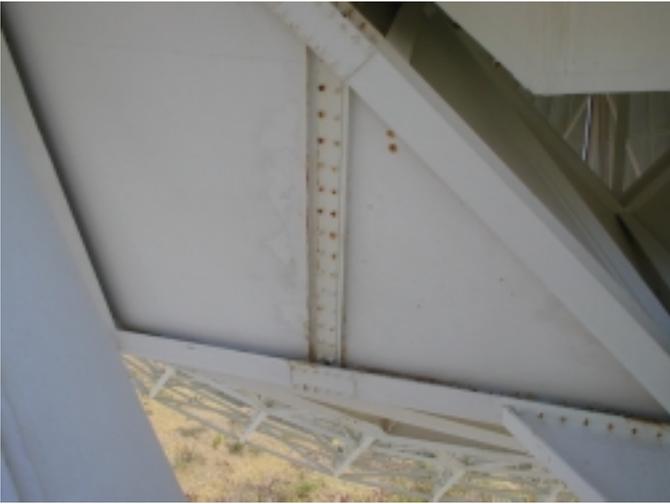
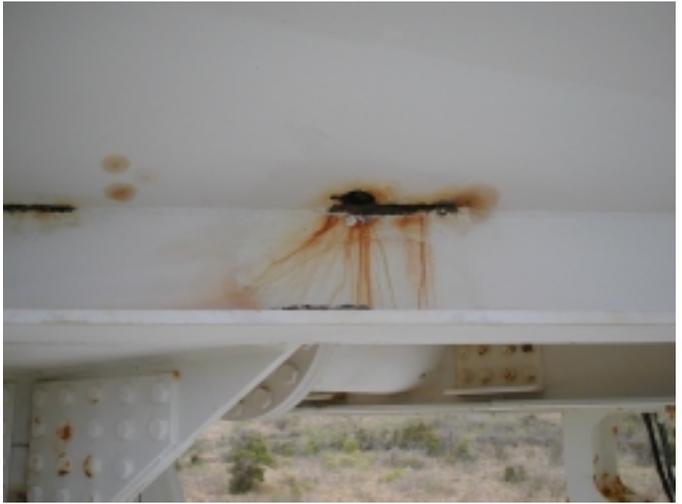
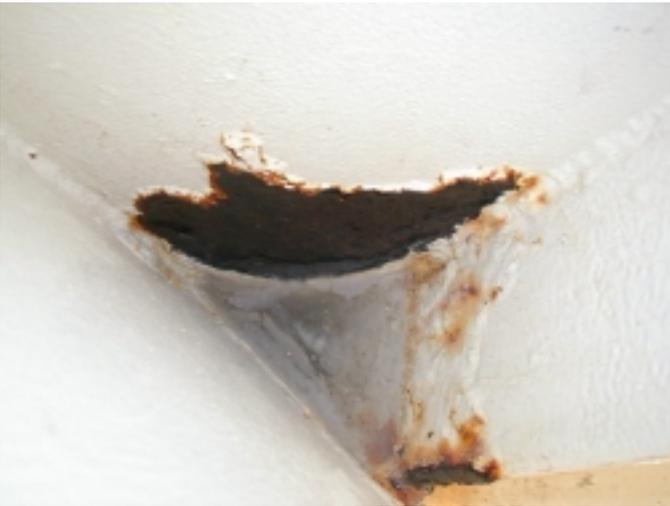
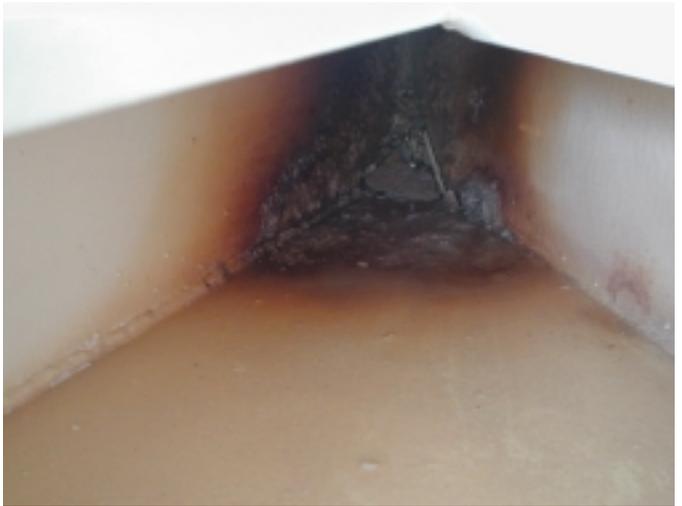
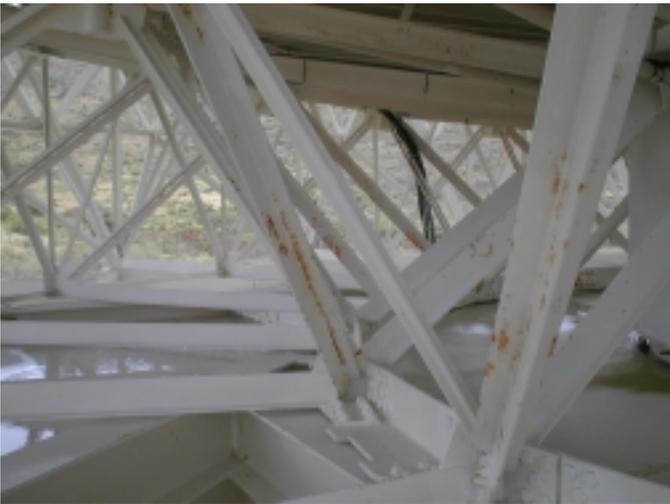
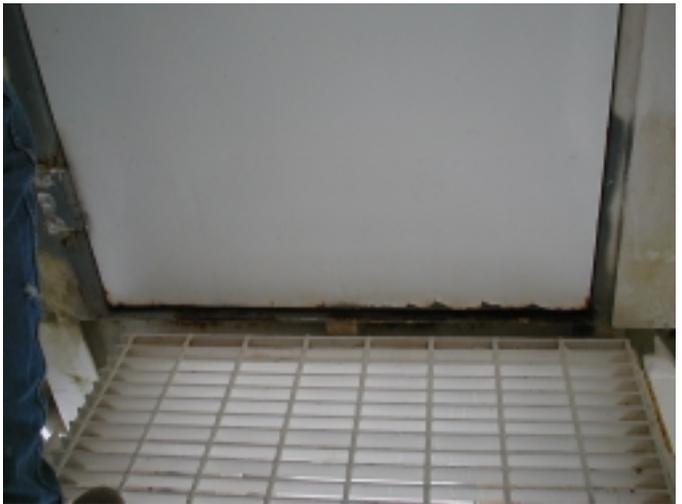
The rails and rail clips on this antenna are rusting. The Vulkem has cracked to the point where it no longer keeps water away from the metal. In fact, it holds water in, facilitating rusting (if that's possible at STX!)

The splice at bolt #119 appears to be sinking over time. Similar behavior was seen at NL by the rail grout repair crew this year. It appears the rail is being slightly, slowly squashed at the splices. This should be repairable by shimming.

The painters appear to be doing an effective job, but rust is still evident.

I did some experiments on ways to slow the deterioration. I scraped off the Vulkem in some bad areas and applied "Rust Cap" primer to the bare metal. Then I sprayed "Great Stuff" foam over half of the primed areas.

We need to monitor these patches, consider other alternatives, and decide how to proceed. I think we can wait a while before doing something, but the longer we wait, the more rust we'll have to deal with. In the mean time, the site techs are removing vulkem in their spare time.
