National Radio Astronomy Observatory  
Socorro, New Mexico

VLBA Antenna Memo #47

Kitt Peak, Arizona VLBA Maintenance Visit June 5-12/03

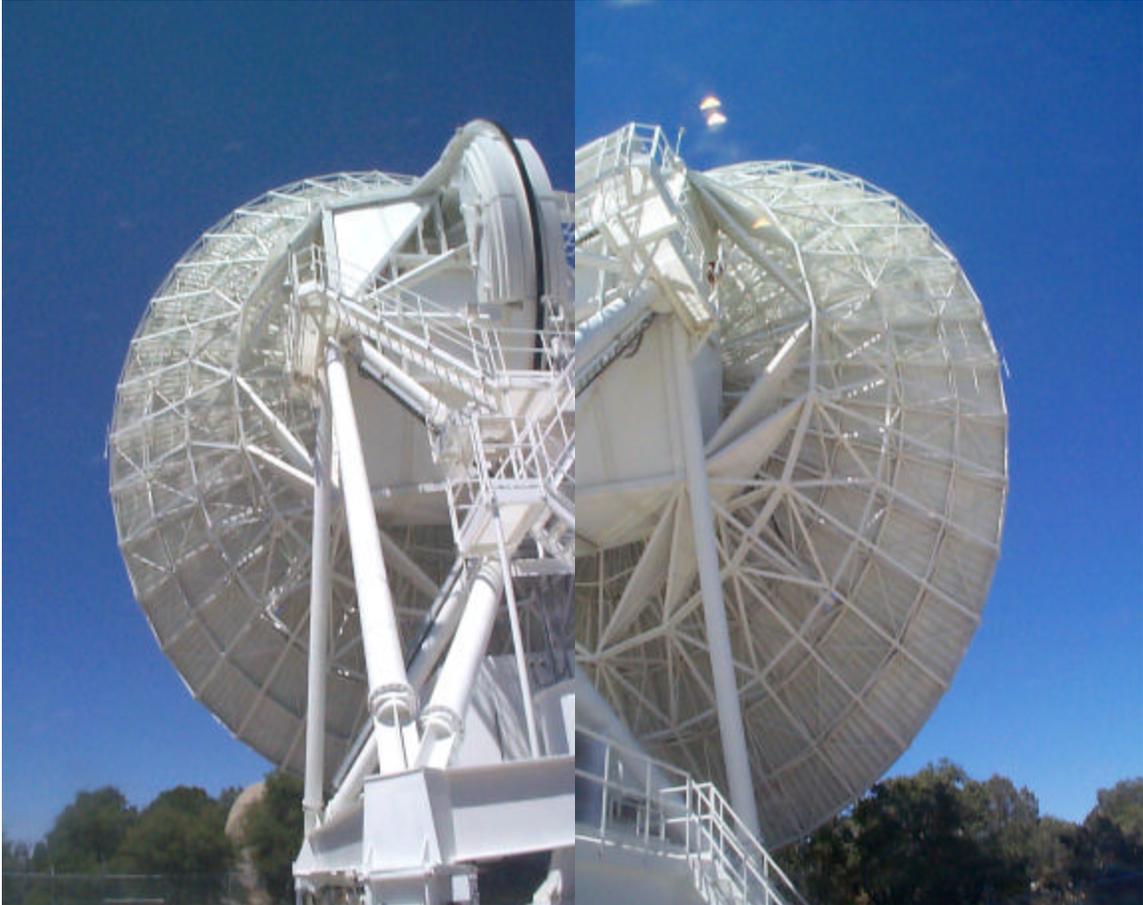
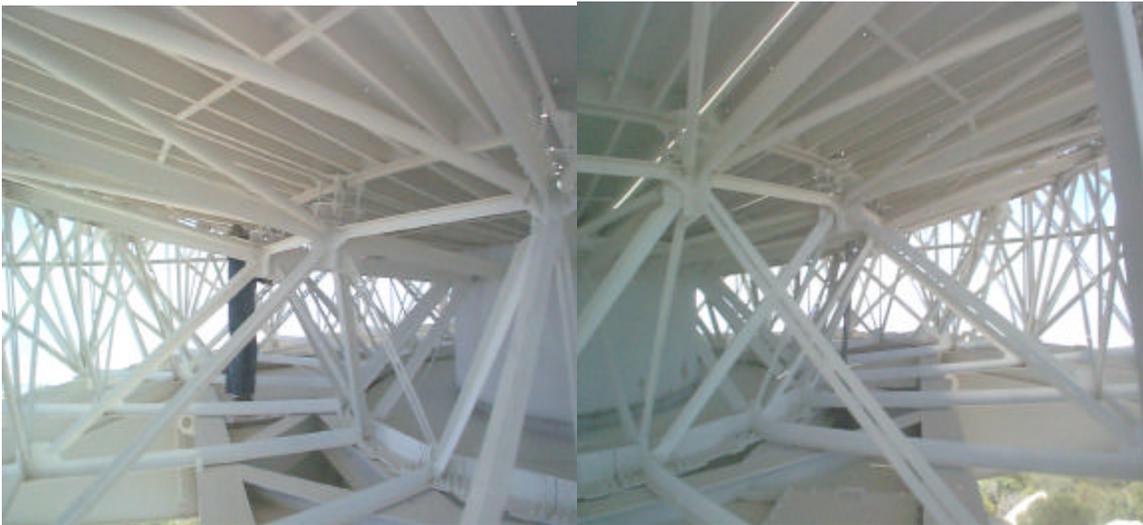
Dish panel bolts were checked. VTX baulk head is in good condition.

The antenna was repainted in two visits (June 2001 and June 2002). All the photos in this report show what a great paint job John Wall and his crew did.
