National Radio Astronomy Observatory
Socorro, New Mexico
VLBA Antenna Memo #73

North Liberty, Iowa VLBA Maintenance Visit April 30-May 7, 2008.
Team members consisted of Steve Aragon, Eric Carlowe, Ray McFarlin,
and Phillip Sanchez. VLBA Site Technicians Mike Burgert and DJ Beard
assisted in all areas of antenna maintenance.

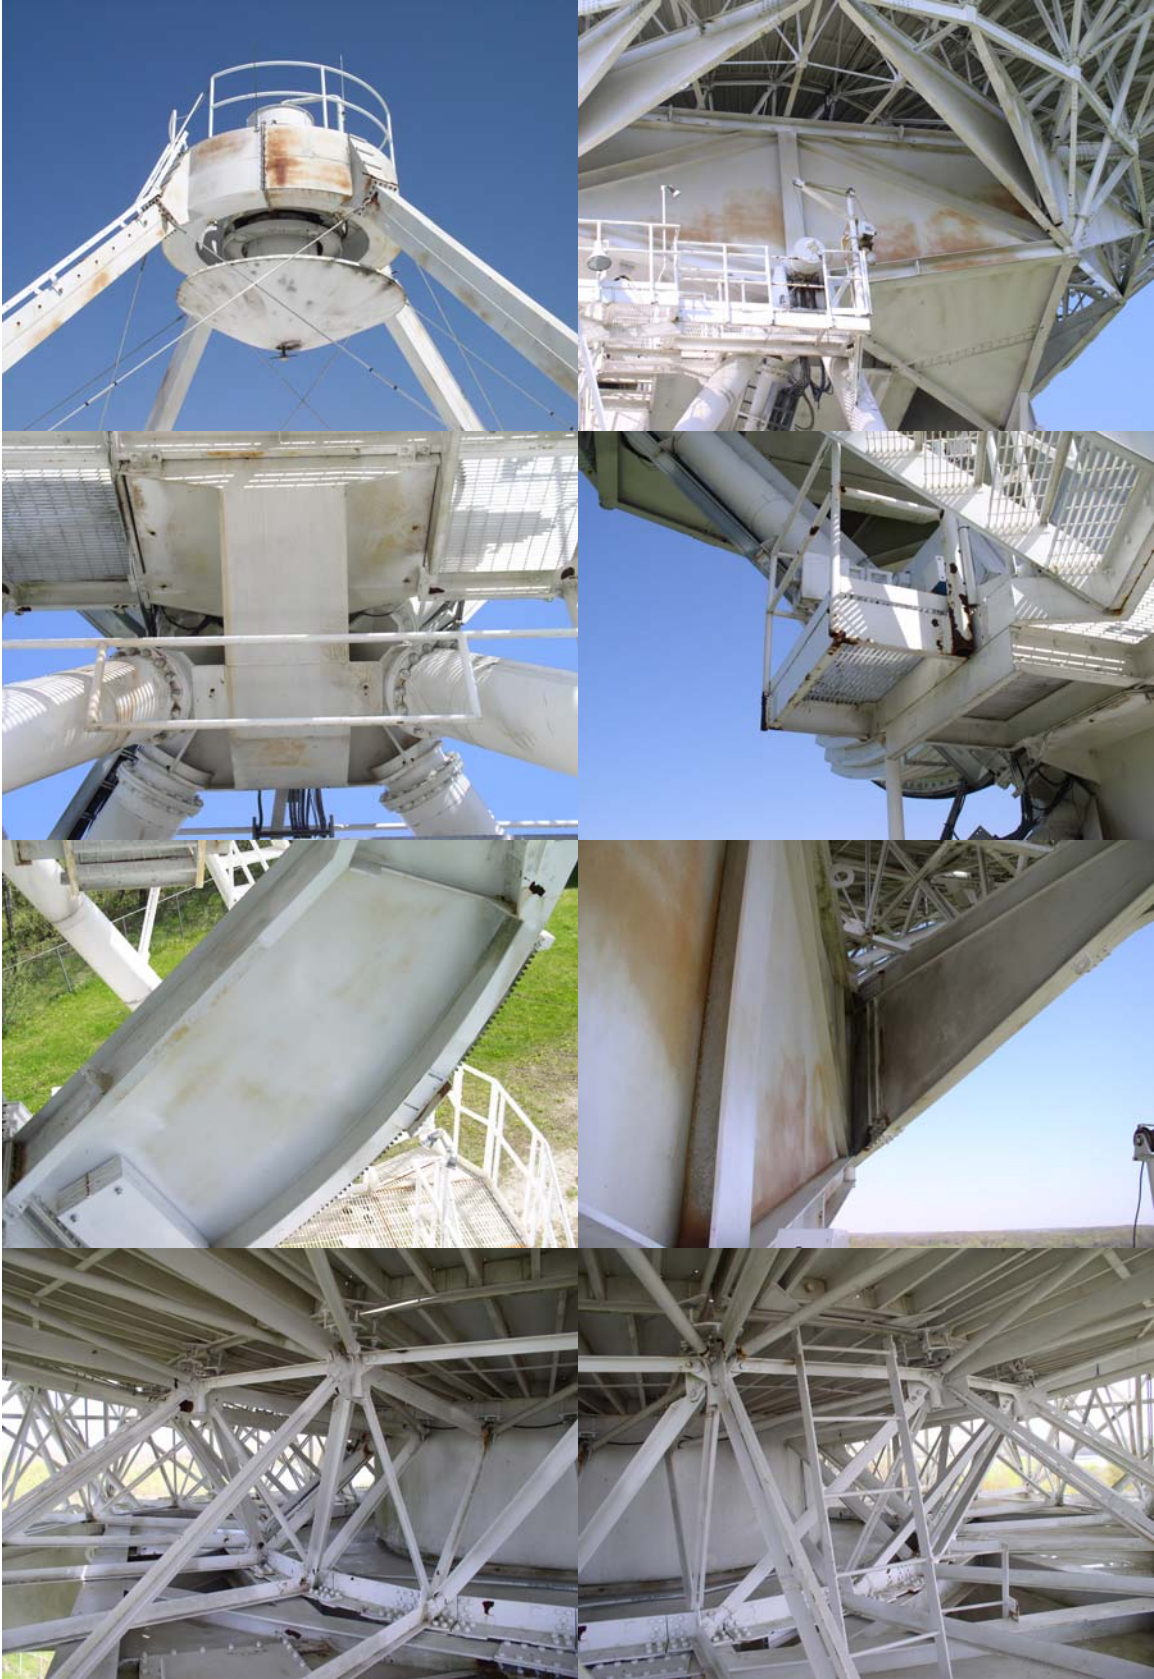
Encoder	Good grease with no metal flakes.
Synchro	Good grease with no metal flakes.
All bearings are very well lubricated.

Pintle bearing is well lubricated with no metal flakes.
