REPORT  
OF THE  
TECHNICAL ASSESSMENT PANEL

COLLAPSE OF THE 300 foot RADIO TELESCOPE

**REPORT of the TECHNICAL ASSESSMENT PANEL  
for the  
300 foot RADIO TELESCOPE at GREEN BANK, WV**

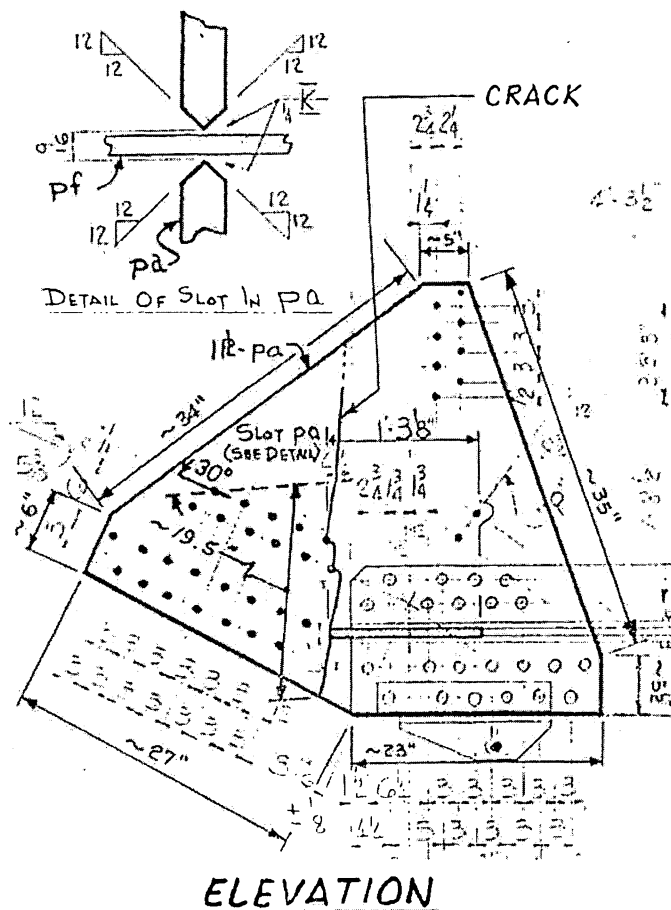
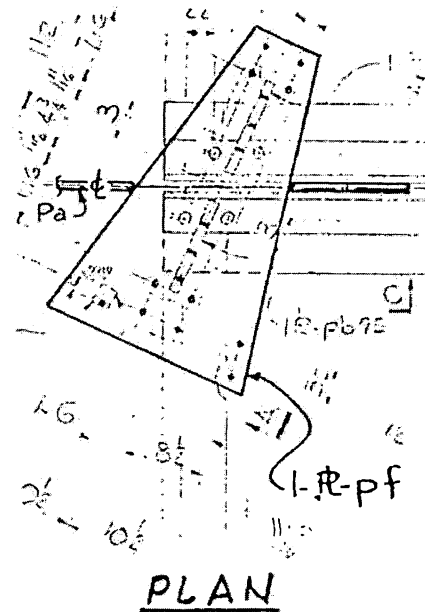
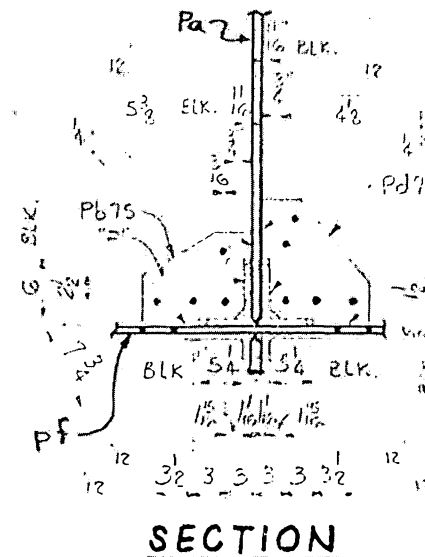
RUPTURED  
GUSSET  $\phi$   
(pa)

2) Visual inspection and laboratory tests of the ruptured gusset removed from the telescope wreckage indicated progressive cracking and eventual rupturing of this plate. The analysis showed that the plate stresses were high enough to cause cracking and crack growth under the cyclic loads from the antenna movements. Rupture of the plate would have resulted in the collapse of the telescope. It should be noted that the telescope had a history of several gusset plate replacements throughout its operational life.

During the investigation of the collapsed structure, a ruptured gusset plate was discovered on the North-East side of the diamond truss. This gusset plate attached the inclined bottom chord member in the first panel of the diamond truss to the adjacent horizontal bottom chord member in the second panel of the diamond truss. In view of this discovery, the scope of work for this analysis was modified to include a preliminary analysis of the stresses in this ruptured gusset plate using the results of the half model analysis for the zenith and 45 degree inclined dish positions.

AVG. BENDING STRESS FLUCTUATION =  $[(117 - 28.1) + (160 - 28.1)]/2 = 110 \text{ ksi}$  ABOVE 28.1 ksi (N&S)  
 (Therefore, since only the yield stress can be developed, the p will yield)

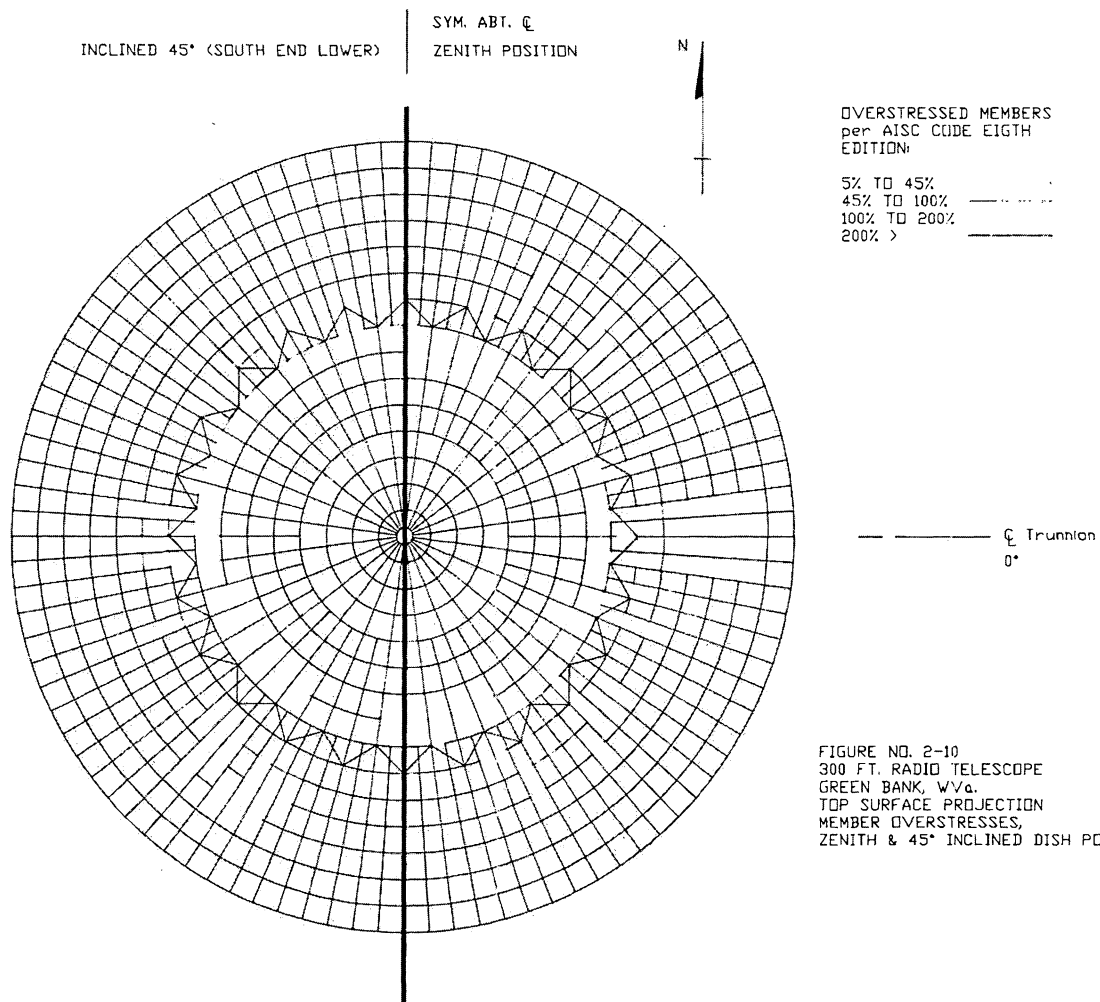
FIGURE NO. 2-10  
300 FT. RADIO TELESCOPE  
GREEN BANK, W.Va.  
TOP SURFACE PROJECTION  
MEMBER OVERSTRESSES,  
ZENITH & 45° INCLINED DISH POSITIONS

Figures 2-10 and 2-11, respectively, illustrate members on the top and bottom dish surfaces. Figures 2-12 through 2-16 illustrate members on the main radial ribs. Figures 2-17 through

d) The number of overstressed members identified was based on the application of only the structure dead load. The inclusion of additional environmental or other short-term loads sustained by the structure over its operational life would have resulted in higher stresses and additional overstressed members.

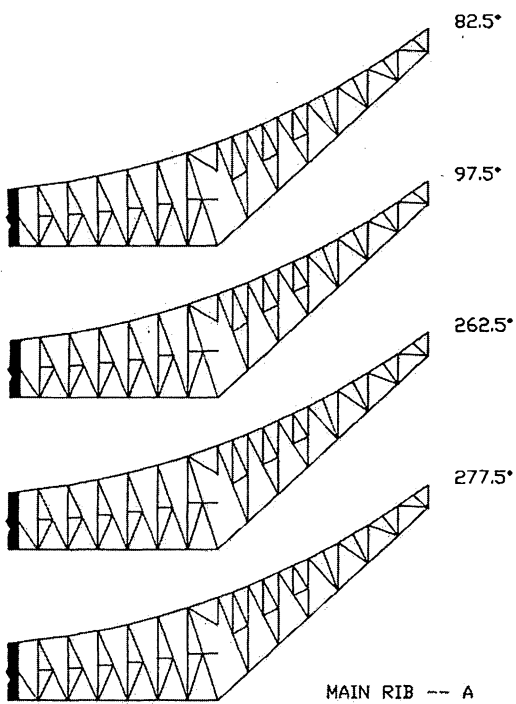
FIGURE NO. 2-15  
300 FT. RADIO TELESCOPE  
GREEN BANK, WV.  
MAIN RIBS, A & D  
MEMBER OVERSTRESSES,  
45° INCLINED DISH POSITION

OVERSTRESSED MEMBERS  
per AISC CODE EIGHTH  
EDITION:

5% TO 45% —————  
45% TO 100% - - - - -  
100% TO 200% ————  
200% > ————

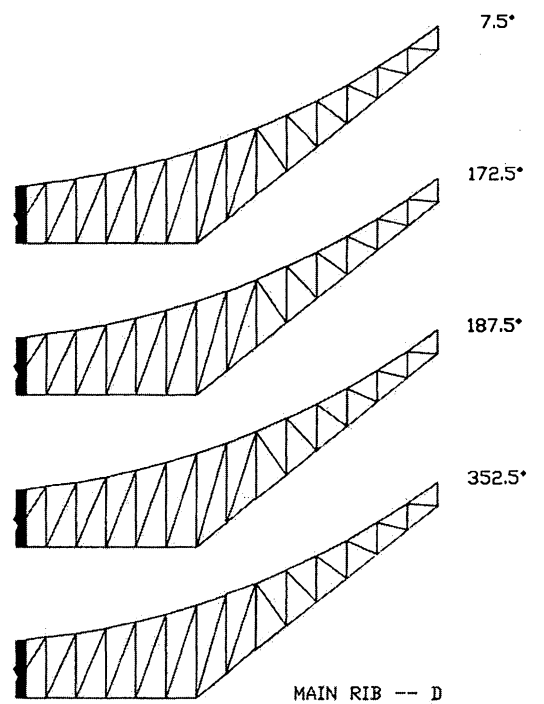
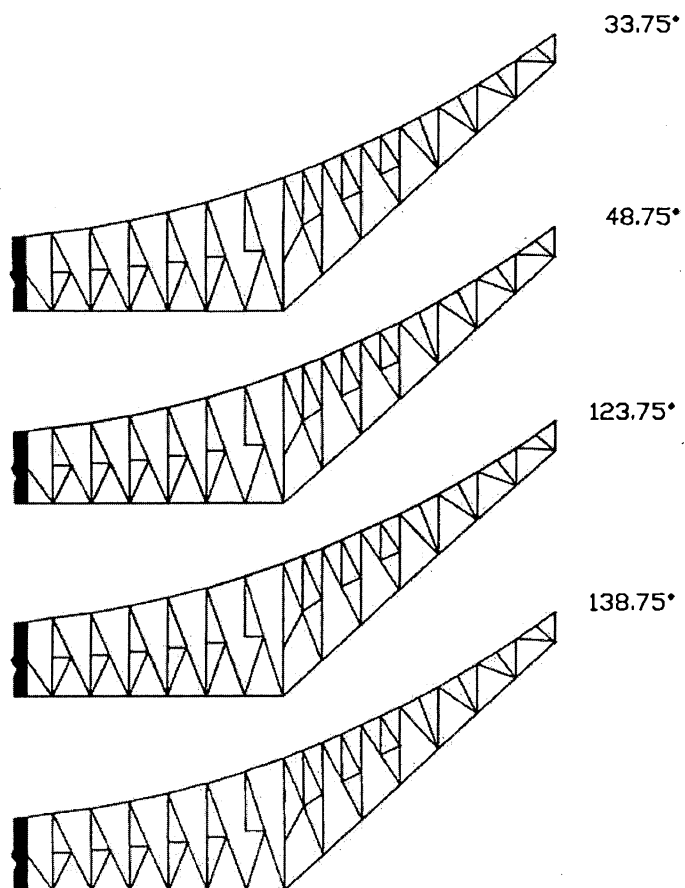
FIGURE NO. 2-16  
RADIO TELESCOPE  
GREEN BANK, WVa.  
MAIN RIBS, B  
MEMBER OVERSTRESSES,  
45° INCLINED DISH POSITION

OVERSTRESSED MEMBERS  
per AISC CODE EIGHTH  
EDITION:

5% TO 45% —————  
45% TO 100% ————  
100% TO 200% - - - -  
200% > ————

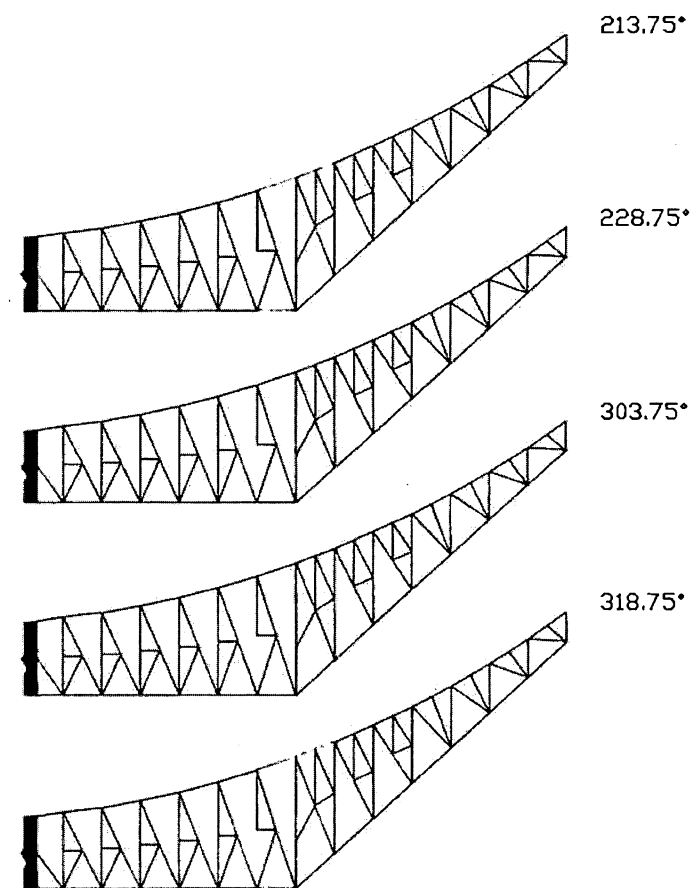
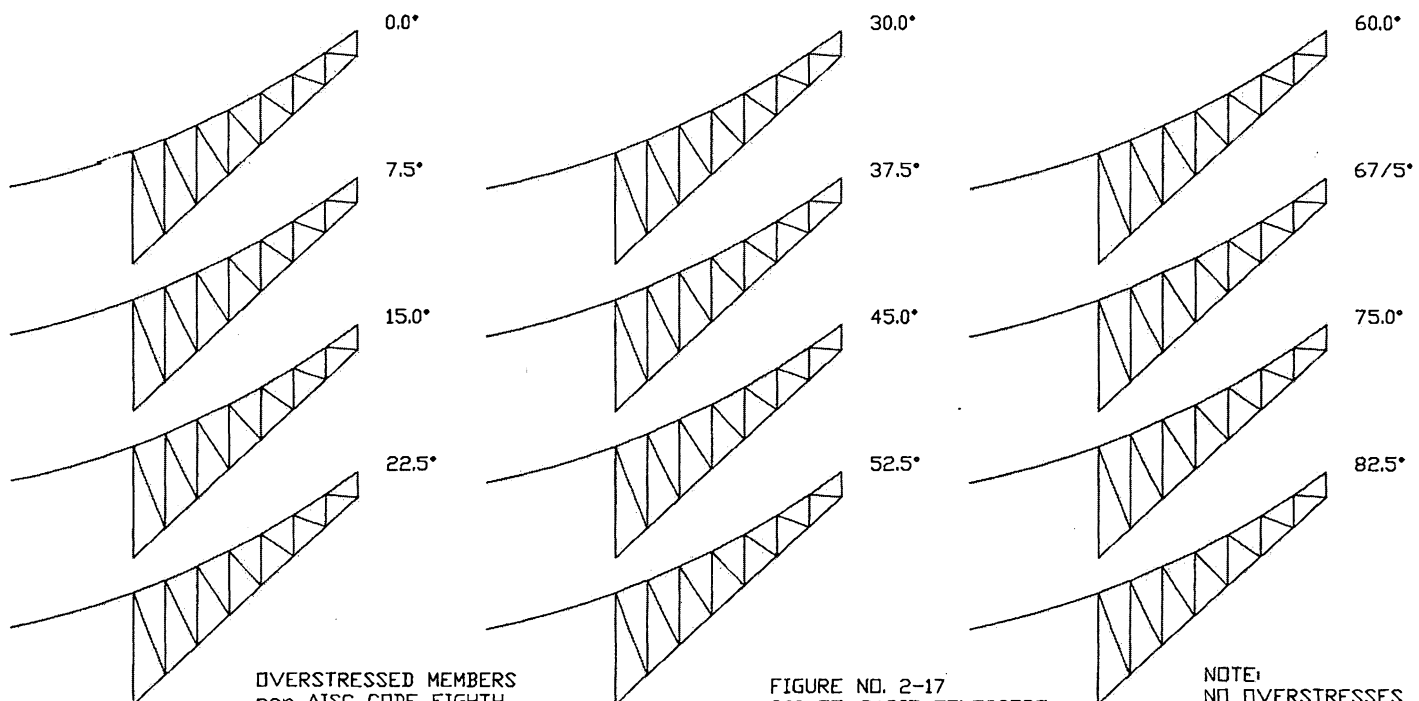
FIGURE NO. 2-17  
300 FT. RADIO TELESCOPE  
GREEN BANK, WV.  
AUXILIARY RIBS  
MEMBER OVERSTRESSES,  
ZENITH & 45° INCLINED  
DISH POSITIONS

OVERSTRESSED MEMBERS  
per AISC CODE EIGHTH  
EDITION:  
5% TO 45% —————  
45% TO 100% - - - - -  
100% TO 200% ————  
200% > ————

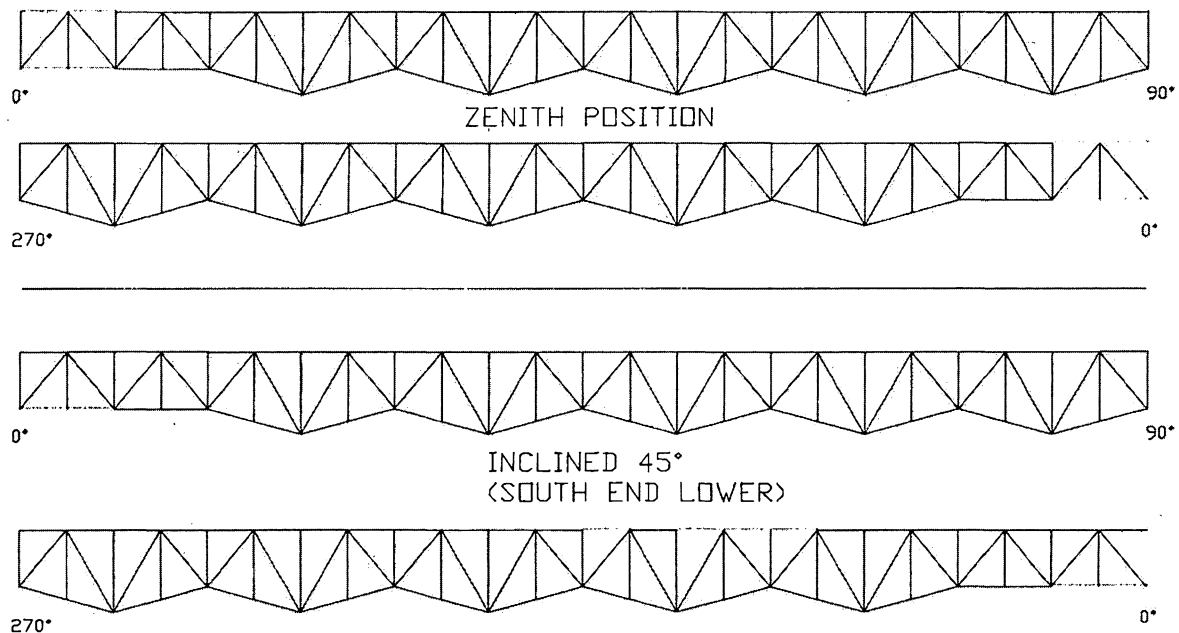
FIGURE NO. 2-24  
300 FT. RADIO TELESCOPE  
GREEN BANK, WV.  
CIRCUMFERENCE 4,  
MEMBER OVERSTRESSES,  
ZENITH & 45° INCLINED  
DISH POSITIONS

OVERSTRESSED MEMBERS  
per AISC CODE EIGHTH  
EDITION:

5% TO 45%    ————  
45% TO 100%    ————  
100% TO 200%    ————  
200% >    ————

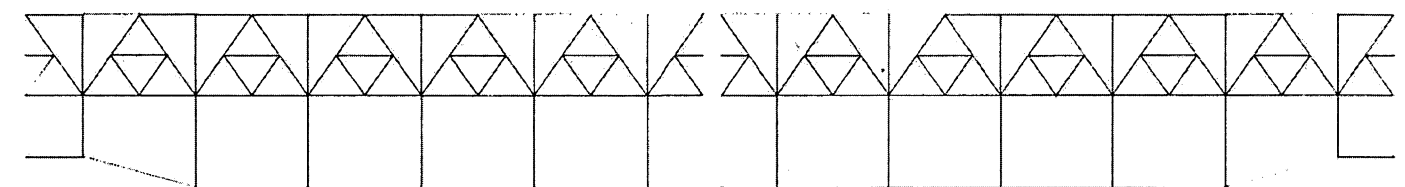
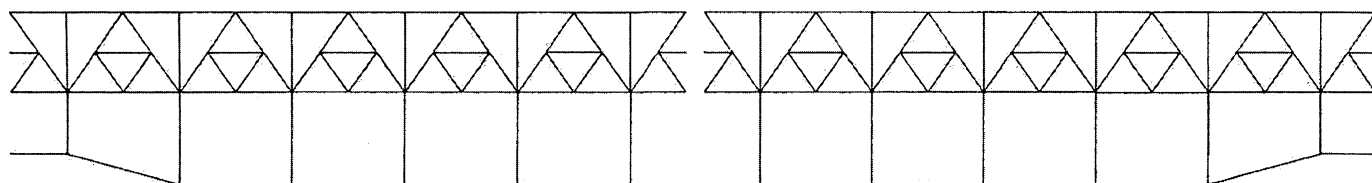
FIGURE NO. 2-29  
300 FT. RADIO TELESCOPE  
GREEN BANK, WV.  
CIRCUMFERENCE 9,  
MEMBER OVERSTRESSES,  
ZENITH & 45° INCLINED DISH POSITIONS

OVERSTRESSED MEMBERS  
per AISC CODE EIGHTH  
EDITION:

5% TO 45% .....  
45% TO 100% ————  
100% TO 200% ————  
200% > ————

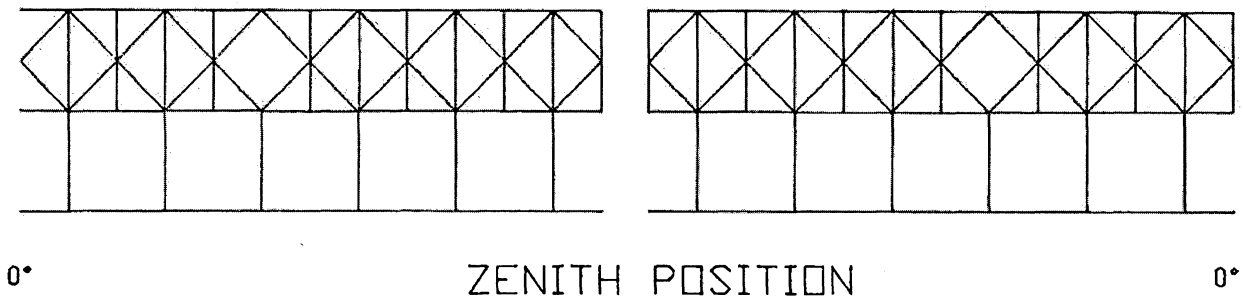
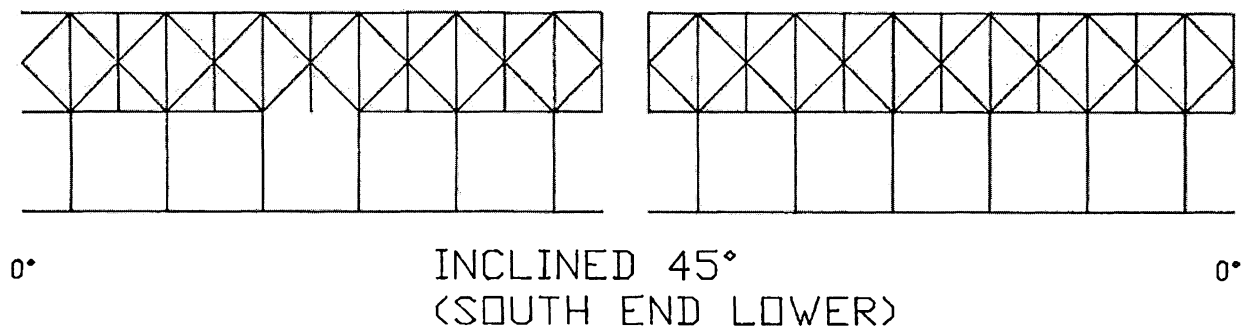
FIGURE NO. 2-30  
300 FT. RADIO TELESCOPE  
GREEN BANK WV<sub>a</sub>.  
CIRCUMFERENCE 10  
MEMBER OVERSTRESSES,  
ZENITH & 45° INCLINED

OVERSTRESSED MEMBERS  
per AISC CODE EIGHTH  
EDITION:

5% TO 45% \_\_\_\_\_  
45% TO 100% \_\_\_\_\_  
100% TO 200% \_\_\_\_\_  
200% > \_\_\_\_\_

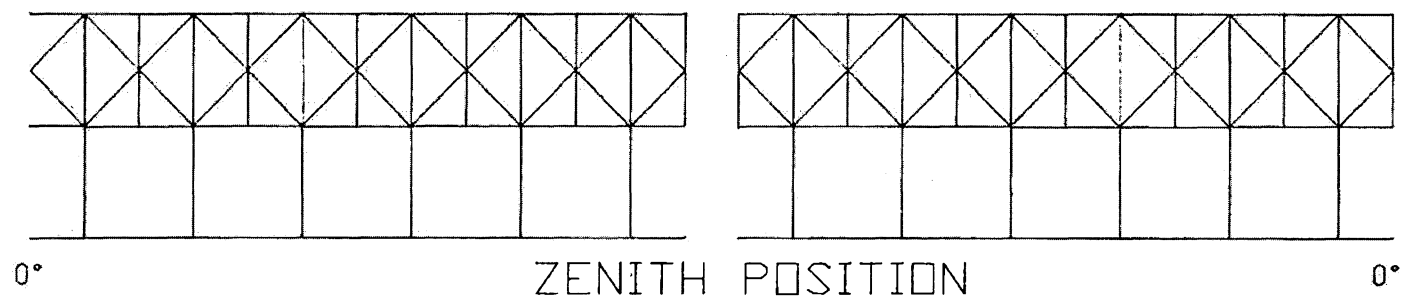
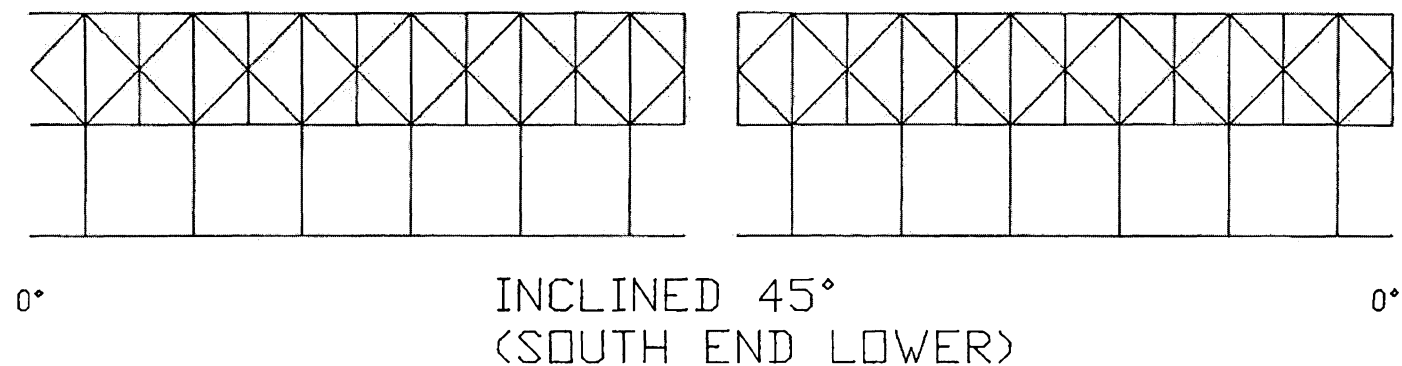
FIGURE 2-31  
300 FT. RADIO TELESCOPE  
GREEN BANK WV. a.  
CIRCUMFERENCE 11  
MEMBER OVERSTRESSES,  
ZENITH & 45° INCLINED

OVERSTRESSED MEMBERS  
per AISC CODE EIGHTH  
EDITION:

5% TO 45% -----  
45% TO 100% -----  
100% TO 200% -----  
200% > -----

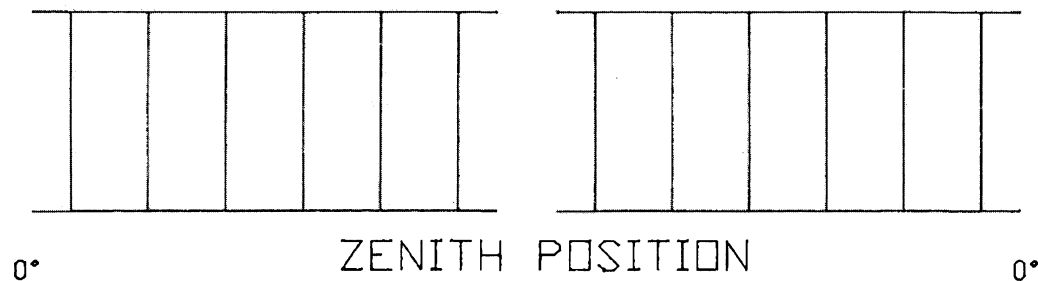
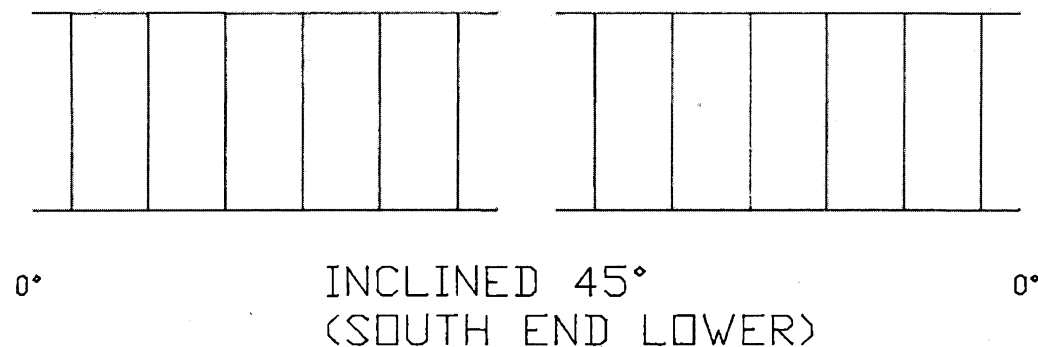
FIGURE 2-33  
300 FT. RADIO TELESCOPE  
GREEN BANK, WV.  
CIRCUMFERENCE 13,  
MEMBER OVERSTRESSES,  
ZENITH &  $45^\circ$  INCLINED POSITION

OVERSTRESSED MEMBERS  
per AISC CODE EIGHTH  
EDITION:

5% TO 45% .....  
45% TO 100% .....  
100% TO 200% .....  
200% > .....

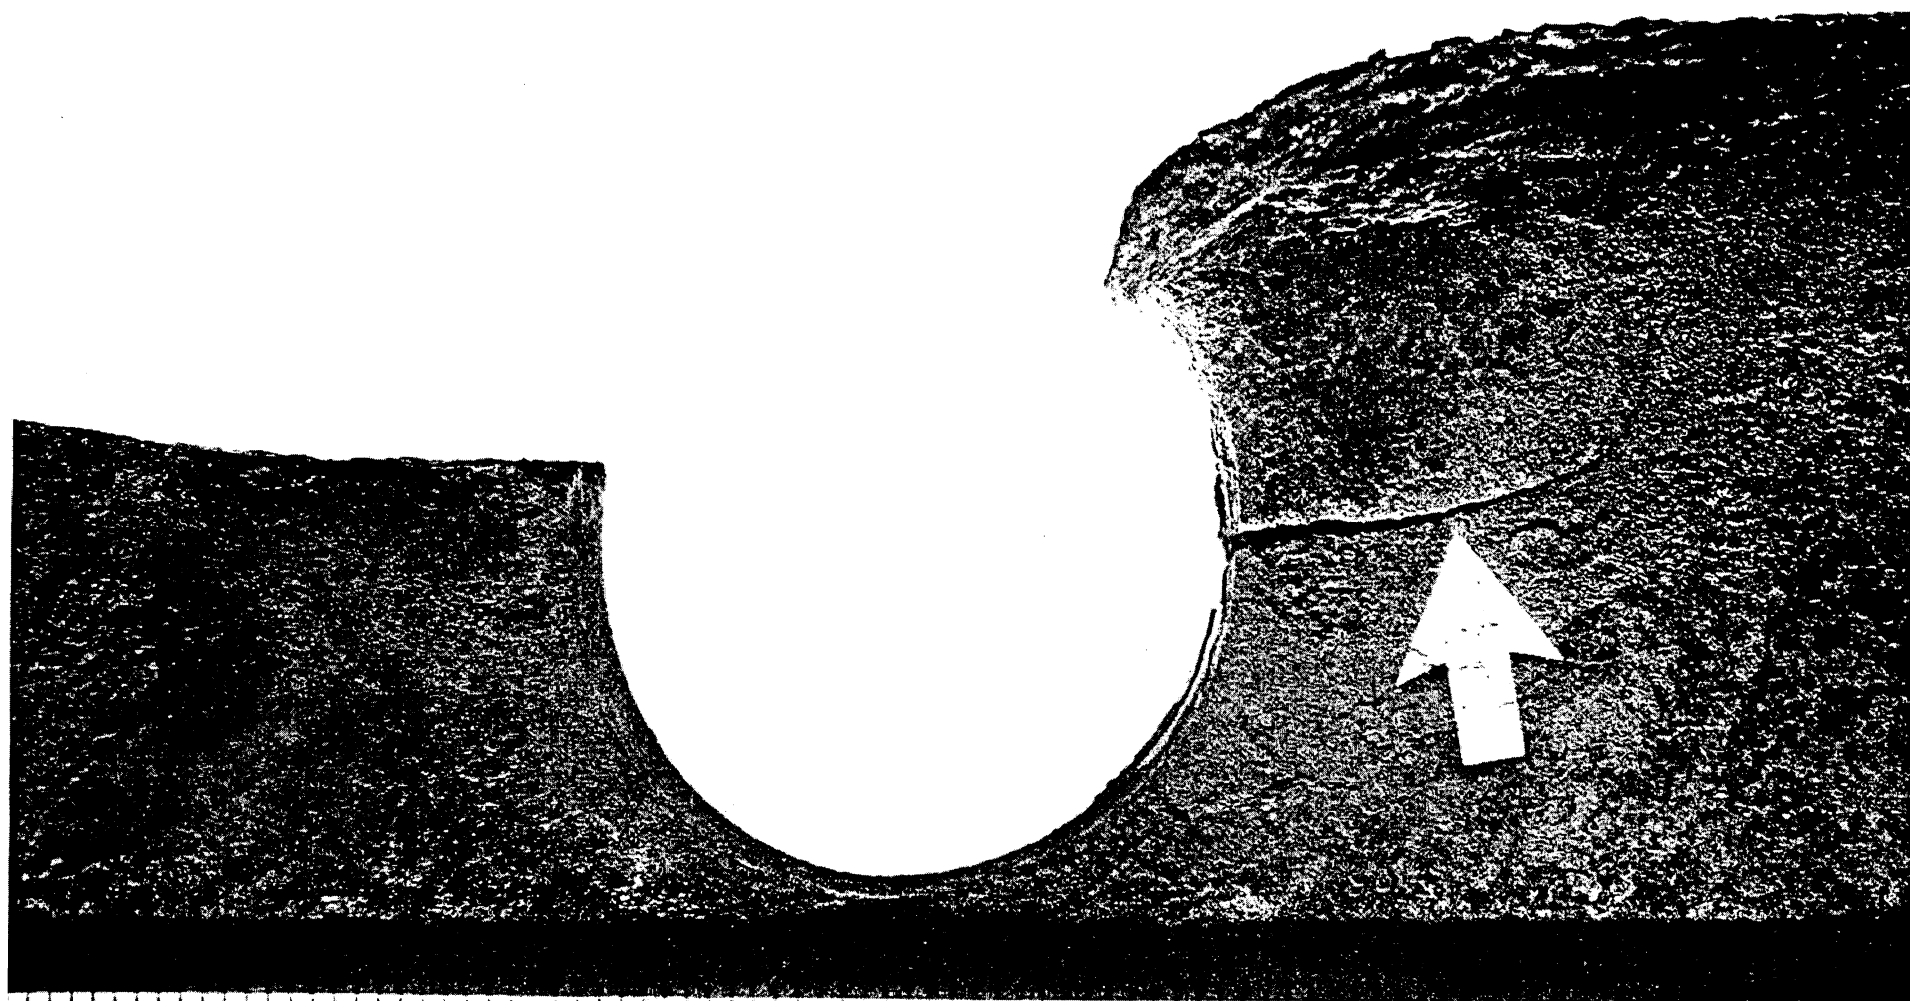
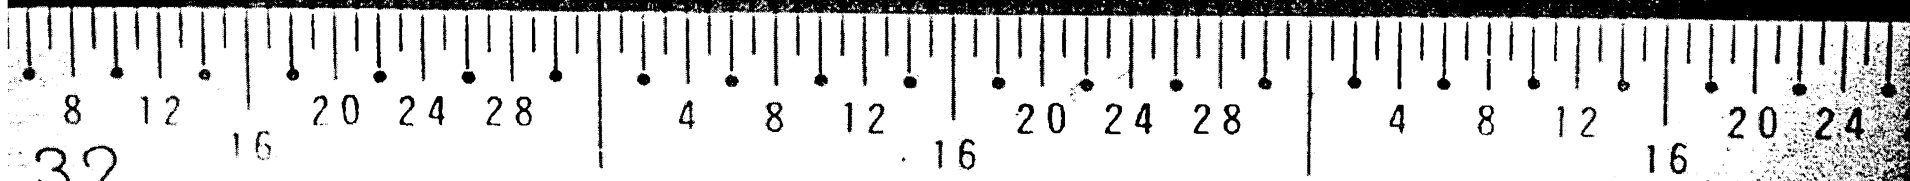
SECONDARY FATIGUE CRACK

Further, the results of the fractographic examination revealed secondary fatigue cracks also had originated at the bolt hole surfaces. The presence of the secondary fatigue cracks at the bolt holes indicates the presence of intermediate to high cyclic stresses.

Close-up photograph showing a secondary fatigue crack (arrow) parallel and adjacent to the primary fracture, as is characteristic of fatigue cracking under intermediate to high cyclic stresses.

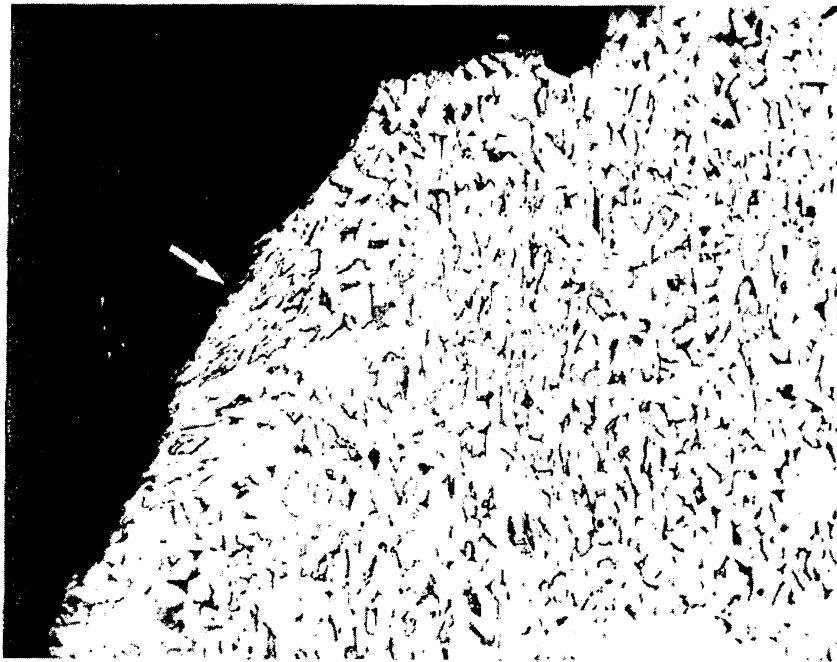
Remote from the fracture origin, the final fracture profile was slanted, transgranular and the grains adjacent to the surface were plastically deformed, as is characteristic of fast ductile fracture. Fig. 11 is a photomicrograph showing fracture profile through the final fracture region.

FRACTURE PROFILE REMOTE  
FROM BOLT HOLE ORIGIN

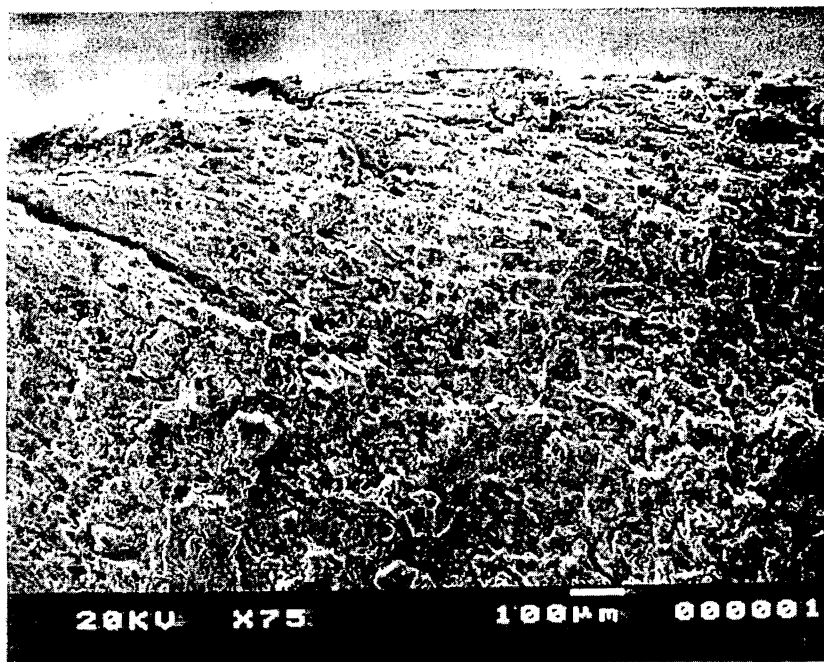
Fig. 12

As shown in Fig. 12, the fracture surface was covered with an oxide scale and no significant fractographic information was obtained.

FRACTURE ORIGIN AT ORIGIN
