National Radio Astronomy Observatory
Antenna Barn Inspection Memo Series – No. 1
Steven Tran
INSPECTION REPORT – VLA Site, July 18 – Sept 26, 2023
ENGINEERING INSPECTION

Introduction

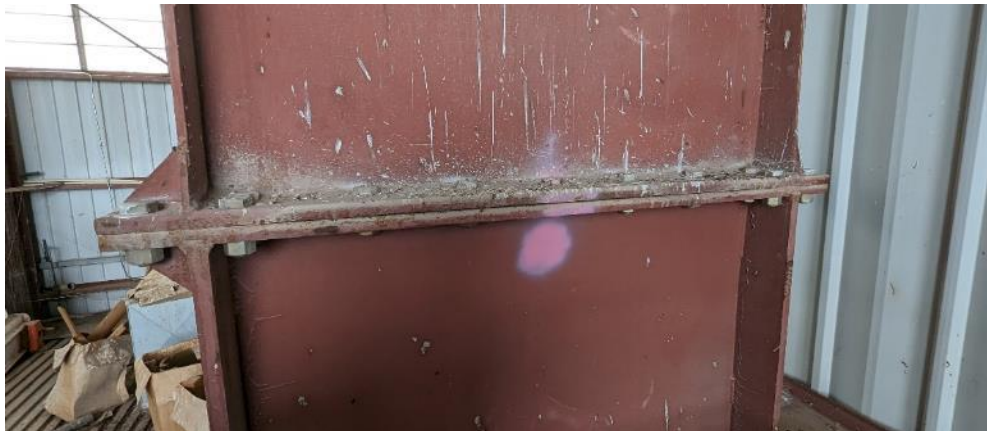
Figure 1: Typical column bolting section (12b)

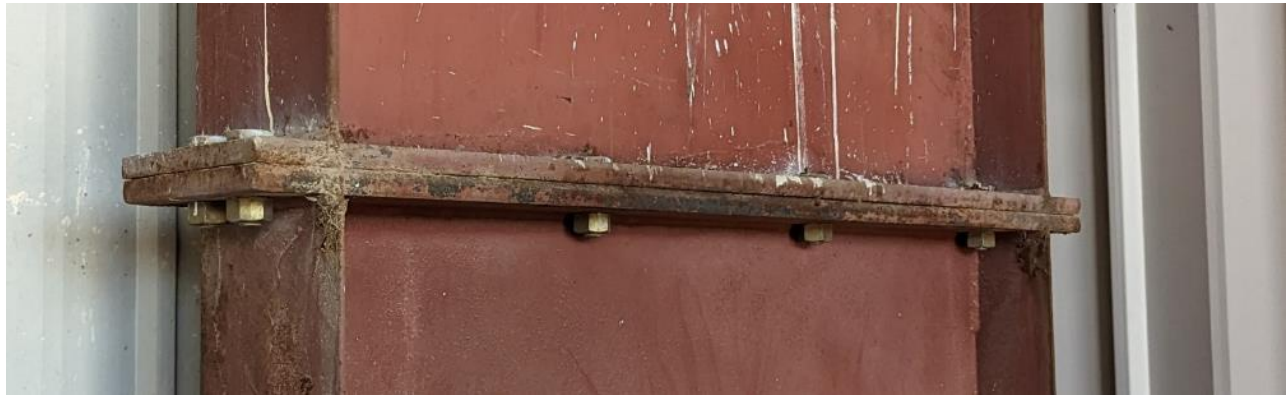
To prevent bolts from loosening, they have to be tightened with enough preload. Typical column bolts were determined to be 1”-8 x 3¼” A325 zinc coated bolts, which required 450 ft lbs. of torque to satisfy recommended preload. The torque required for other structural bolts of different sizes can be found in table A3 on page 30. The typical bolt tested has rotated 0-5 degrees, confirming that these bolts had previously been pretensioned to the equivalent of about 450 ft-lbs or higher. This falls within the tabulated torque ranges from multiple online sources for coated A325 fasteners seen in table A3.

Figure 2: Image of bolts with zinc coating (11c)

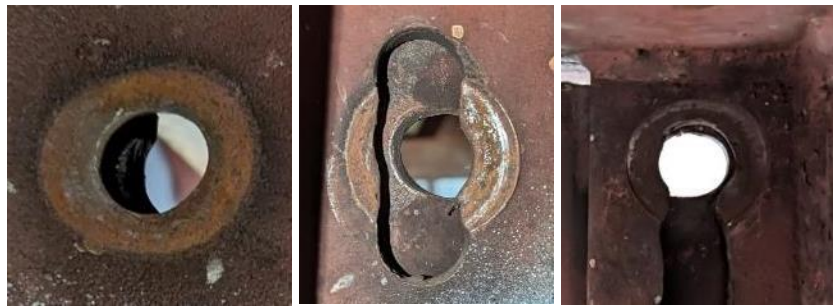
Figure 13 shows the misalignment of bolt hole 2 from 10d with bad alignment, compared to the alignment of bolt 1 of 9d which had a good fit. Figure 14 shows a visual difference after die grinding.

Figure 13: Left & Middle – Bolt hole 2 (10d). Right – Bolt hole 1 (9d).

A pneumatic die grinder was used to expand the holes for bolts 1 and 2 (10d), and bolt 4 (7d), which allowed the bolts and nuts to sit flat onto the flat washers after installation. This is a quick fix for the next few bolt replacements if needed, but installing a new tee joint will eventually be needed. In total, bolts 1 and 4 from 7d and 9d, and bolts 1 and 2 from 8d and 10d were replaced.

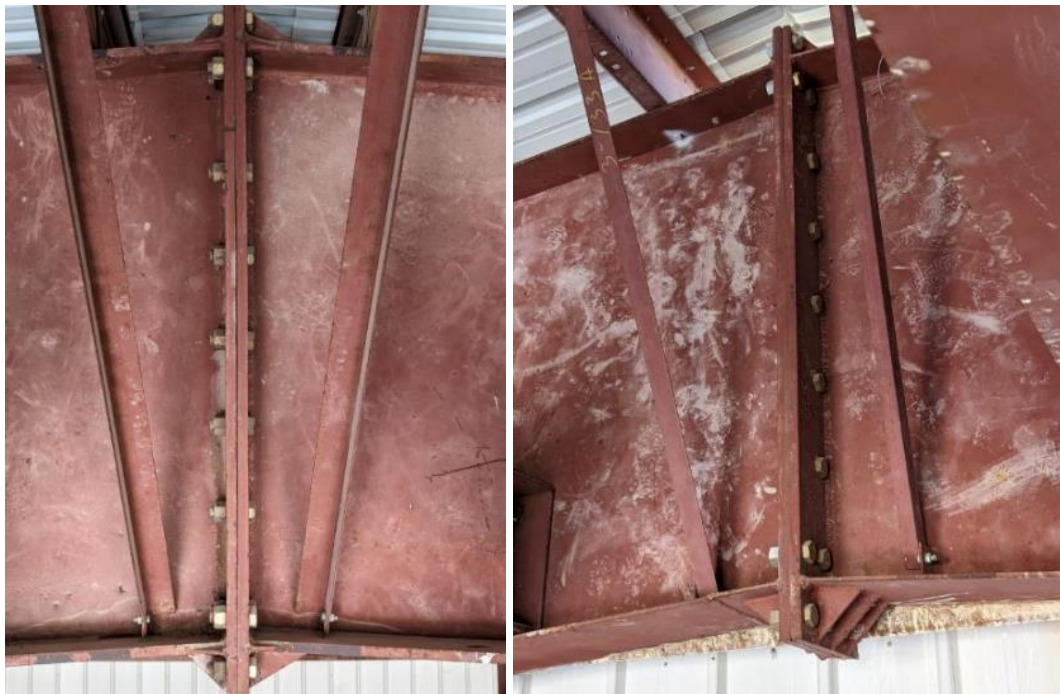
Figure 15: Left – Bolt 12 (14c) replaced with SAE grade 5 bolt. Right – Class 8.8 metric replacement of bolt 21 (5b). All f level bolting sections appeared to be in good condition, with no signs of looseness or damage.

Figure 16: Left – (5f). Right – (6f).

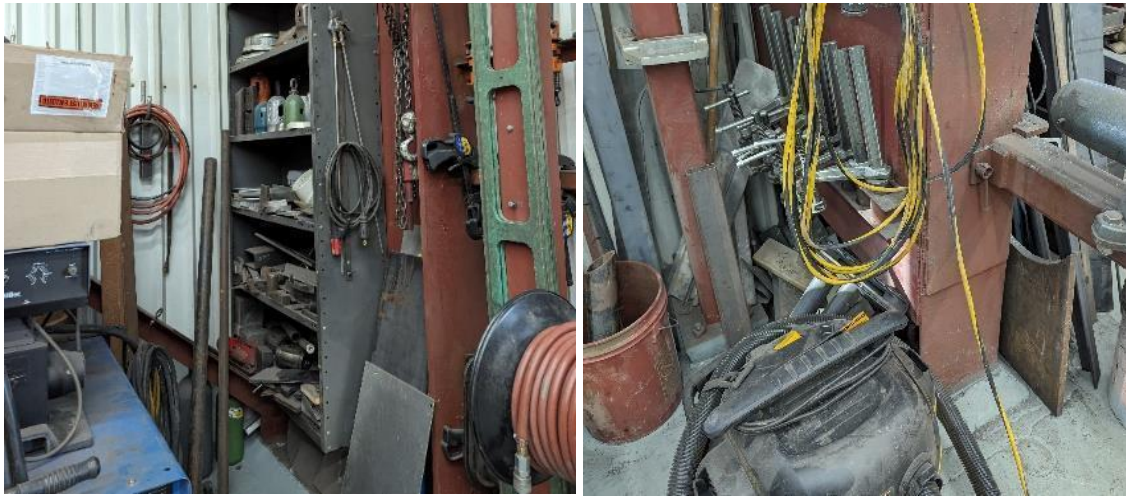
Many anchor bolt sections are unreachable or covered. Figure 17 shows exposed anchor bolt sections, while figure 18 shows anchor bolts in the welding shop with equipment around them, and figure 19 shows unobtainable anchor bolts. Defined by the American Institute of Steel Construction (AISC), a snug-tightened joint is when the members in a connection have achieved firm contact by the bolts in the joint, and the bolts have been tightened sufficiently to prevent removal of the nuts without a wrench. All anchor bolts appear to have a snug-tight condition, which satisfies pre-installment conditions.

Figure 18: Covered anchor bolt sections in welding shop. Left – (6a). Right – (7a).

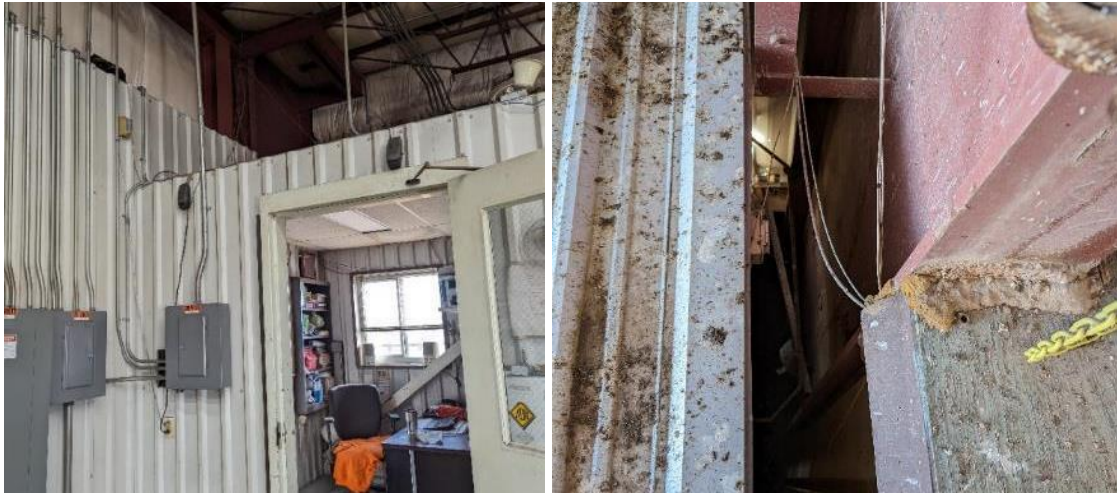
Figure 19: Section 5a unreachable. Left – Inside welding shop. Right – From welding shop roof.

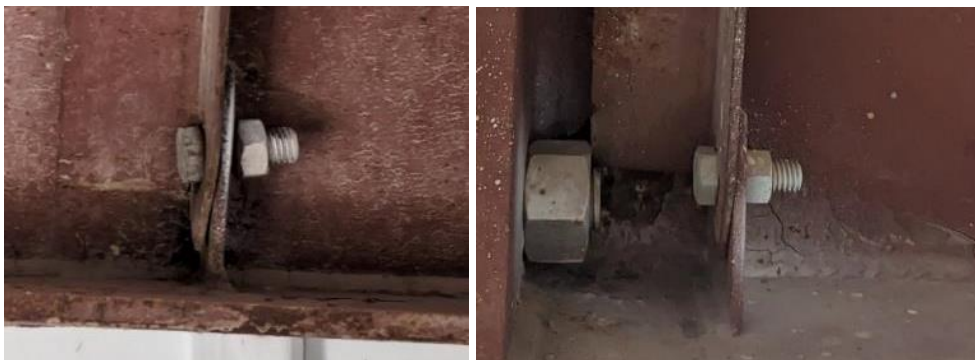
The majority of auxiliary members inspected have been within CS1 or lower, with less corrosion and cracking conditions than the columns. However, similar to the columns their connections are the usual concern with some found to be at CS2. This was more commonly found with the flange braces at the south wall, connecting roof truss 6 to the purlins. Most flange braces were found to be loose and could easily be shaken, or loose bolts could be seen moving when wind speeds were high. X bracings like at W-D3 would continue to wobble after an initial shake. However, these X bracings, cross rods, and other members are usually intended to keep the structure square, preventing it from tilting over. So absolute tightness of these members is not required.

Figure 20: Typical flange brace bolting. Left – Flange brace 9 on south wall. Right – Near bolt 11 (2e).

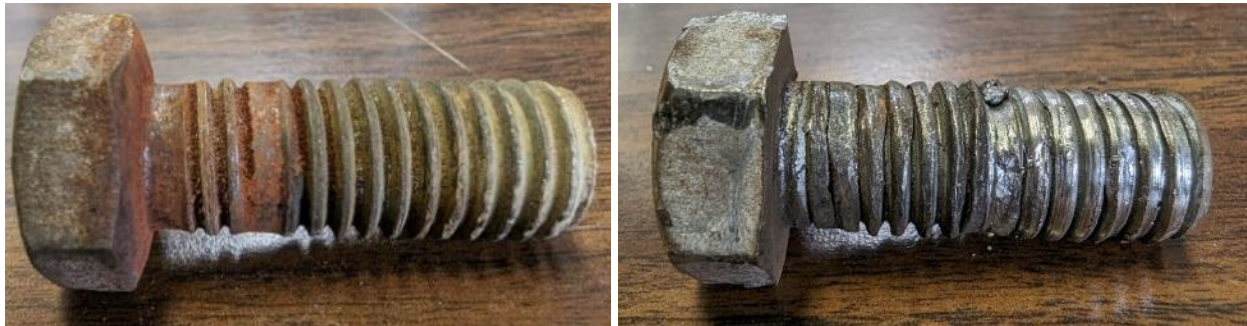
Figure 22: Left – Replaced from flange brace 12. Right – Replaced from flange brace 11.

Not all compromised flange brace bolts had been replaced due to manlift and time limitations, but future replacements should implement flat washers. Cross rods at R-B5 should be re-installed if possible. The holes in the antenna barn roof should be further inspected and sealed before the next monsoon season starting June 2024, to prevent corrosive damage of the structural members and any items susceptible to water damage in the barn. Cleaning and repainting high corrosion areas such as section 14d, is another low priority item.

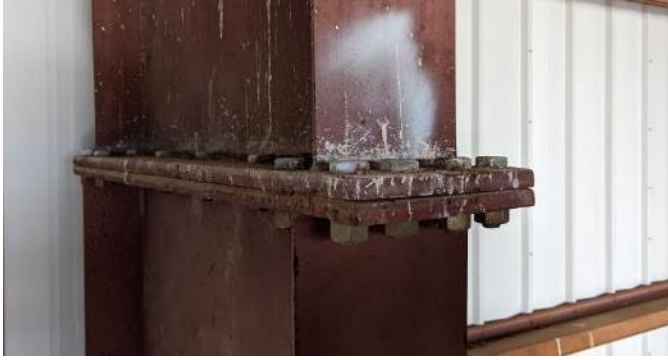
9c
 		9d Had good clearance

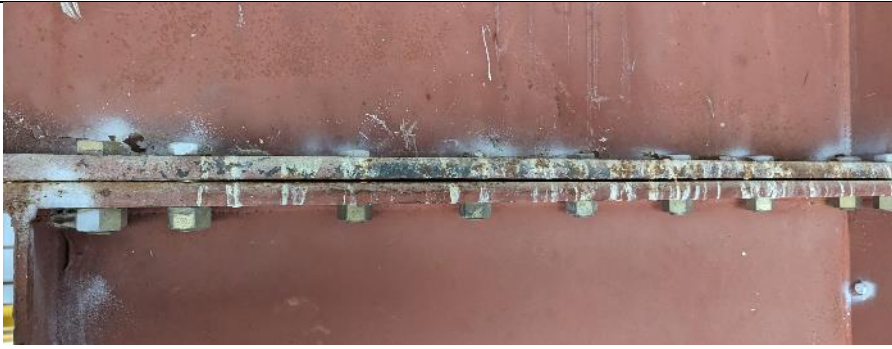
15d Gap but tight Bolts 23-26, 1-9

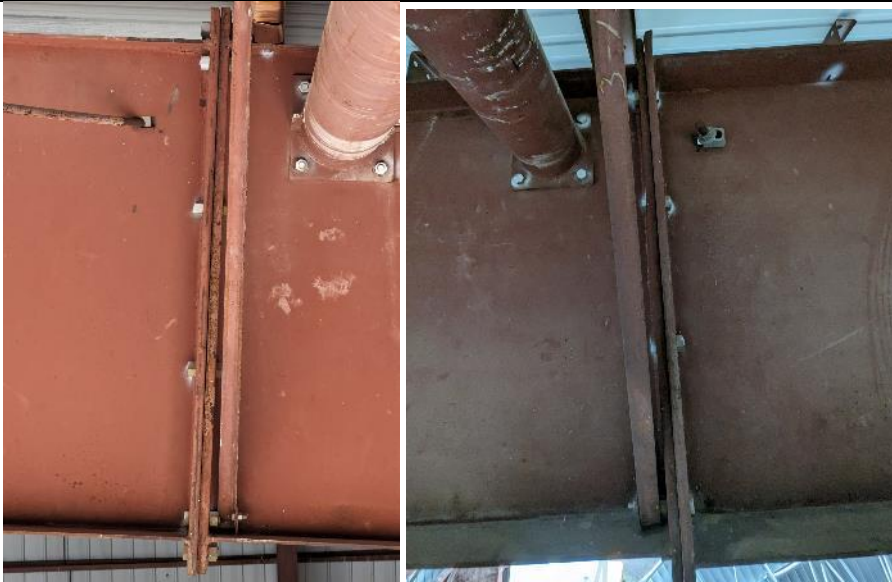
15e Left – Bolts 1-6 Right – Bolts 7-12
 	16c A lot of debris
