### VLBA Antenna Memo Series – No. 109

TRIP REPORT – North Liberty, October 20-25, 2025

#### 1. Trip Summary

A group from the VLA traveled to the North Liberty, Iowa VLBA station to rebuild all four gearboxes and replace one of the FRM linear shafts:

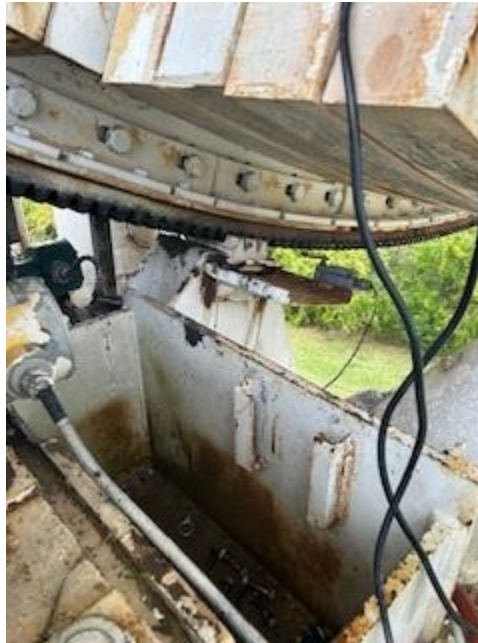
Figure 6: Elevation Stow Pin

In both cases of the FRM linear shaft and elevation gearbox rebuilds, the stow pin was inserted as a safety precaution. The stow pin is a three-tooth gear sector that provides full engagement with the bull gear.

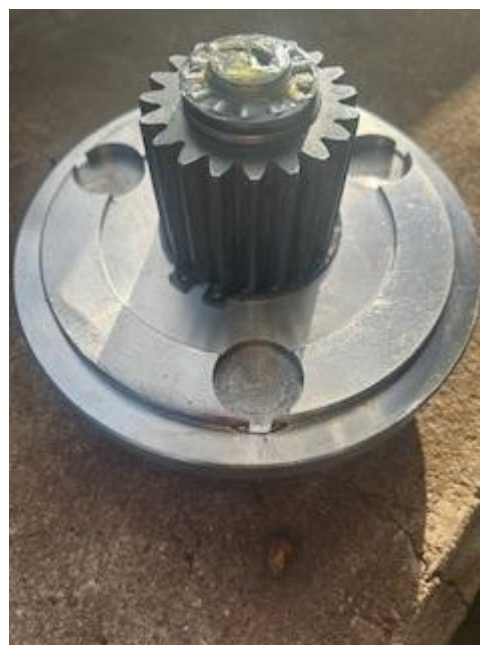
Figure 16: New First Stage Carrier

The desire was to replace the first stage carrier due to that fact the rear ring gear of the second stage sun had worn into the carrier surface shown in Figure 15. However, the replacement carrier was poorly machined, and the material felt substantially lighter than the existing one. One of the site tech made the attempt at removing burrs and protrusions of material left on the part. Given the discoloration on the components within the AZ #2 gearbox we decided to use the original carrier.

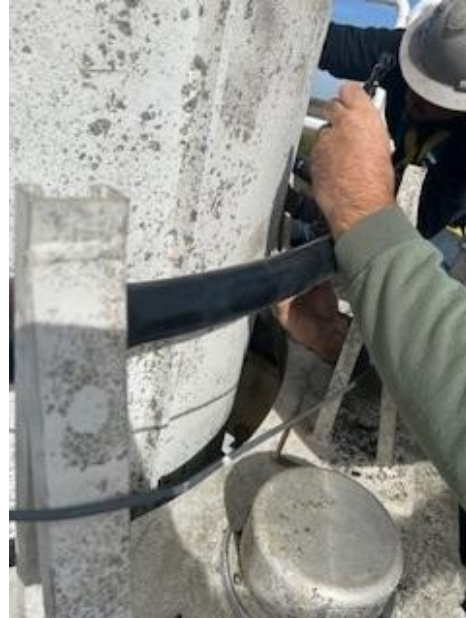
*Figure 27: FRM Flex Shaft*

Prior to replacing the flex shaft, both bevel gearbox couplings needed to be clamped down as to not unintentionally drive the focus lead screw. Removing the flex shaft can allow for the potential energy in the lovejoy coupling to transmit rotational power to drive the gearbox leading to a misalignment of the FRM. Scribing the position of the flex shaft brackets aided in returning the new flex shaft to its initial position. Sensor cable ties were also replaced. However, we were not able to manage the additional task of replacing the pinion gear (motor-to-ring gear) on the FRM.
