## 1. Trip Summary

## 2. Executive Summary

**National Radio Astronomy Observatory**  
**VLBA Antenna Memo Series – No. 112**  
Chantel Flores and Fernando Santoro  
**INSPECTION REPORT – Fort Davis, March 10-12, 2026**

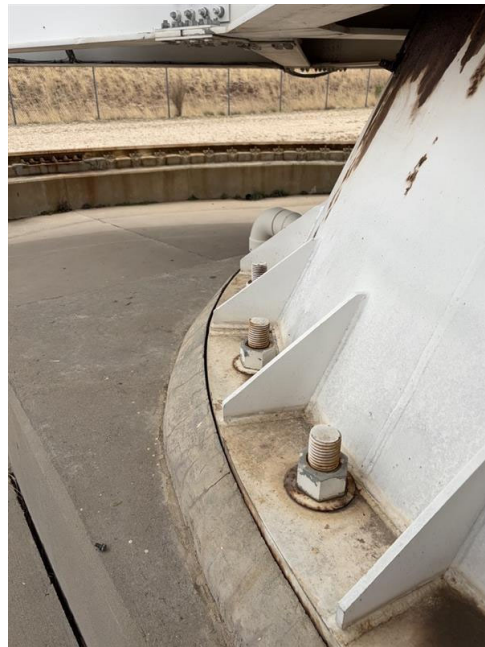
Figure 16: Pintle Bearing Assembly (Exterior)

The porthole to the pintle bearing room was inspected and found to be in good condition. The plexiglass cover does not currently have a weather seal, and some superficial rust was observed at the flange interface, indicating that water may be entering (superficially) through this area.

As part of Safety Corrective Action 3621 (VLBA Pintle Bearing Room Porthole Cover Redesign), a threaded pin will be installed at the upper portion of the mounting flange to support the cover when all fasteners are removed. In addition, a silicone gasket will be applied to the cover to prevent water infiltration. This solution will be initially applied in PT and then to FD during the upcoming Tiger Team.

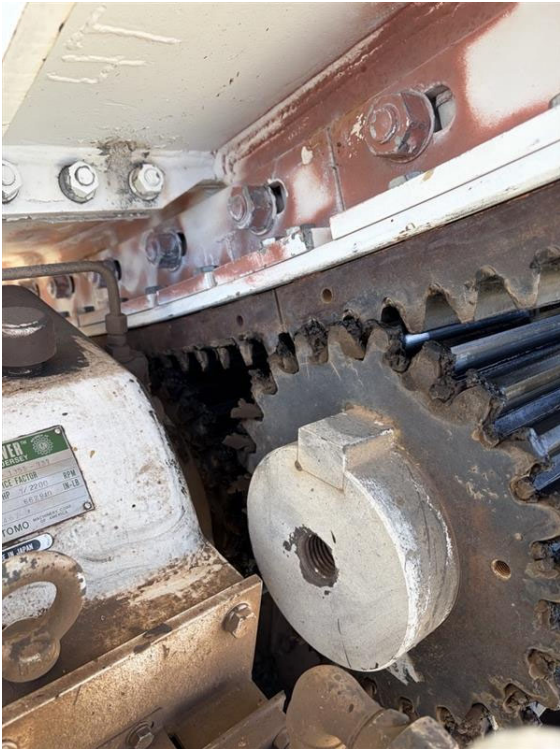
Figure 25: Pinion Gear and Bull Gear

Open gear grease is used on the sector (bull gear) and pinion gears. It's tackier than our semifluid greases used on azimuth and elevation bearing, sticking to our open gears without running off. Further open gear applications are to be investigated against current operating conditions for improved wear protection. Noises from gearbox drives have been reported after rebuilds and are being investigated. Acoustic imaging, axial clearance determinations along with motor and meshing points within stages will be evaluated in the coming weeks.

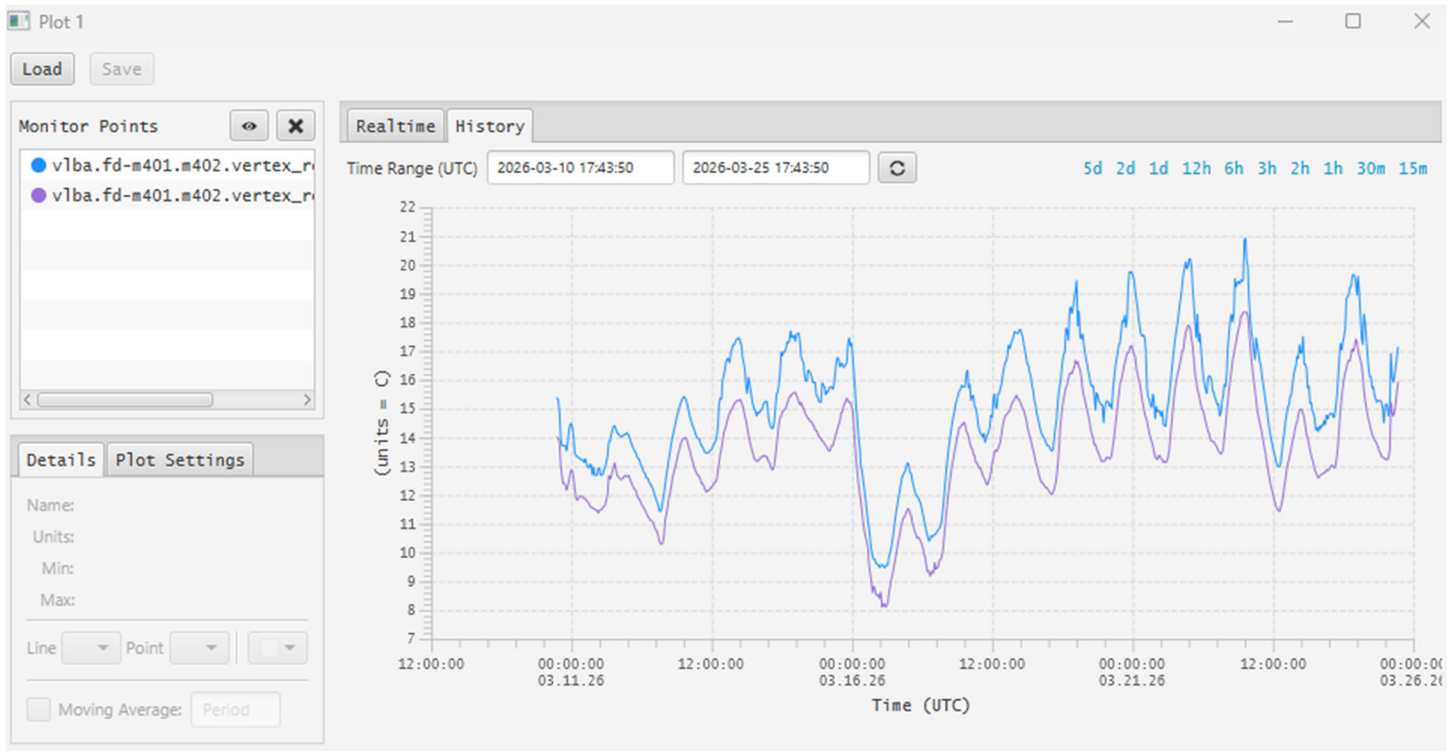
Figure 35: Temperature Readings (Vertex Room)

The above figure shows temperature readings for the upper and lower vertex room. The line color for the upper vertex room is blue and the lower vertex room is purple. Cooling for FD is set around 16.19°C . The difference between the two levels can vary anywhere from two to four degrees. Extreme outdoor conditions can contribute to larger temperature differences due to the location of the air handler with respect to the dish and the two room levels.

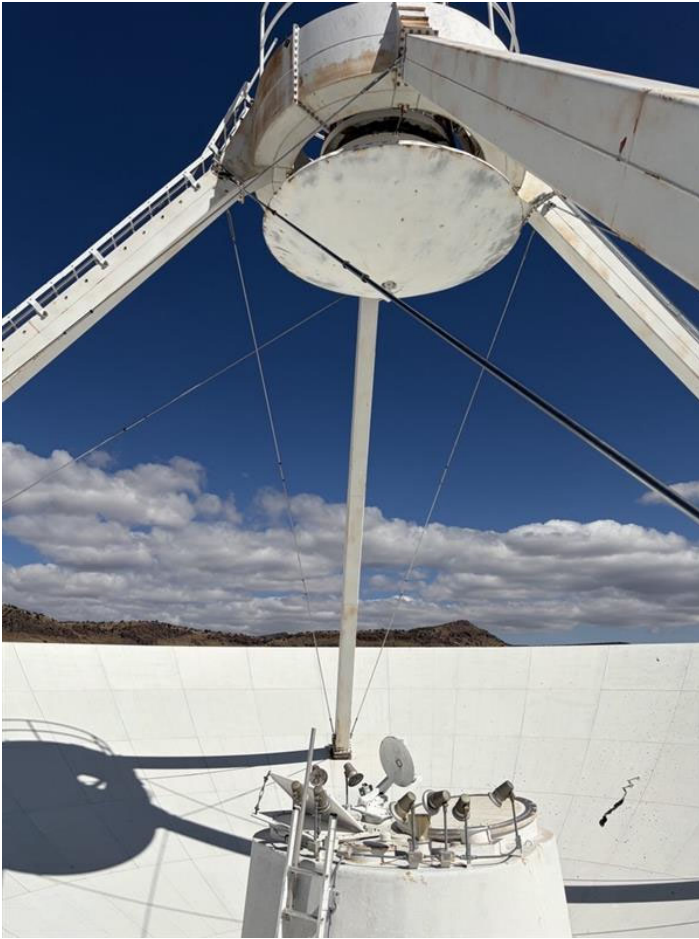
Figure 38: Feed Cone

Slightly northeast of the vertex room hatch door, several panels were stained with a hardened black residue seen in Figures 39 and 46. Some components of the feed cone were also found with similar spotting. It was later detected that the FRM bumper material had degraded and leached onto the lower-level structures. Despite minimal staining, the feed cone is well maintained. Though the feed cone is minimally insulated, walls showed no visible problems. Though the feed cone is minimally insulated, walls showed no visible problems, such as cracks and insulation delamination. No actions required

The torsional rod assemblies (eight total) provide stiff load paths. For each guy wire, no significant droop was present. Any unequal guys could shift the demand on any one wire seen in Figures 38, 40 and 41. The subreflector quad legs (four total) are located outboard to the apex ring terminating at the primary reflector (see figure 40). The surface condition was generally good, with no distinct issues affecting the structural integrity of these quad legs. No weep holes were found along the joints of these members. These are generally small openings to allow for water to escape. Some sites prone to water intrusion include weep holes. This ensures that trapped moisture can exit.

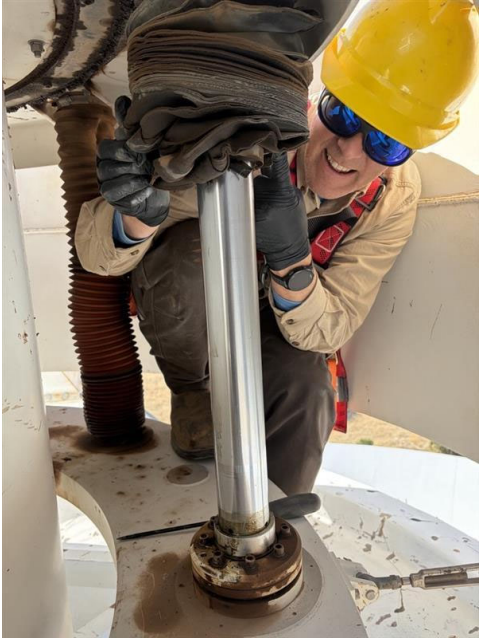
Figure 47: Linear Shaft #1

All four bellows of the FRM linear shafts were opened to allow visual inspection of the shaft surfaces. The shafts were found to be in good condition, with no significant dents, scratches, scoring, or other visible damage. Lubrication appeared adequate on all four shafts. The flex drive and pinion gear were also inspected and found to be in good condition, with no visible signs of wear.

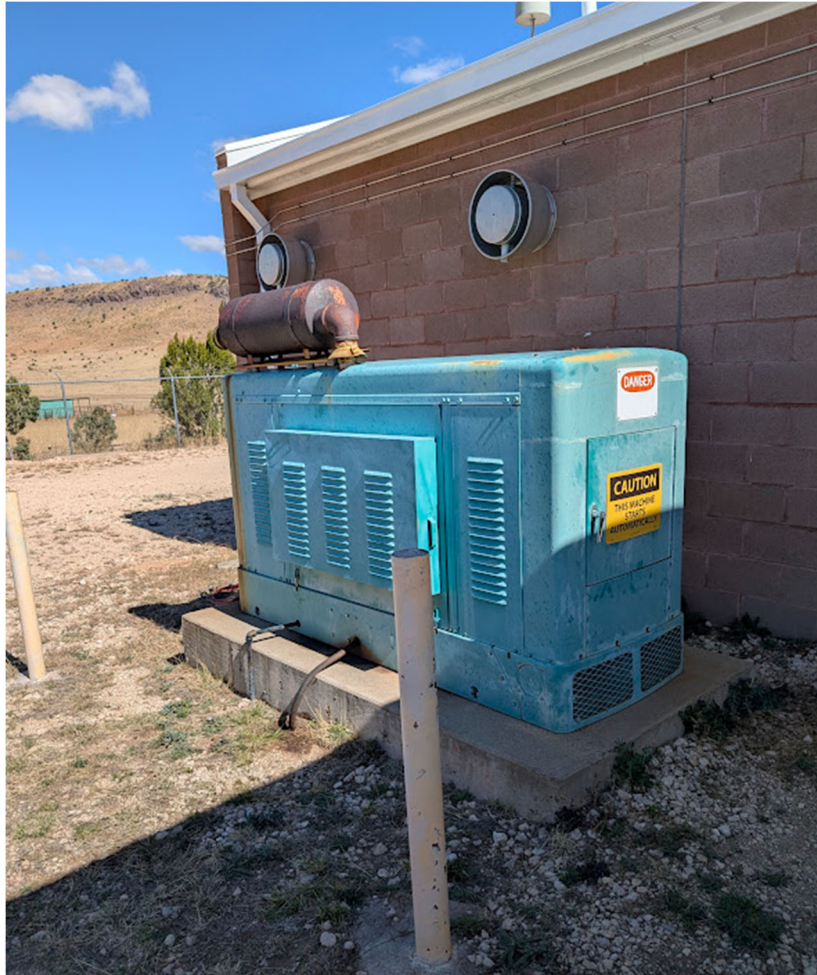
Figure 51: Site Generator

Fort Davis is one of three VLBA sites awaiting a new generator installation. The original propane generator can be seen below in Figure 51.
