1. Trip Summary

An engineering scout trip was conducted at the Brewster, Washington VLBA station on June 10-11, 2026. The engineering inspection was represented by:

This engineering inspection trip report summarizes inspection activities performed at the BR VLBA antenna from June 10-11, 2026 (Figure 1).

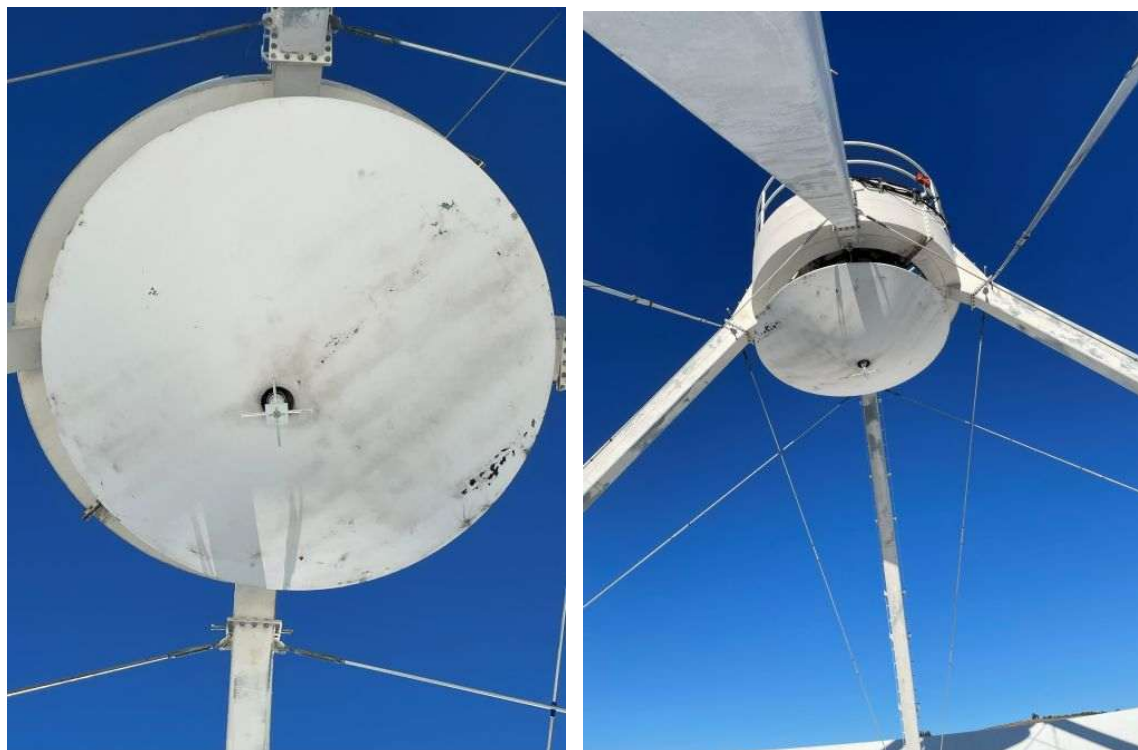
Figure 35: Subreflector Assembly

Paint fading was visible on the subreflector (Figure 35), along with moderate areas of topcoat delamination. Compared with other sites, however, the subreflector surface remains relatively uniform and is among the less affected exterior surfaces. Preventive maintenance should include sanding, filling, and repainting the affected areas during this year's upcoming Tiger Team visit.
