NATIONAL RADIO ASTRONOMY OBSERVATORY
Socorro, New Mexico

VLBA Antenna Memo Series No.20

St. Croix Corrosion Report

J. E. Thunborg
August 7, 1999

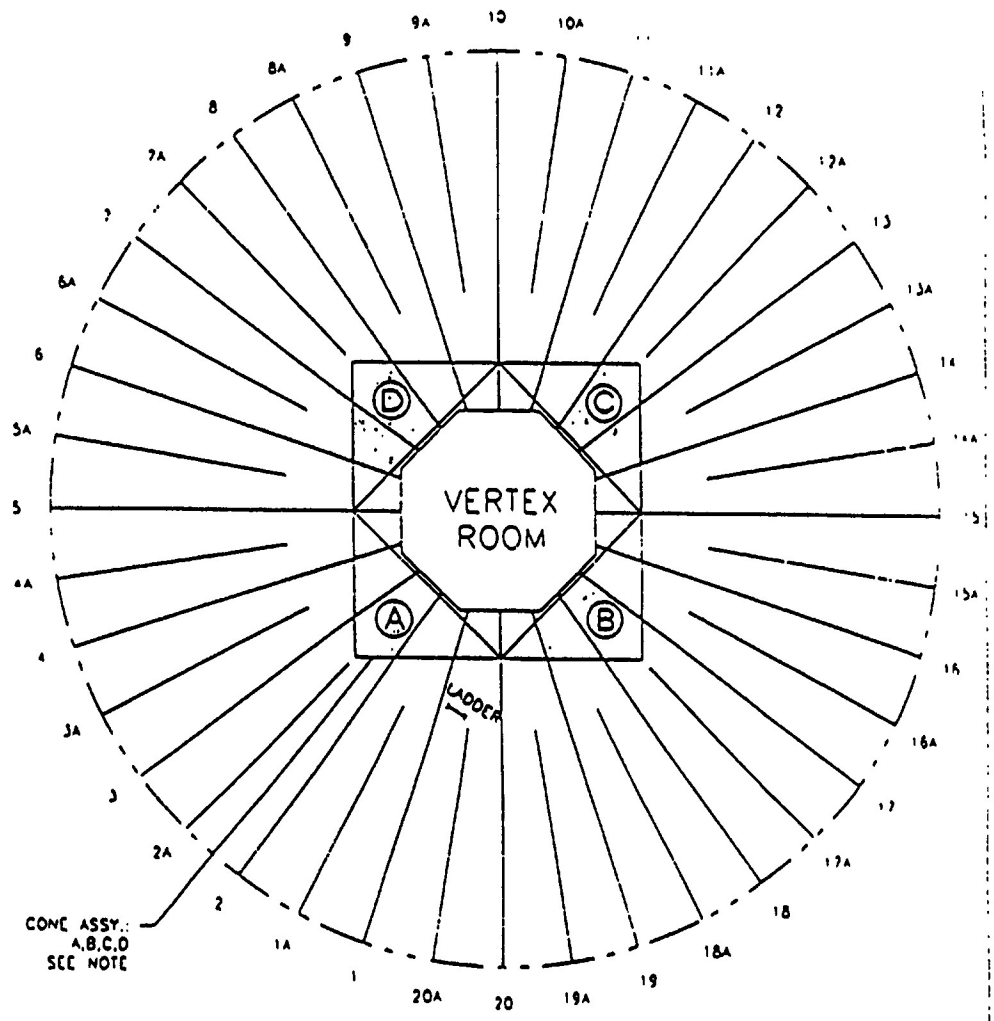
JOINT LISTING REQUIRING REPAIR
(NOT INCLUDED)

- * ANGLE PEELING
- ** WF BEAM AROUND VERTEX TOUCHUP
- *** SMALL RUST SPOTS

NOTE - INSPECT CONE ASSY INTERNALLY
REPAIR/PAINT AS REQUIRED
