National Radio Astronomy Observatory
Socorro, NM

VLBA Antenna Memo Series #34

Brewster Maintenance Visit
July 23rd through 30th, 2001

Jim Ruff
8/2/01

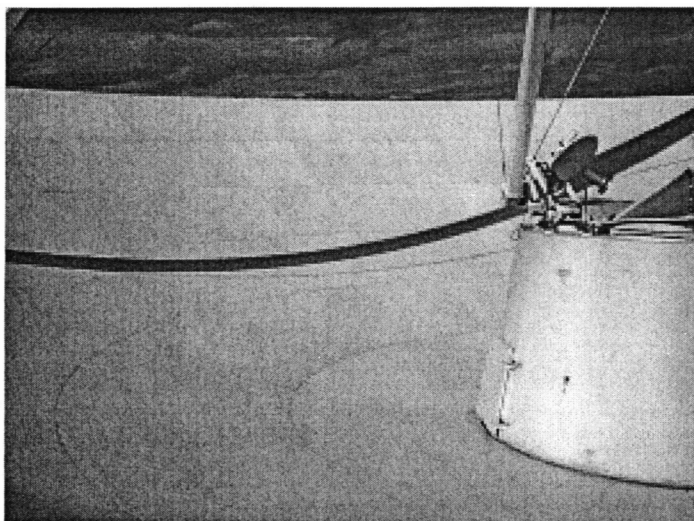
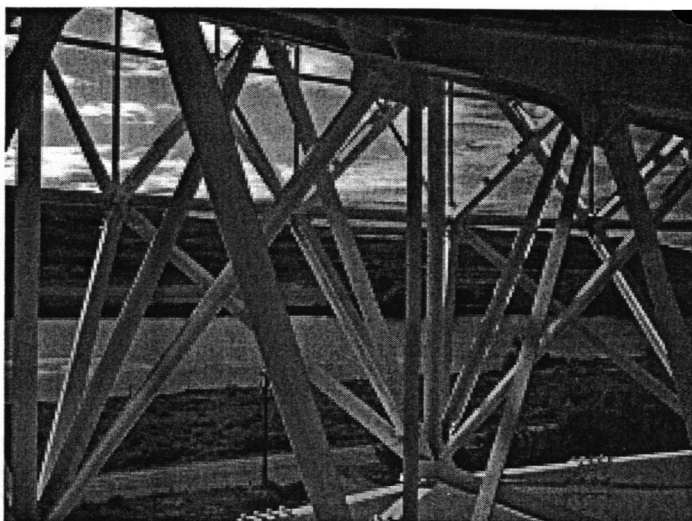
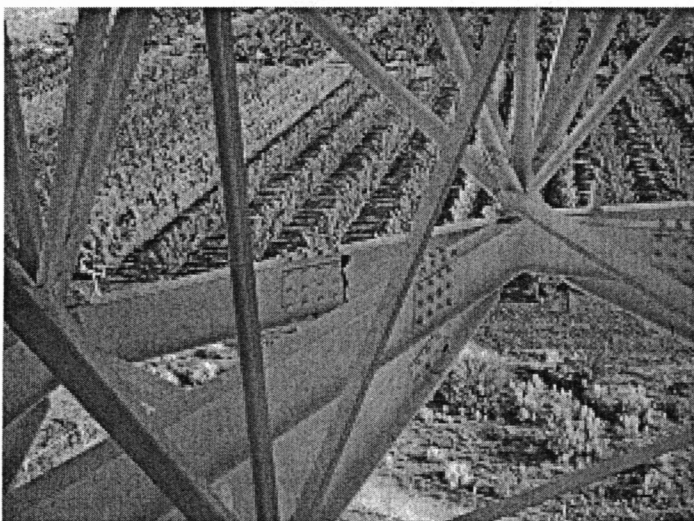
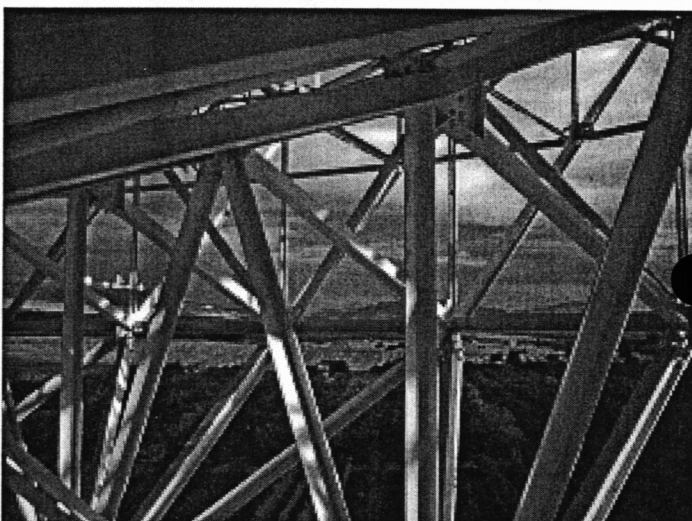
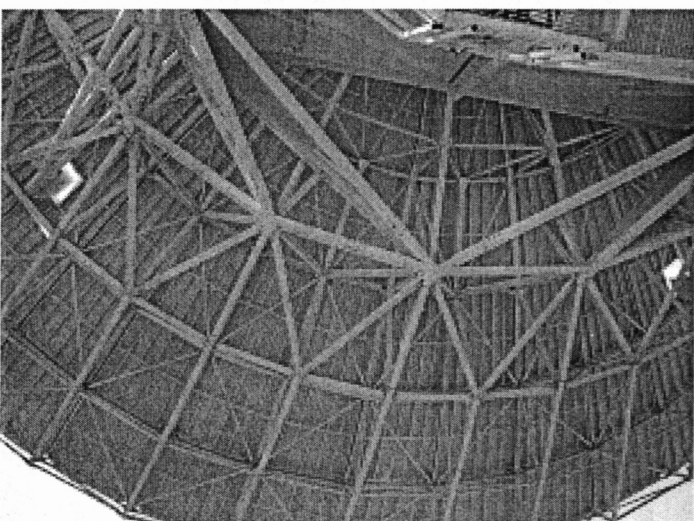
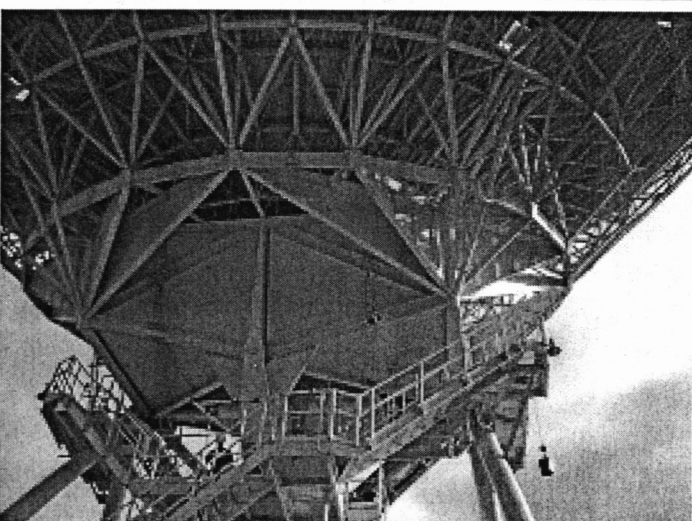
The rail at Brewster is very flat, with less than 0.030" deviation in elevation after the tilt is removed. The first order tilt is only 6 arcsec.

The paint on this antenna is in excellent condition.
