**National Radio Astronomy Observatory
Socorro, NM**

VLBA Antenna Memo Series #36

**Pie Town Maintenance Visit
2001**

**Jim Ruff
1/04/02**

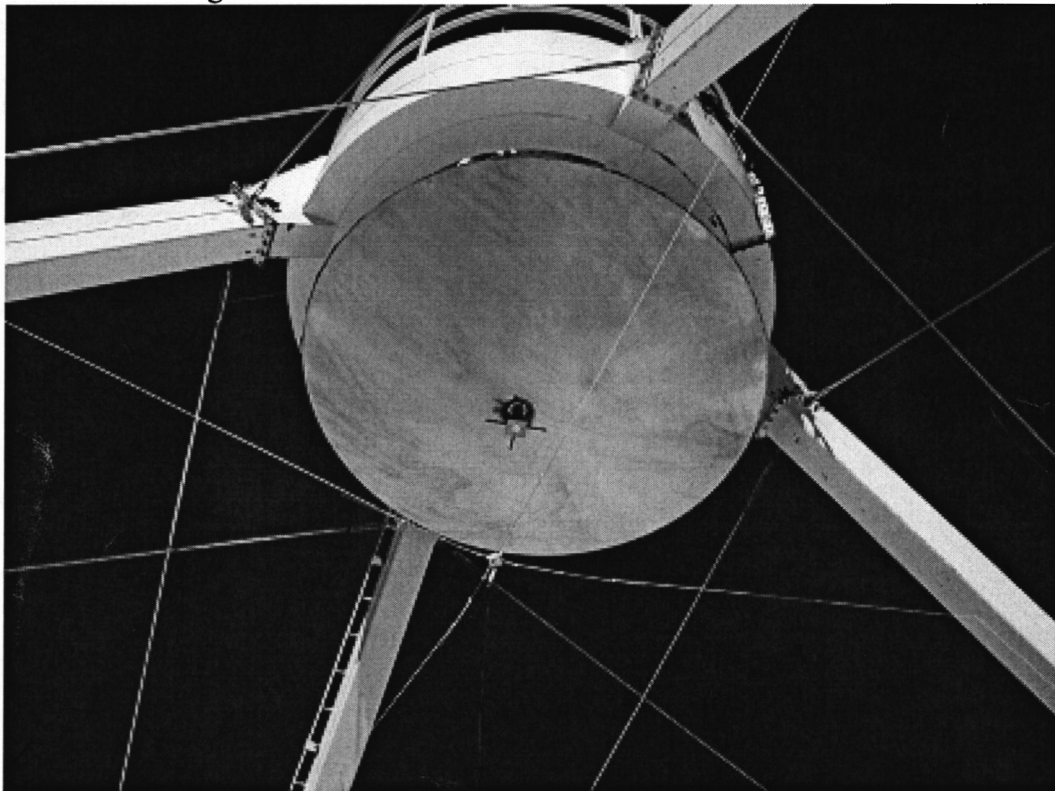
Kelly and Eric were treated to a training session on use of the Sellstrom system and general fall protection. They are using short nylon webs to attach the Sellstrom trolleys to their harnesses. These webs are lightweight and strong, and would facilitate rescue in event of a fall. But, they can not be left outside when not in use. This issue is being investigated.
