NATIONAL RADIO ASTRONOMY OBSERVATORY
Socorro, New Mexico

VLBA Antenna Memo Series No.37

Owens Valley Gearbox Repair

J. E. Thunborg
April 26, 2002

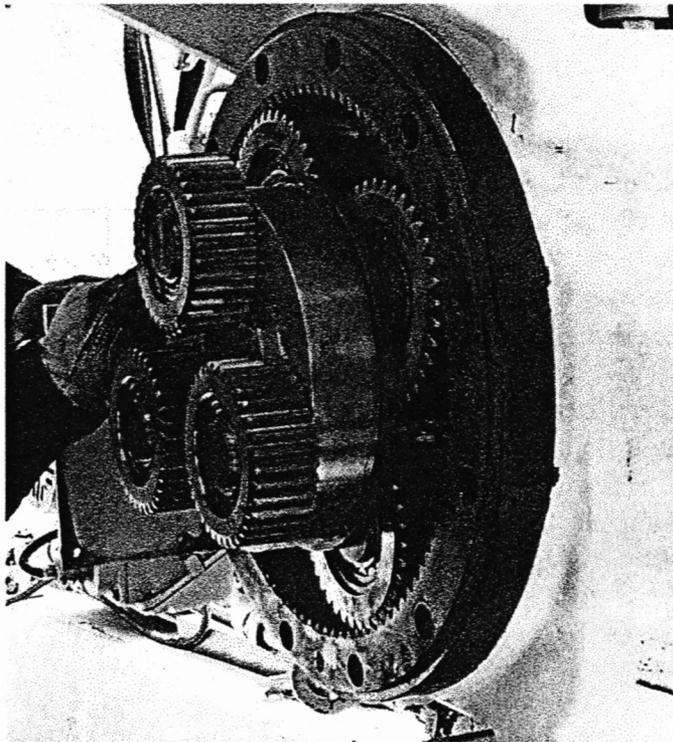
On April 4, 2002, The Owens Valley VLBA Antenna was removed from service because of frequent “azimuth current motor sums greater than 30 amps” errors. The motor current plots recorded during observations showed periodic current fluctuations of 5 - 10 amps amplitude and 2 hour period. After a complete check of the drive electronics, the site techs (Jim Brown and Bill Robins) used a ½ inch drill motor to power the antenna in Azimuth. They found that the antenna had tight spots where the drill motor did not have sufficient power to turn the antenna.
