**National Radio Astronomy Observatory
Socorro, NM**

VLBA Antenna Memo Series #40

**St Croix Maintenance Visit
April 8th through 25th, 2002**

**Jim Ruff
6/24/02**

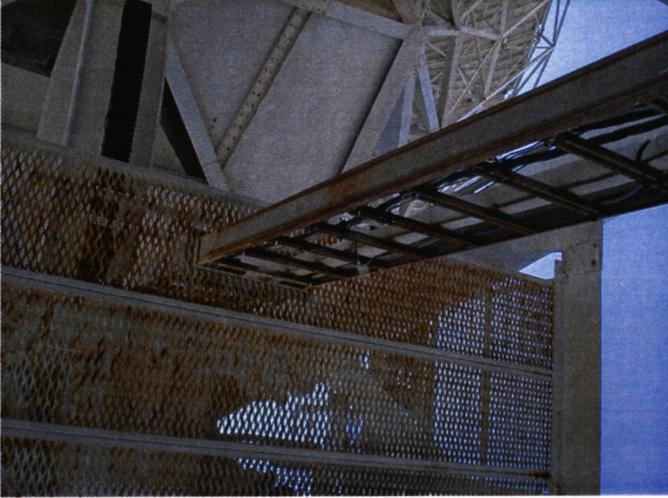
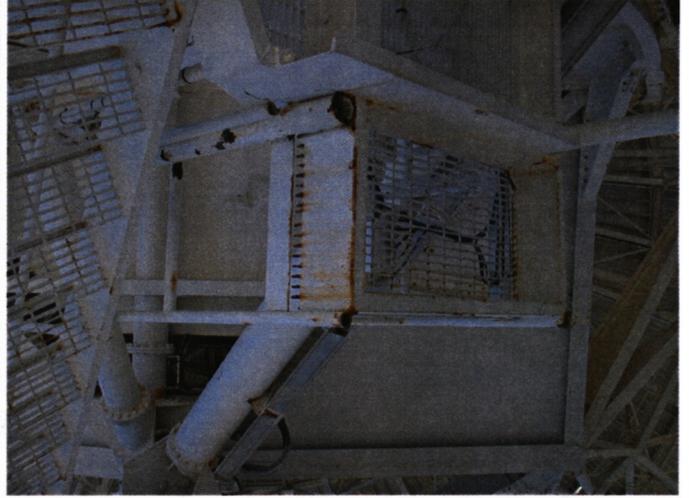
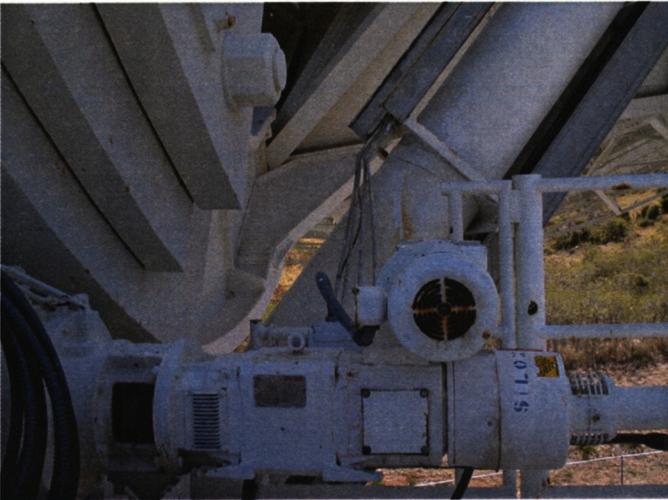
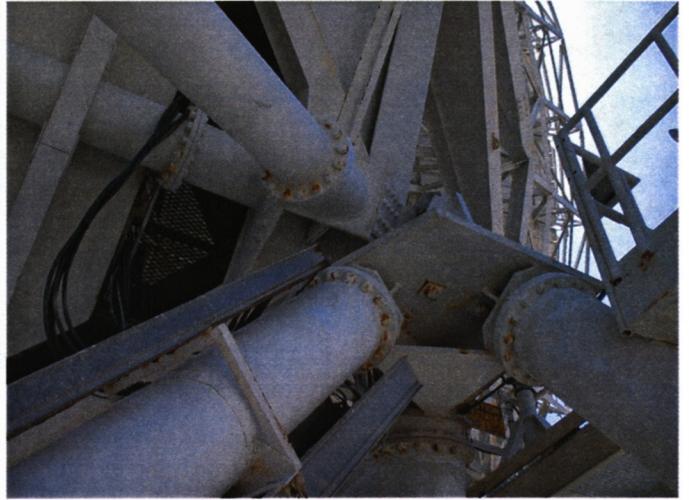
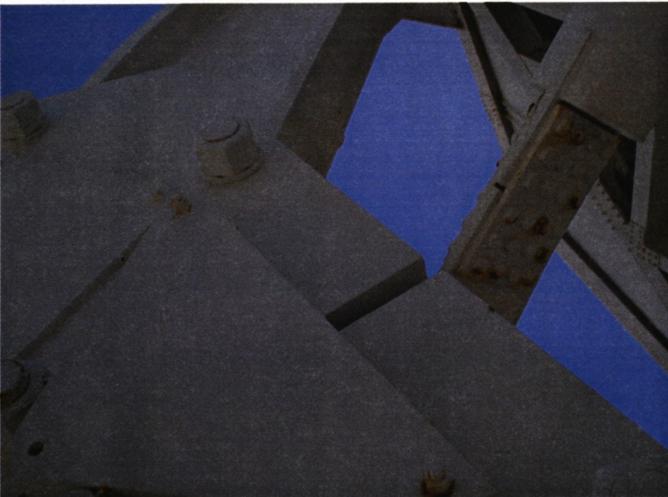
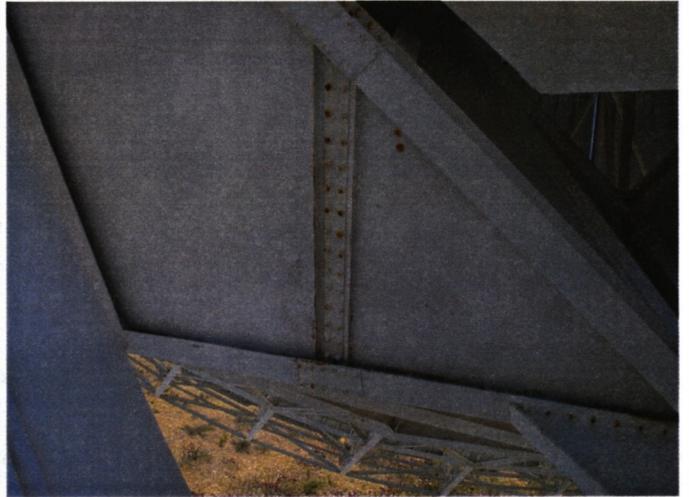
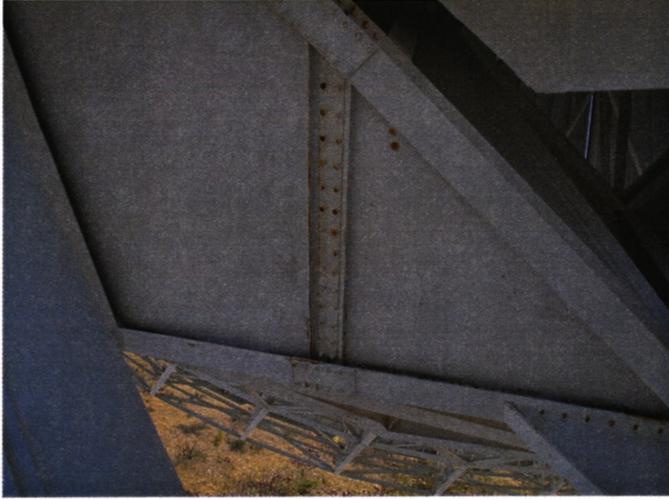
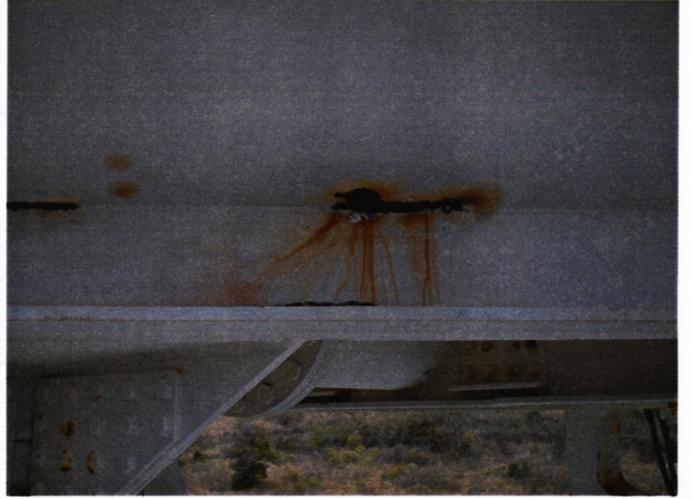
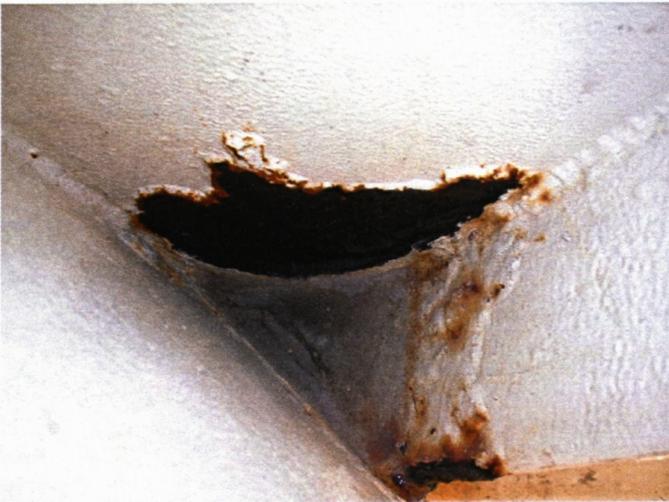
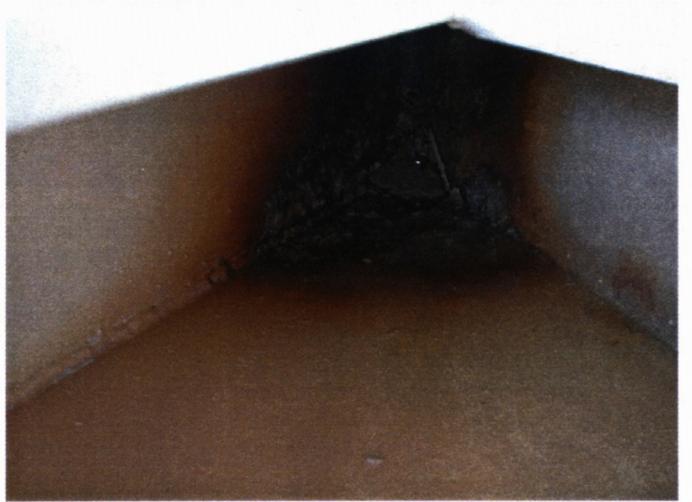
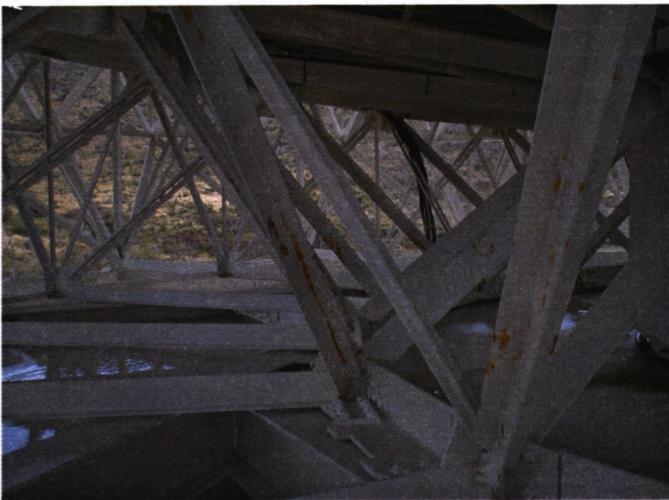
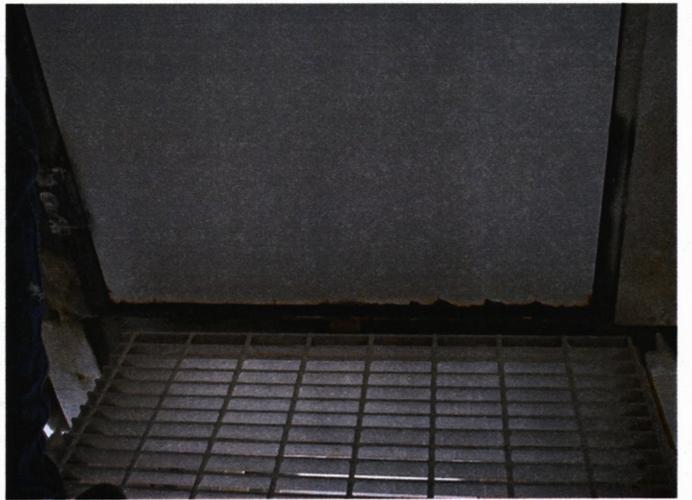
The splice at bolt #119 appears to be sinking over time. Similar behavior was seen at NL by the rail grout repair crew this year. It appears the rail is being slightly, slowly squashed at the splices. This should be repairable by shimming.

The painters appear to be doing an effective job, but rust is still evident.
