**National Radio Astronomy Observatory  
Socorro, NM**

**VLBA Antenna Memo Series #41**

**Hancock Maintenance Visit  
June 3<sup>rd</sup> through 10<sup>th</sup>, 2002**

**Jim Ruff  
6/25/02**

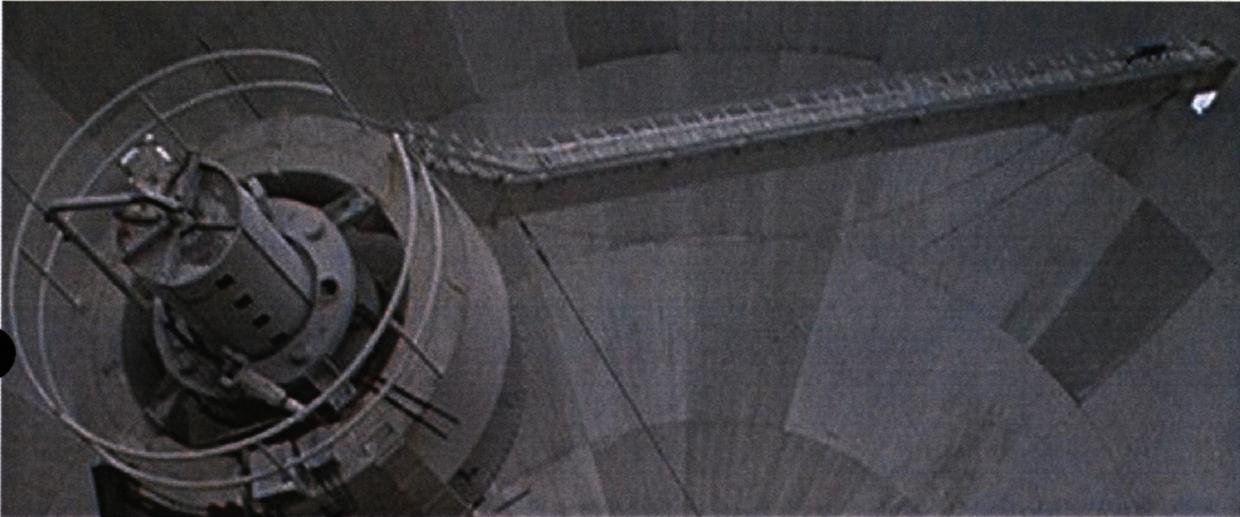
**An apex handrail, quad leg ladder and Sellstrom fall arrest system were installed. The site techs were treated to a training session on use of the Sellstrom system and general fall protection.**
