NATIONAL RADIO ASTRONOMY OBSERVATORY

VLBA Antenna Memo Series No. 48

St. Croix Elevation Bearing Replacement - Trip Report

J. E. Thunborg September 10, 2003

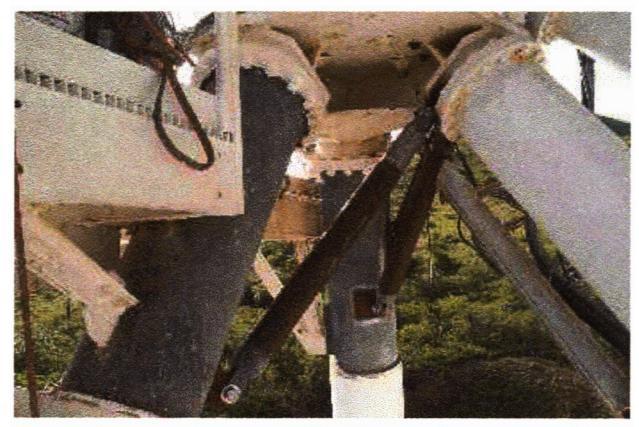
Metal particles were found in the grease on the condenser side elevation bearing at St Croix. After carefully watching this bearing for several months, it was decided that the bearing needed to be replaced. Steve Aragon, Kelly Greene, Ramon Gutierrez, Phillip Sanchez and Jon Thunborg were dispatched to St Croix to replace the bearing with the capable help of site technicians Peter Allen and Tazewell Reed.

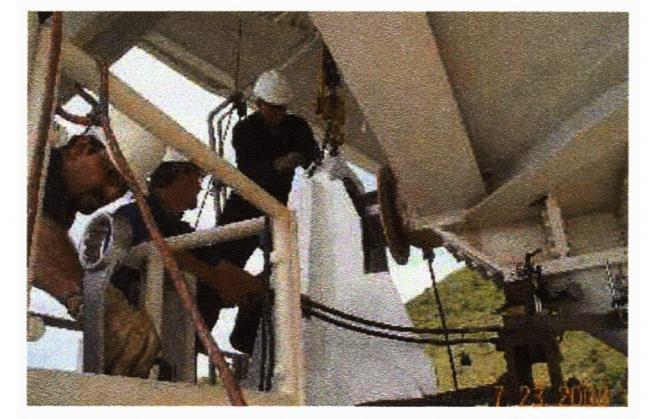
During the Las Alamos elevation bearing change, we experienced deflections in the antenna structure that were greater than were desired. Therefore, the finite element model was refined to better simulate the entire structure under the load path required for the bearing change. Using this model, it was found that installing the two struts shown in the photo in addition to the jack support beam, brace beam and anti-rotation pin that were installed in Las Alamos as described in

VLBA antenna memo #29 significantly reduced both the stress and deflection of the structure.

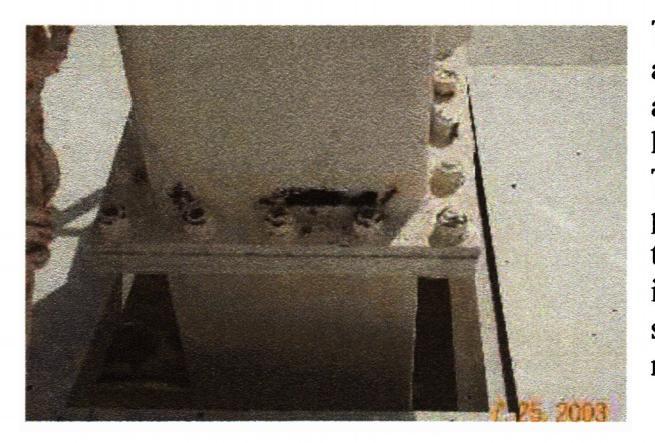
This picture shows a hole that has corroded all the way through the quad leg of the antenna. The steel on this side of the quad leg has completely failed due to this corrosion. The reason that the corrosion is so bad on this part of the quad leg is that water runs down the inside of the quad leg and pools on an internal lip in the quad leg. This quad leg should be repaired during the next maintenance visit.
