**National Radio Astronomy Observatory
Socorro, New Mexico**

VLBA Antenna Memo #57

Owens Valley, CA. VLBA Maintenance Visit Sept. 23 thru Oct. 1 2004.

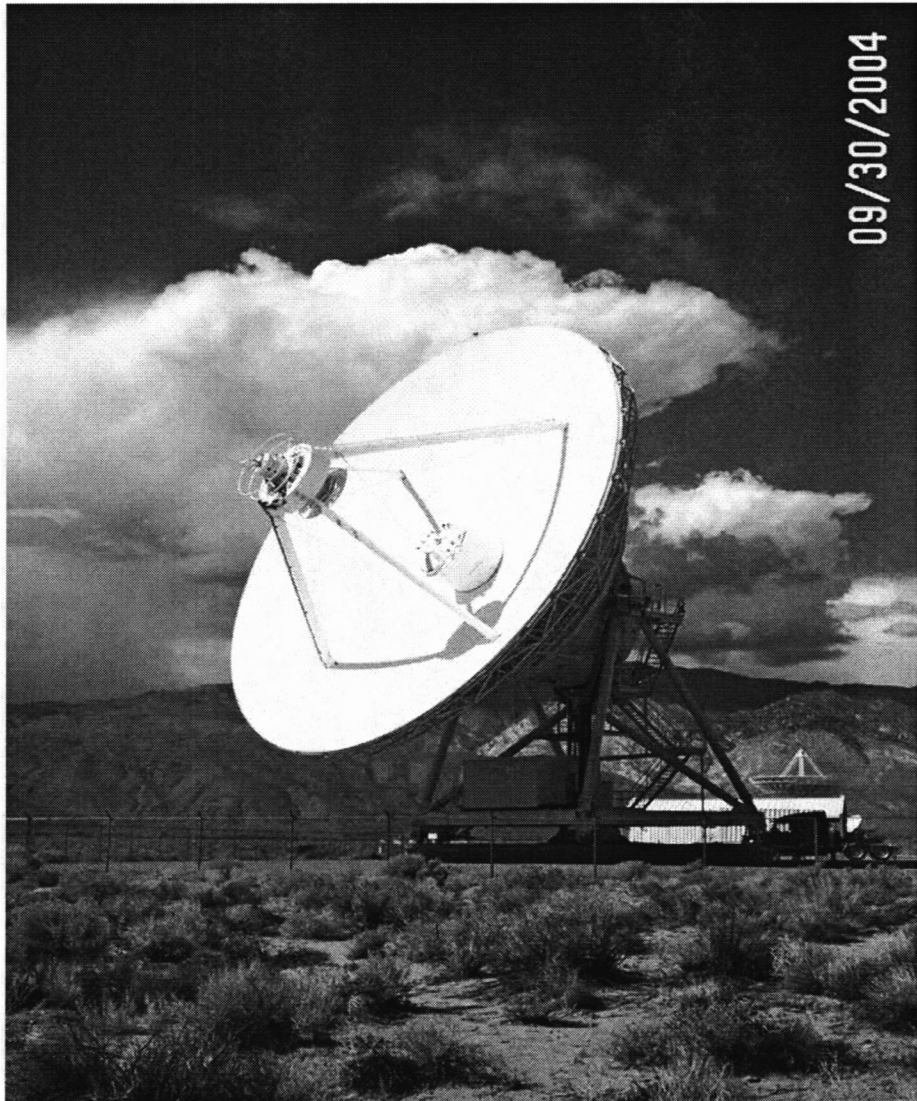
Team members consisted of Steve Aragon, Eric Carlowe, Ramon Gutierrez, Ken Lakies, Bob McGoldrick and Phillip Sanchez. VLBA Site Technicians Jim Brown and Bill Robbins assisted in all areas of maintenance during the visit. A completed task list is attached.
