NATIONAL RADIO ASTRONOMY OBSERVATORY
Socorro, New Mexico

VLBA Antenna Memo Series No.68

St. Croix VLBA Antenna Painting and Surface Preparation Requirements

J. E. Thunborg
May 8, 2007

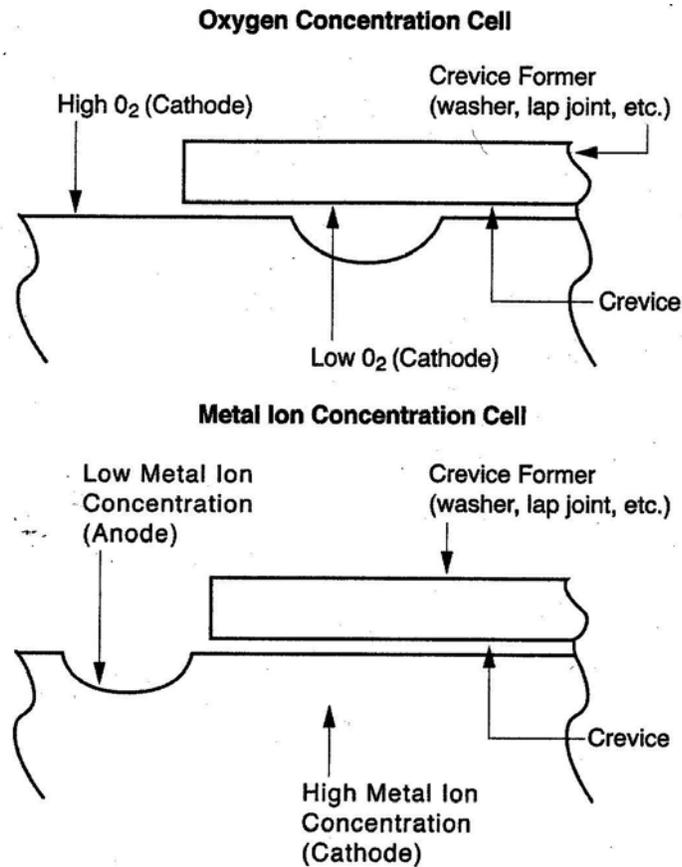
The most corrosion on the structure is occurring where the structural members are bolted together. These bolted connections have lots of edges so they are susceptible to the edge problems as described above. In addition, crevice corrosion is also a major problem at these connections. Crevice corrosion occurs in the pockets that form when pieces of metal are held together in a lap joint, under washers or between a bolt and a nut. There are two types of crevice corrosion. The first occurs when an area of low oxygen concentration inside the crevice causes the inside surfaces to become anodic to the surface outside the crevice. A second form of crevice corrosion occurs when corrosive elements inside the crevice, such as salts and moisture, create a build-up of corrosion products. The interior of the crevice becomes a cathode and the exterior of the crevice shows severe corrosion because it becomes the anode. Severe pitting and loss of structural strength can occur from this concentrated form of corrosion. See Figure 1.

FIGURE 1 Concentration cell corrosion. Top: Oxygen concentration cell. Bottom: Metal ion concentration cell. Courtesy of SSPC: The Society for Protective Coatings; 4th Edition, *Good Painting Practice, SSPC Painting Manual, Volume I*.

Our inspections at St. Croix indicate that most of the corrosion is taking place outside of the crevices indicating the metal ion concentration cell type crevice corrosion.

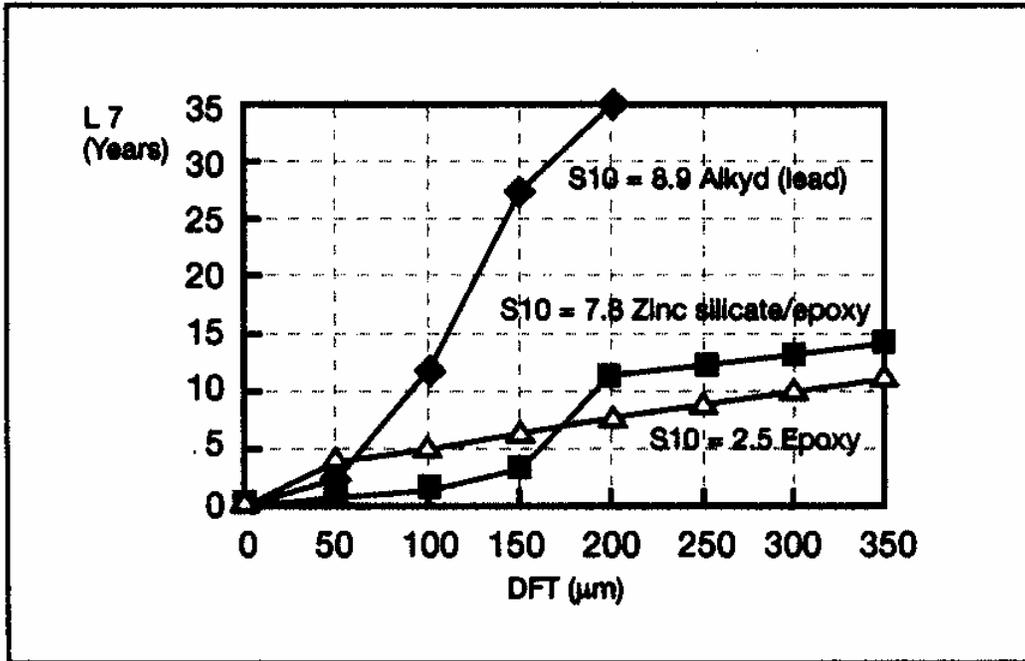
Coating condition is assessed as the percentage of coating breakdown over a large area. Repainting is usually initiated when a coating system reaches rust grade 7 (0.3 percent area rusted) according to ASTM D 610 or, at worst rust grade 5.5 (1.8 percent area rusted) [26].

The above graph compares the time to reach rust grade 7 for 3 coating systems in a seacoast environment [24]. The St. Croix antennas Zinc Silicate/Epoxy system was specified to have a Dry Film Thickness (DFT) of 275-375 µm. According to the chart, this represents an L7 life of 13 – 14 years. The antenna was built in 1992 and is now 15 years old.
