NATIONAL RADIO ASTRONOMY OBSERVATORY
Socorro, New Mexico

VLBA Antenna Memo Series No.76

St. Croix VLBA Antenna Painting and Surface Preparation

J. E. Thunborg
March 31, 2009

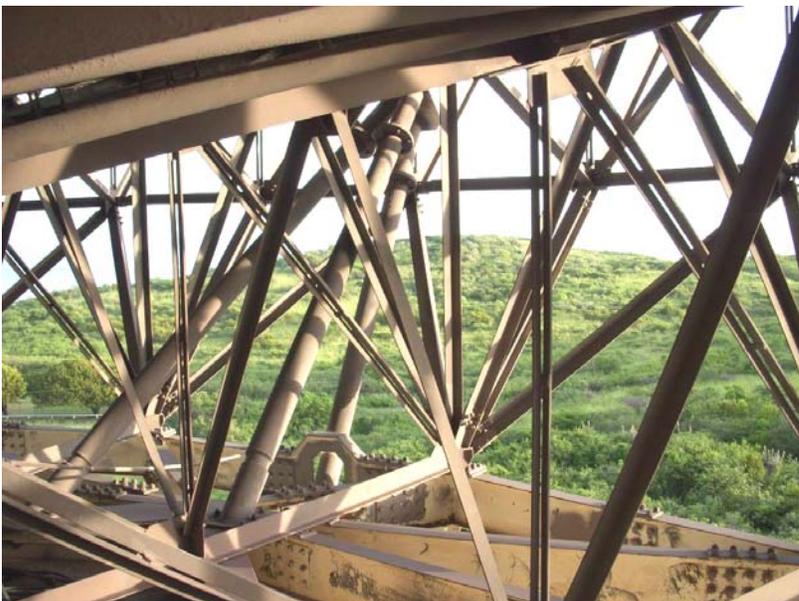
Figure 7, Backup Structure Truss Primed with Organic Zinc Primer.

The dry film thickness was measured with a Type I thickness gauge and was found to be between 2-4 mils. This is consistent with the 3 mil recommendation on the Amercoat 68HS Product Data Sheet.

The backup structure was primed with Amercoat 68HS using conventional spray with mechanically agitated pressure pots. Conventional spray was chosen over airless spray on this part of the structure because of the complexity of the bolted connections. The paint had to be sprayed from several angles to get coverage on the complicated connections. Airless spray would have resulted in excess dry film paint thickness at the connections. The air supply to the pressure pots was filtered and dried with an after cooler and water separator.

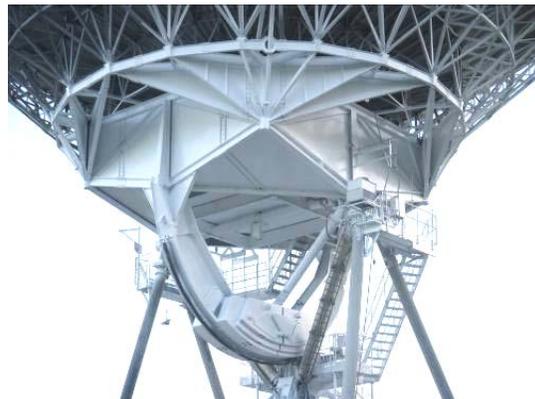
Figure 11, Completed Antenna.

The majority of the corrosion on the antenna is being inhibited by the new paint job. The paint adhesion is adequate and the paint system is performing well where it was applied properly. There are however, several holidays in the paint that will need to be addressed before the corrosion in these areas progresses to the point where additional surface prep will be required. These holidays should be encapsulated as soon possible with Amerlock 400 epoxy applied by brush. A small crew of NRAO or locally contracted painters should repair these holidays as soon as possible. After these holidays are repaired, only minimal paint system maintenance will be required for the next few years. The expected life of the paint job in the coastal environment, assuming the current holidays are repaired, is 10 – 12 years.
