VLBA Antenna Memo Series #41

Hancock Maintenance Visit
June 3rd through 10th, 2002

Jim Ruff
6/25/02

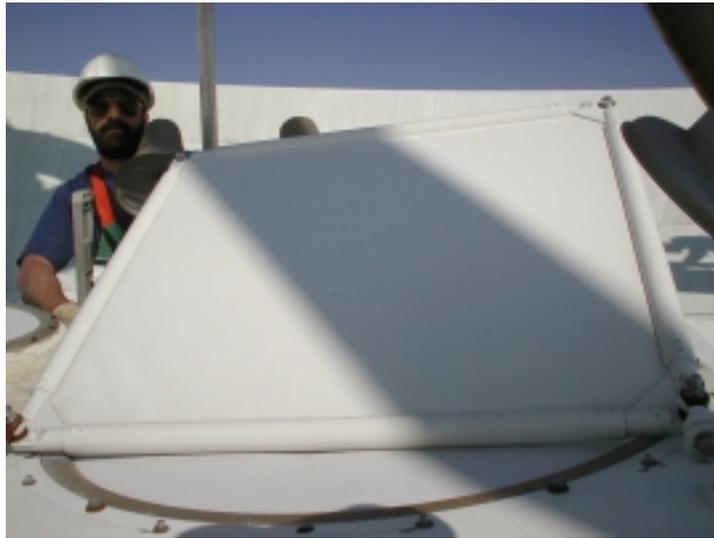
The azimuth bearings were inspected. One needed replacing. The outer races had been rotated previously, so we didn't do it.

Az Bearing Grease Inspection				
	Drive 1	Drive 2 (new style)	Tach side Idler	Other Idler
Inner	some flakes	some flakes	very fine flakes	clean
Outer	some metal & pitting	replaced	many flakes, no pitting	several small flakes

Drive Wheel Alignment			
Wheel #	Horizontal Error	Vertical Error	Radius Error
D1	0° 1' 31"	0° 0' 2"	0.24" (out)
D2	22"	0° 3' 16" (too flat)	0.17 out
